Service Bulletin

Bulletin No.: 25-NA-050

Subject: DTC U0265 and Other Front Camera Module Software Concerns

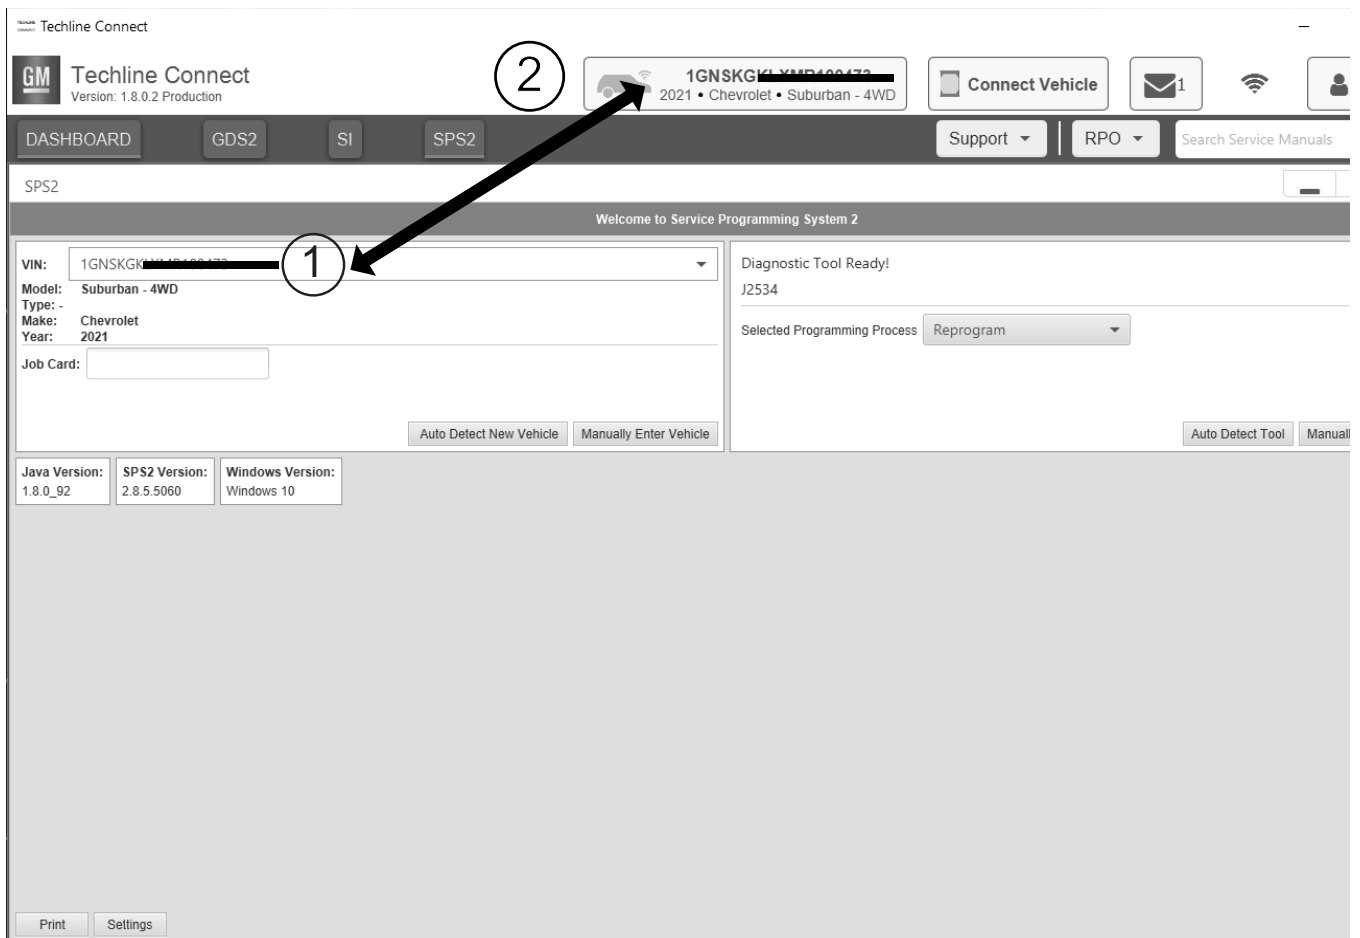
5743643

Caution: Be sure the VIN selected in the drop down menu (1) is the same as the vehicle connected (2) before beginning programming.
