PRODUCT CAMPAIGN BULLETIN

APPLICABILITY: 2020-2022 MY Legacy
2020-2022 MY Outback

NUMBER: WRA-24R

SUBJECT: Safety Recall – ODS Sensor Replacement

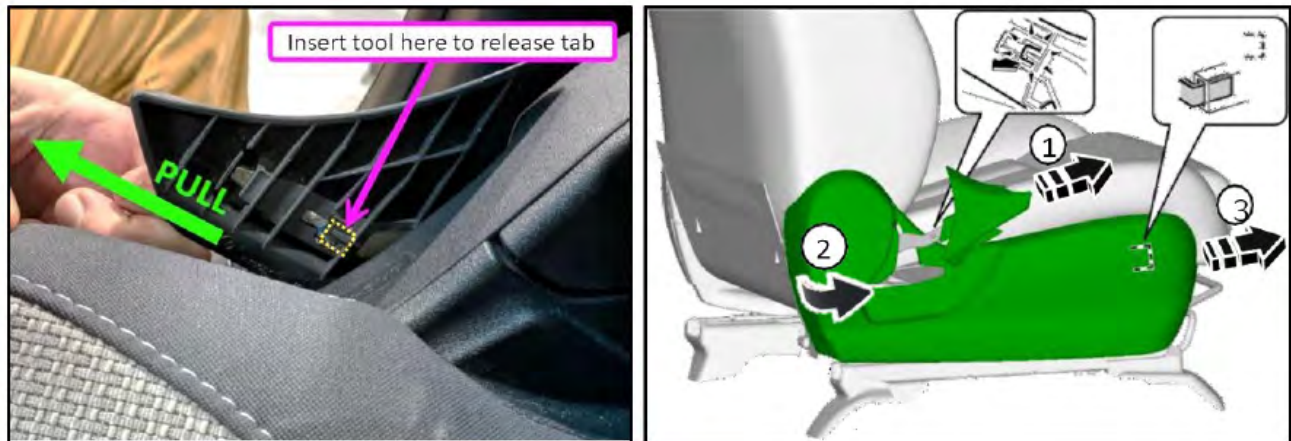
STEP 8: Pull up on the backrest adjustment handle and insert a small screwdriver or plastic trim tool into the handle cover locking tab. Once the tab is released pull the handle cover toward the front of the vehicle to remove. Once the handle cover is removed, release the rear section of the seat side cover. With all the holding clips released, the cover can then be removed by pulling towards the front of the vehicle.

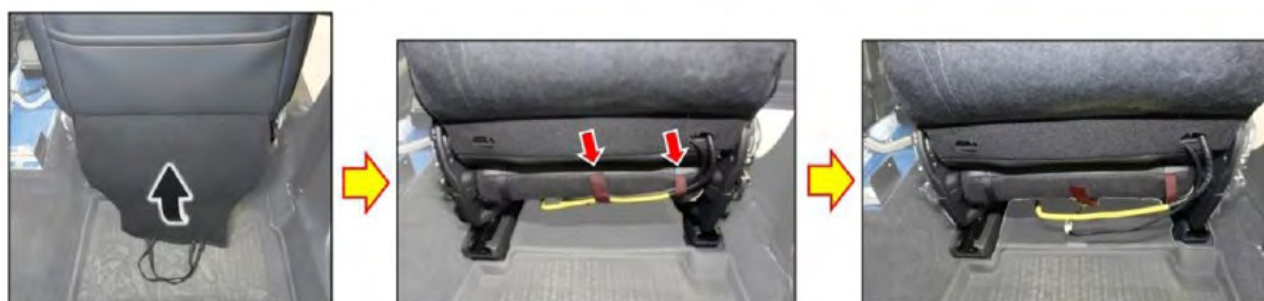
STEP 12: Tuck the hanging section of the cover into the rear pocket of the seat. Release the two Velcro straps and free the two harness sections.

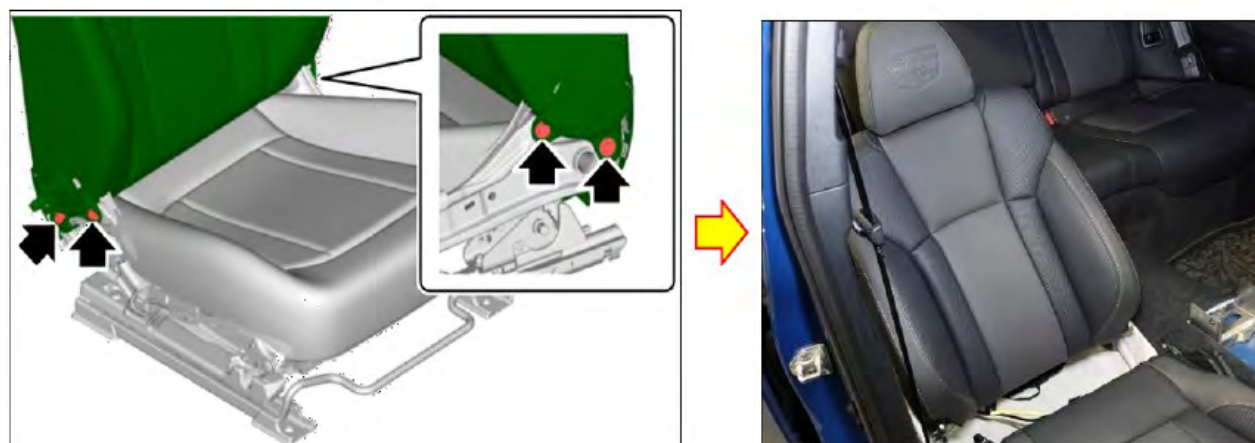
STEP 13: Unbolt and discard the four bolts mounting the seat backrest to the bracket. Place the backrest into the rear seat footwell area.

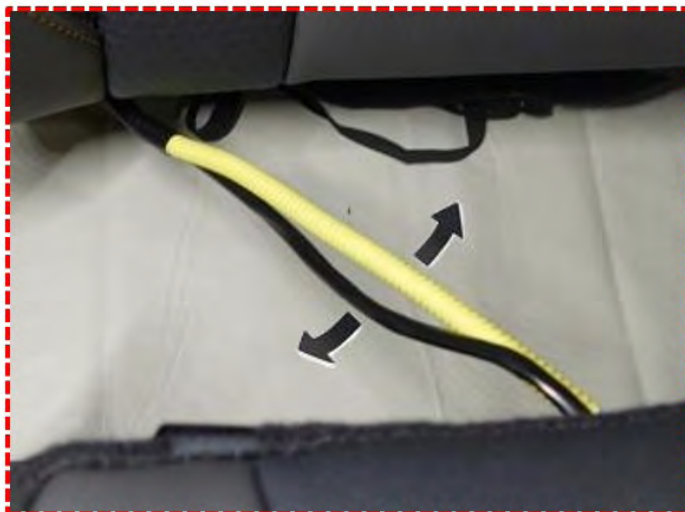
CAUTION: Confirm the harness section does not have any excessive tension and is free from pinching of any kind.

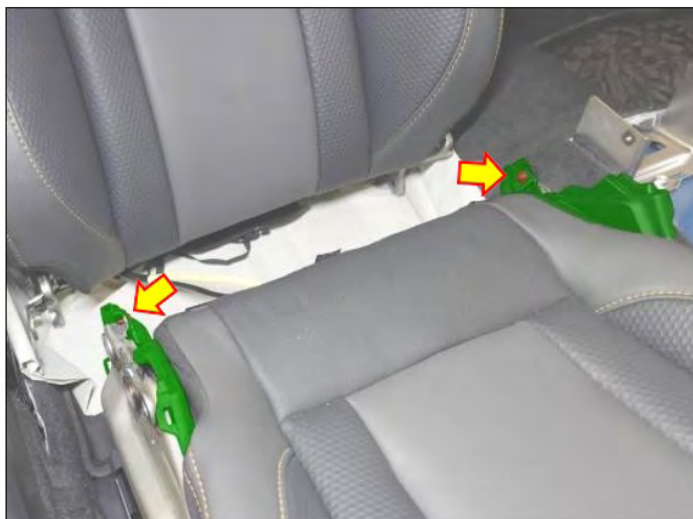
STEP 14: Remove both mounting screws for the inner cushion covers.

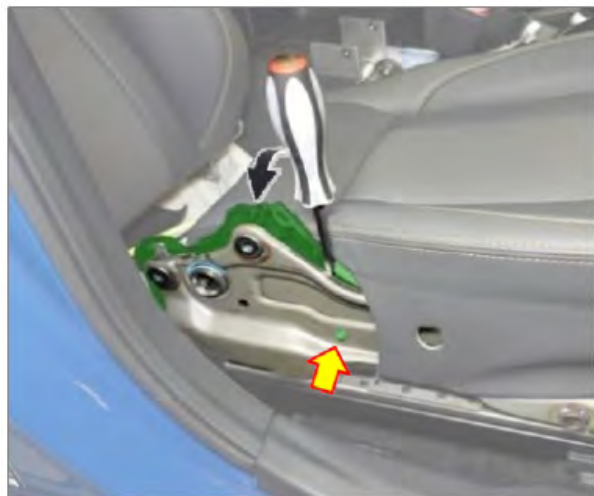
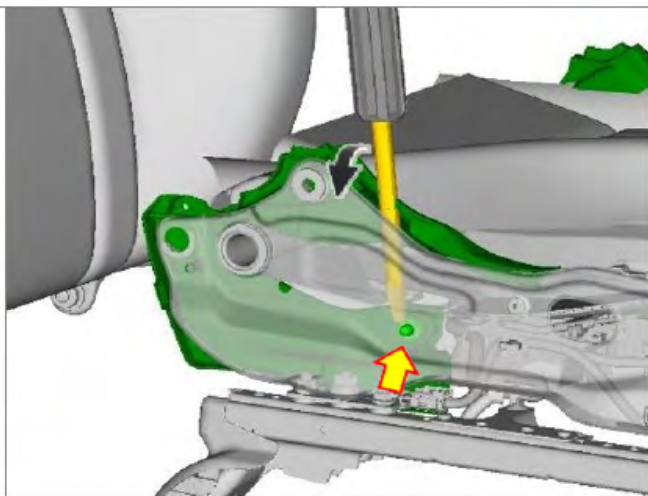
STEP 15: Starting with the outside cover, release the mounting clip using a large flat blade screwdriver or suitable plastic trim tool.

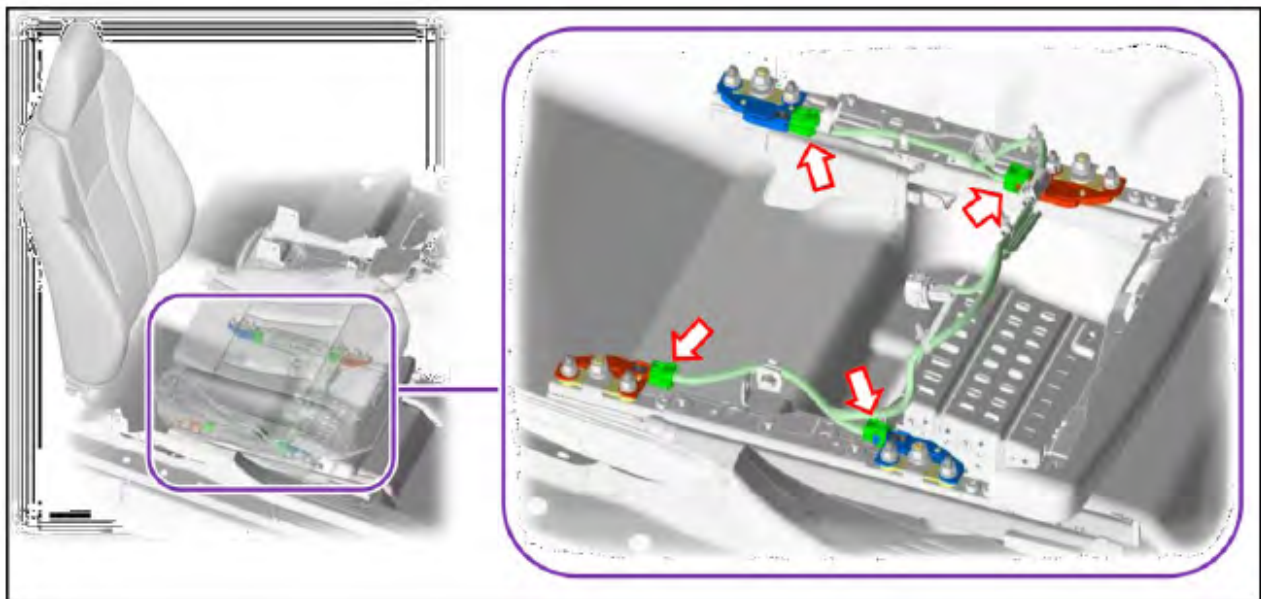
STEP 17: Disconnect all four Occupant Detection connectors under the seat. The connectors can be accessed from the rear footwell.

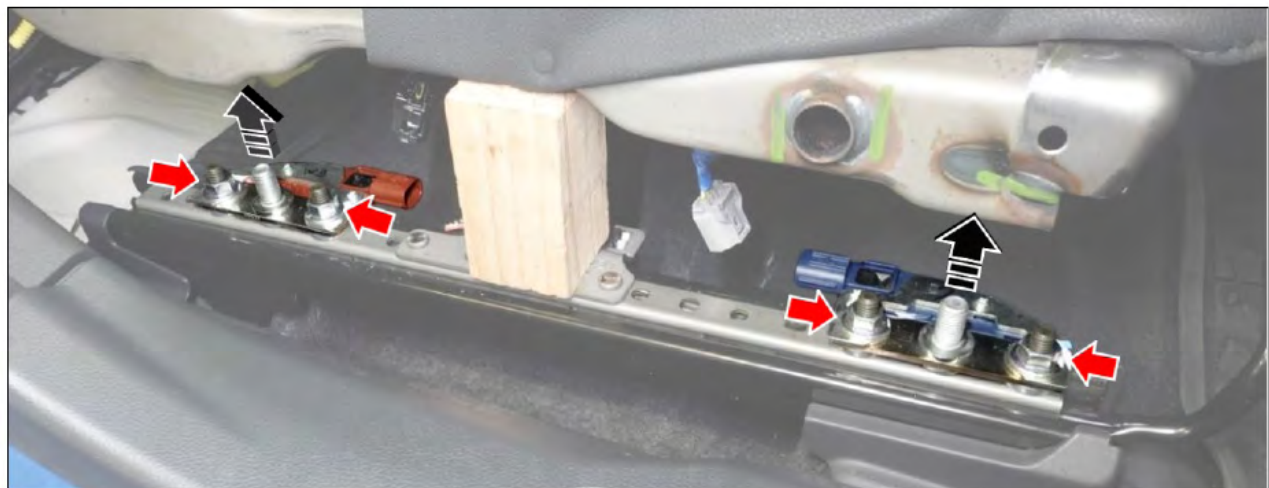
STEP 20: Remove and discard the four 12mm (M8) sensor mounting nuts. The two sensors can then be removed and discarded.

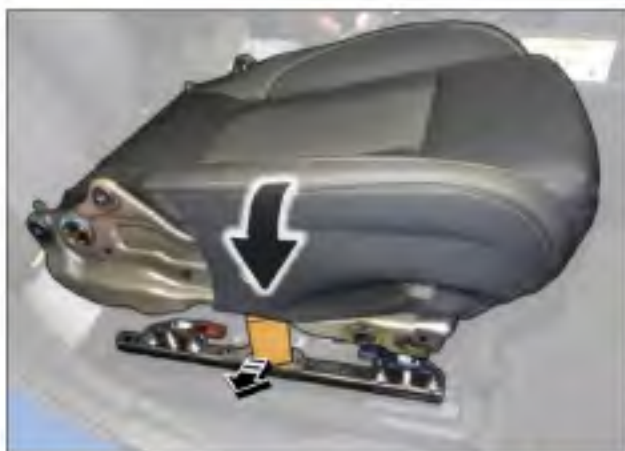
STEP 22: Remove the block and CAREFULLY lower the cushion frame.

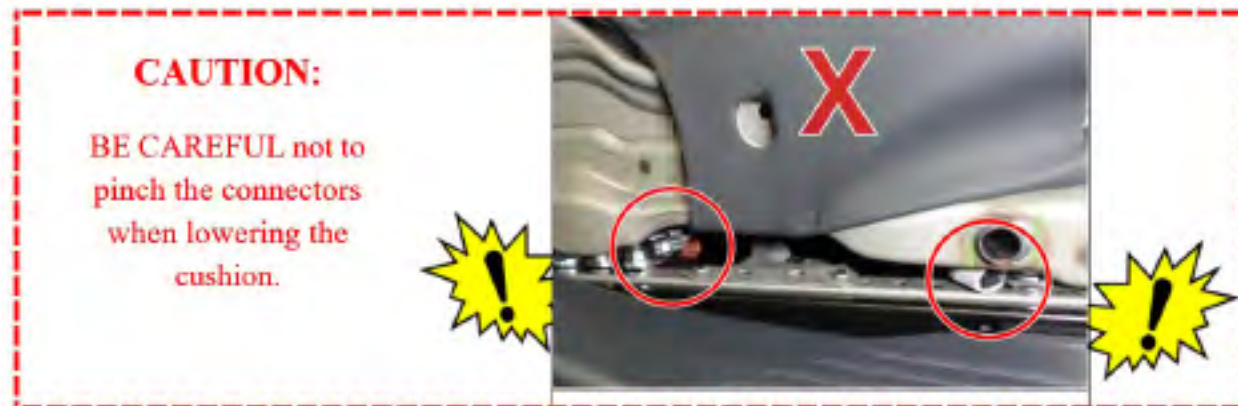
NOTES:

- Slowly lower the cushion while monitoring the bolt of the sensor and the insertion hole of the cushion frame.
- Do not secure the seat until the inner sensor has been replaced.

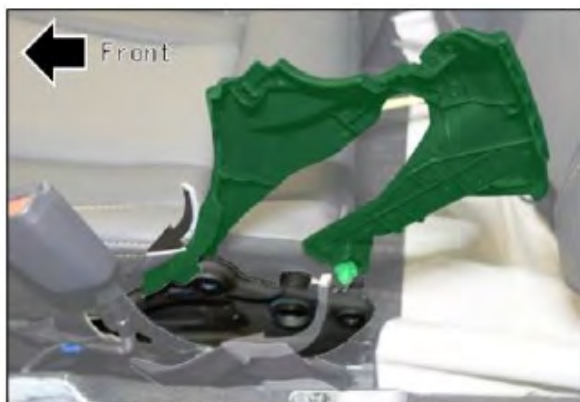
STEP 29: Install the inner cushion cover by inserting the grooved section at the tip of the cover along the metal frame. Once in the correct alignment, insert the mounting clip. Confirm the mounting clip positioning when complete.

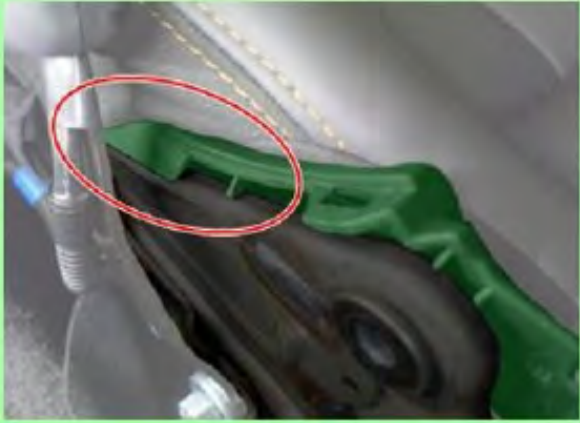
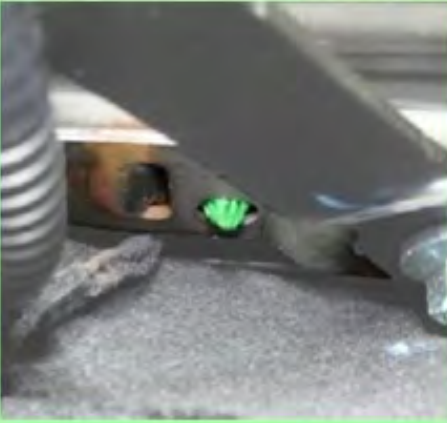
Mounting condition of the cover	Clip Position
✓

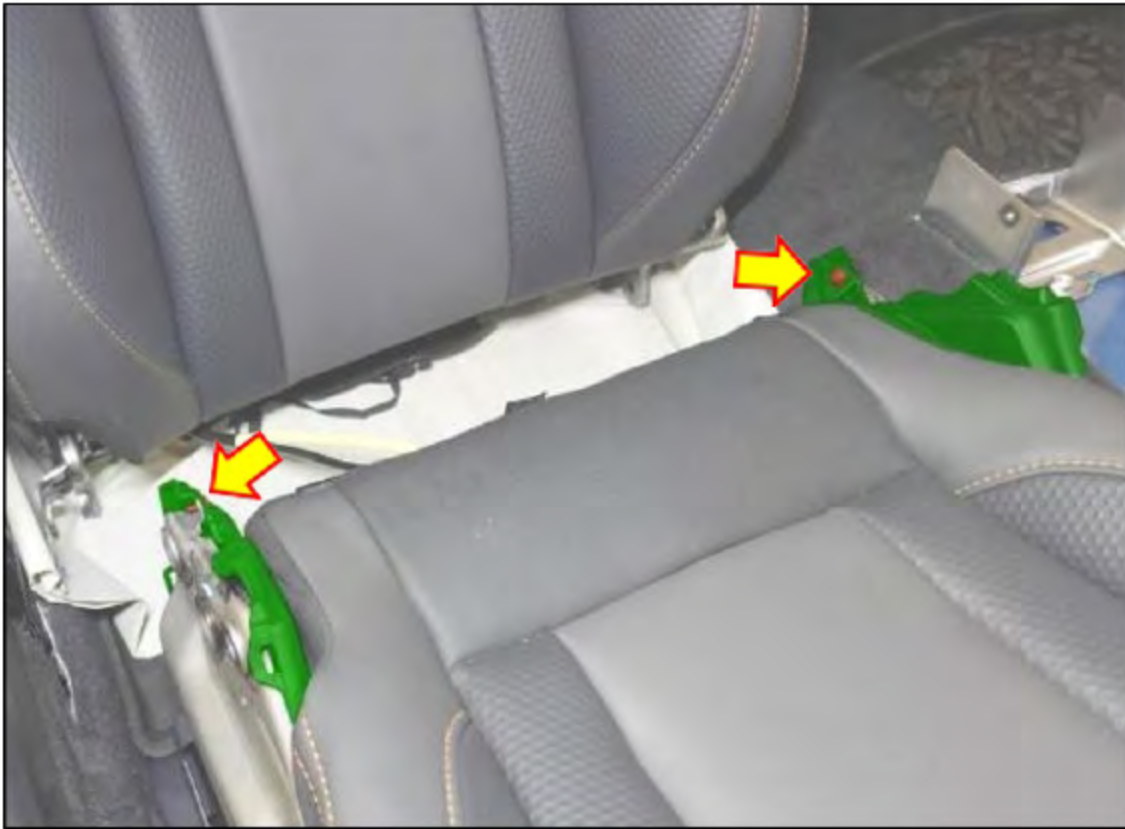
STEP 31: Reinstall the two mounting screws for the inner cushion covers.

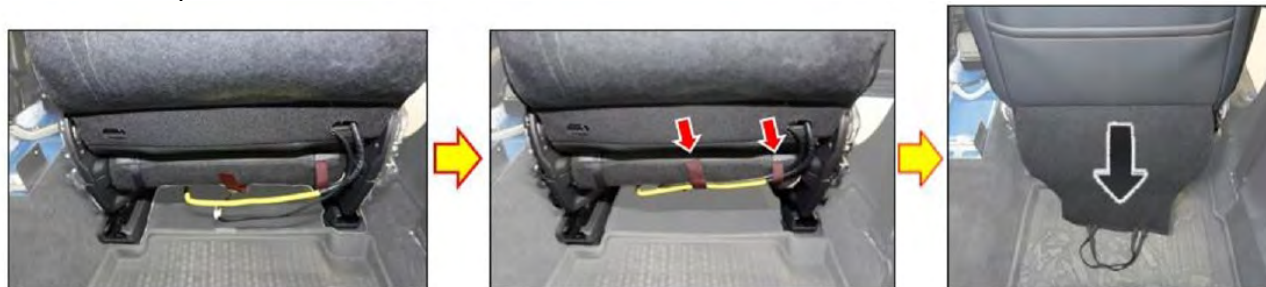
STEP 33: Secure the two Velcro straps and harness sections. Untuck the hanging section of the cover from the rear pocket of the seat.

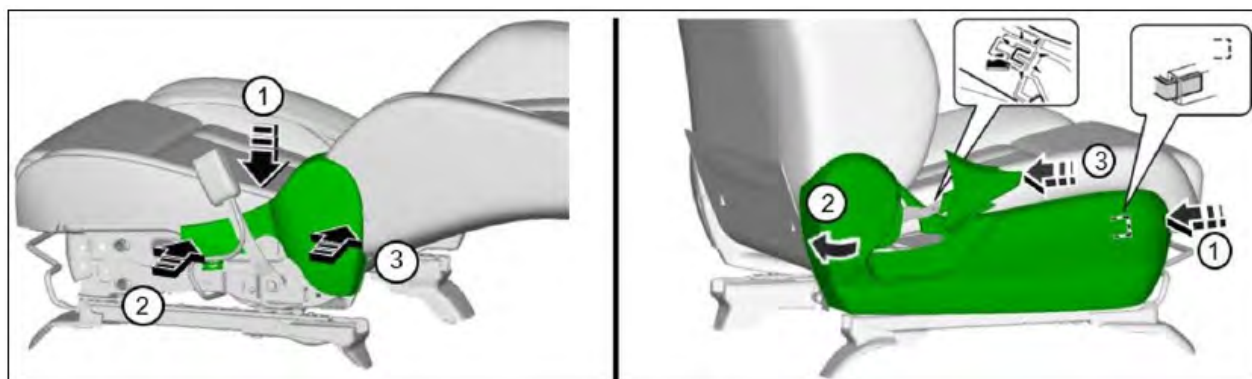
STEP 35: Reinstall the inner and outer hinge covers and handle.

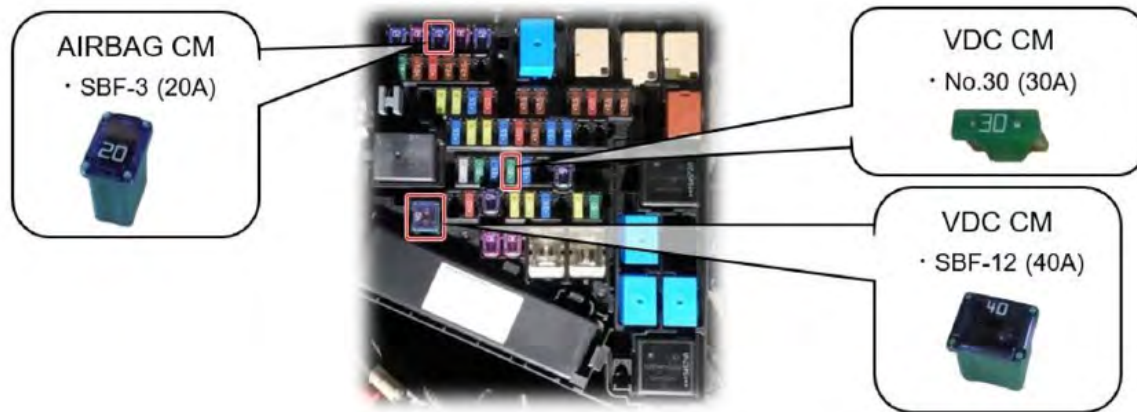
STEP 36: Reinstall the center console and gear selector cover.

STEP 37: Reinstall the fuses.

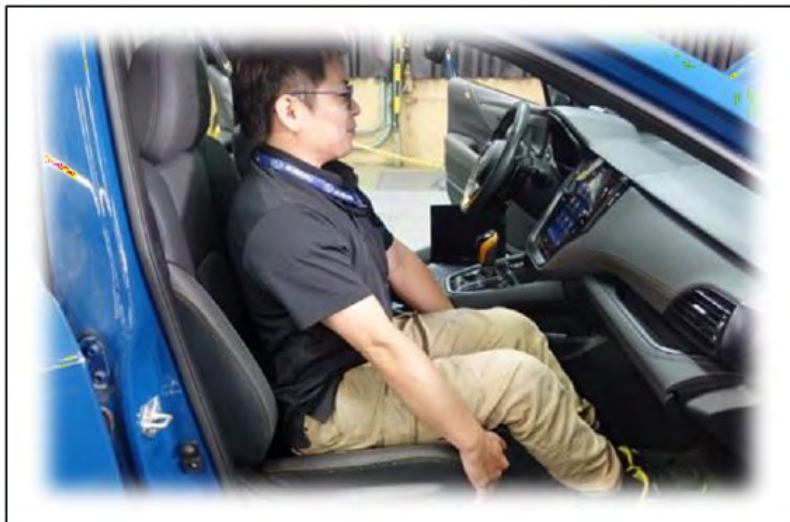
STEP 38: Sit on the front passenger seat and slightly move around while adjusting the positions.

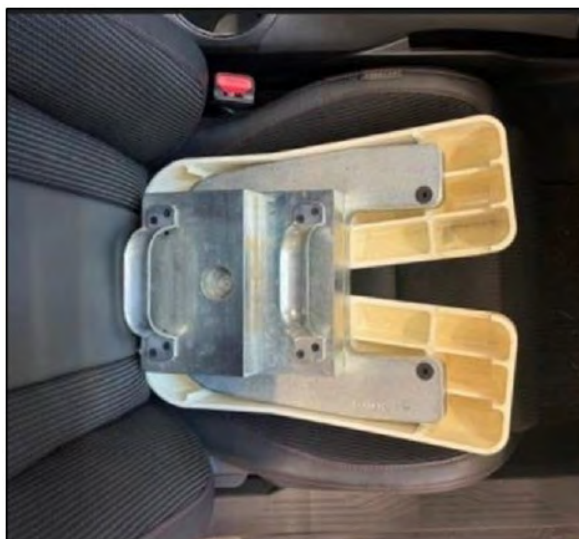
STEP 41: Confirm the seat and backrest are adjusted fully forward. Install both components of special tool #J-47673.

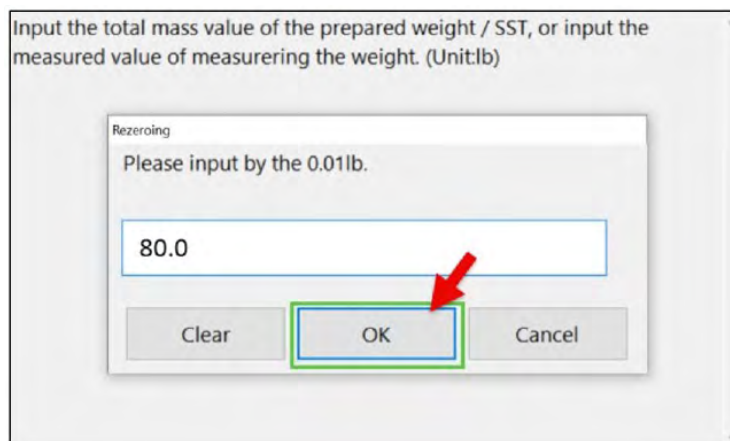
STEP 42: Input 80.0 lbs. Click the “OK” button to continue.

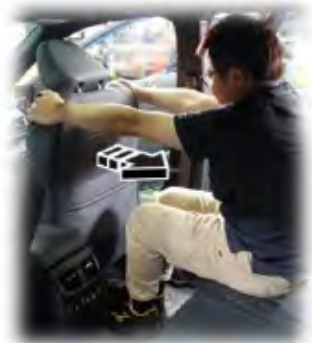
STEP 44: While sitting in the passenger rear seat, pull the backrest toward the rear of the vehicle and monitor the values. The front sensors should have a negative (-) value and the rear sensors should have a positive (+) value.

Item	Value	Unit	Maximum	Minimum	Average
<input checked="" type="checkbox"/>	AB Front-Left Sensor Load Value	-37.75	kg	-0.13	-37.75	-4.97
<input checked="" type="checkbox"/>	AB Front-Right Sensor Load Value	-35.90	kg	0.22	-35.90	-4.60
<input checked="" type="checkbox"/>	AB Rear-Left Sensor Load Value	45.33	kg	45.33	0.09	6.39
<input checked="" type="checkbox"/>	AB Rear-Right Sensor Load Value	35.23	kg	35.23	-0.31	4.53

Item	✓	✗		
	Case1	Case2	Case3	Case4
	Value	Value	Value	Value
Front-Left Sensor Load Value	- 37.75	45.33	- 37.75	45.33
Front-Right Sensor Load Value	- 35.90	35.23	45.33	- 37.75
Rear-Left Sensor Load Value	45.33	- 37.75	- 35.90	35.23
Rear - Right Sensor Load Value	35.23	- 35.90	35.23	- 35.90

IMPORTANT: In a case when the values do not match the desired specification, it possible the sensor mounting position is incorrect.

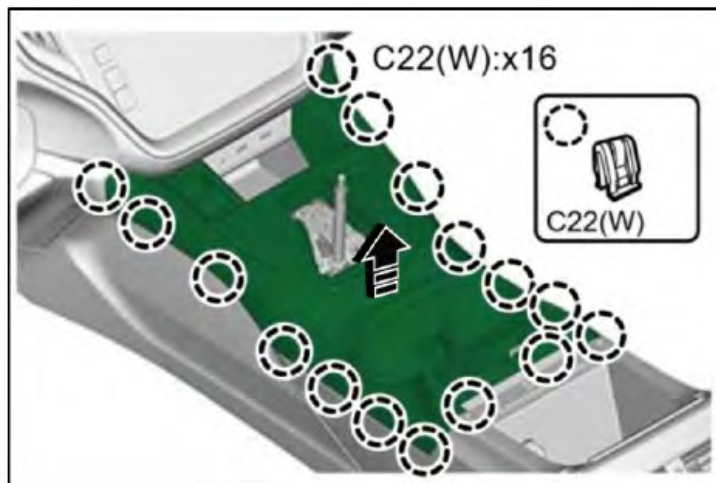
STEP 7: Release the holding clips for the front cover assembly. Disconnect the electrical connection and lift in the upward direction the remove the cover.

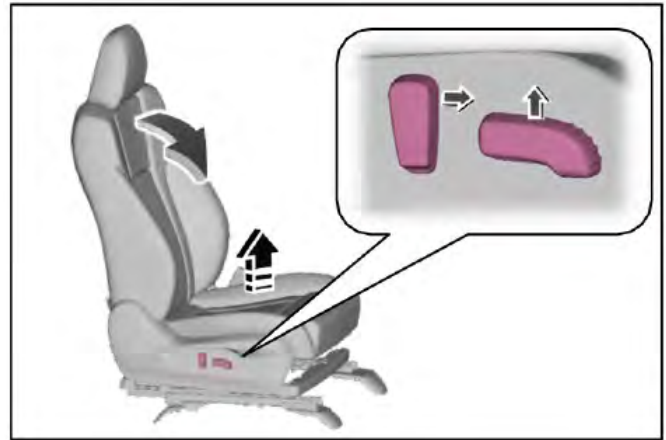
STEP 9: Tilt the seat backrest fully forward and raise the seat bottom to the maximum height.

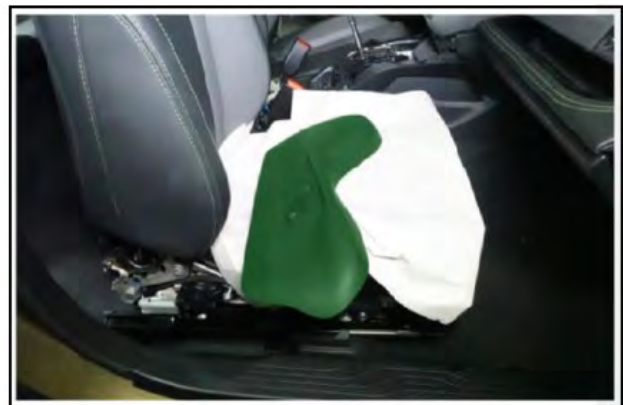
STEP 10: Release the rear section of the seat side cover. With all the holding clips released, the cover can then be removed by pulling towards the front of the vehicle. There is no need to disconnect the switch/harness. The cover can be placed on top of the seat. A clean fender cover or cloth can be used for seat protection.

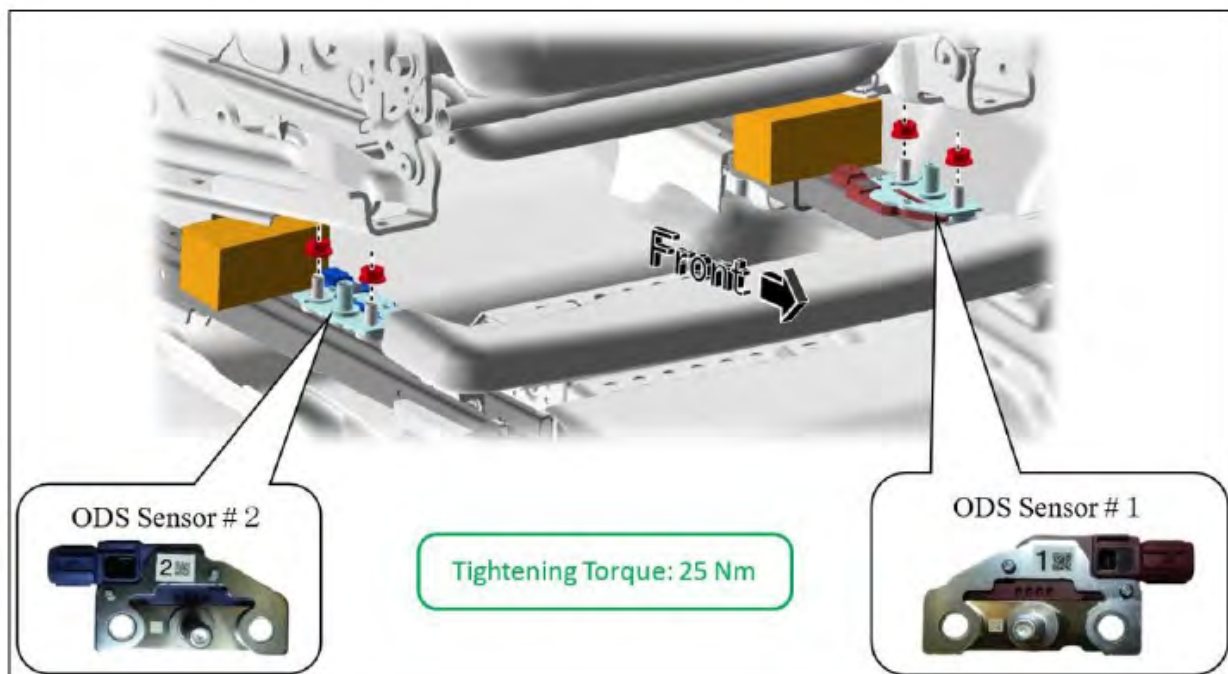
STEP 17: Confirm the identification numbers of the NEW Occupant Detection Sensors are #1 and #2. Mount the #1 (**Brown**) sensor to the inner front position and the #2 (**Blue**) sensor to the outer front position. Torque the NEW sensor mounting nuts (p.n. 64157AN02A) to 25Nm (18.5ft-lbs).

NOTE: Take special care in handling the new sensors.

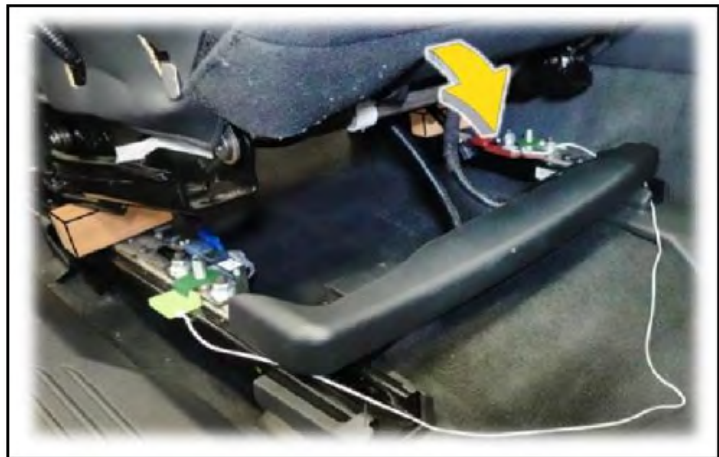
STEP 19: Tuck the connector of sensor sensors into the cushion frame. Remove the blocks and CAREFULLY lower the cushion frame.

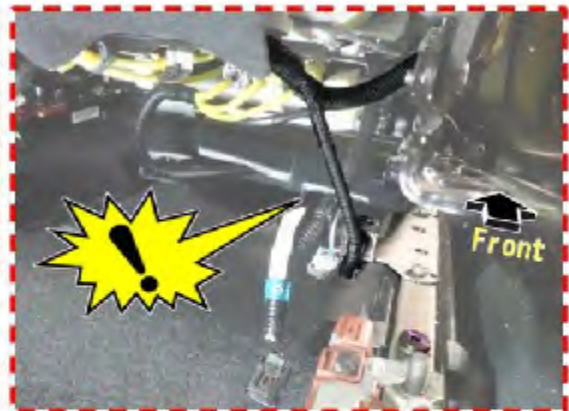
STEP 21: CAREFULLY raise the rear of the seat assembly 35-40mm (1.4 to 1.6 inch). Insert both of the pre-prepared blocks between the cushion frame and the seat rail.

- DO NOT damage the slide sensor when inserting the block into the outer rail.
- Pay close attention to the seat harness when lifting the cushion frame. Excessive tension may cause damage to the harness.

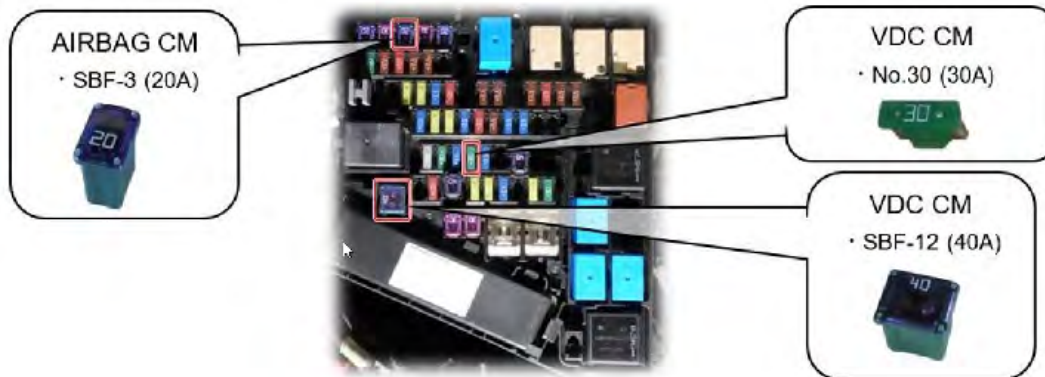
STEP 33: Reinstall the center console and gear selector cover.

STEP 34: Reinstall the fuses.

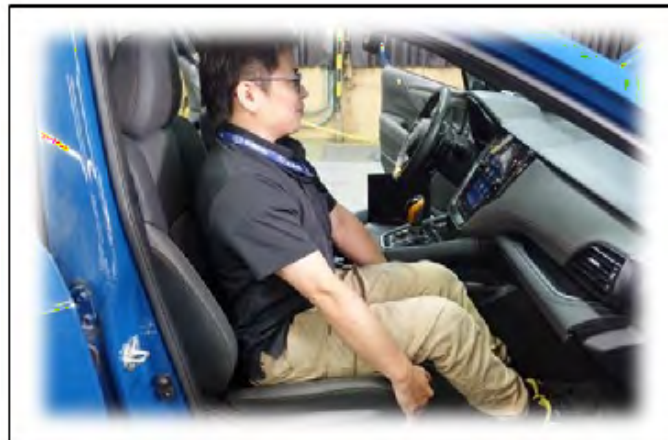
STEP 35: Sit on the front passenger seat and slightly move around while adjusting the positions.

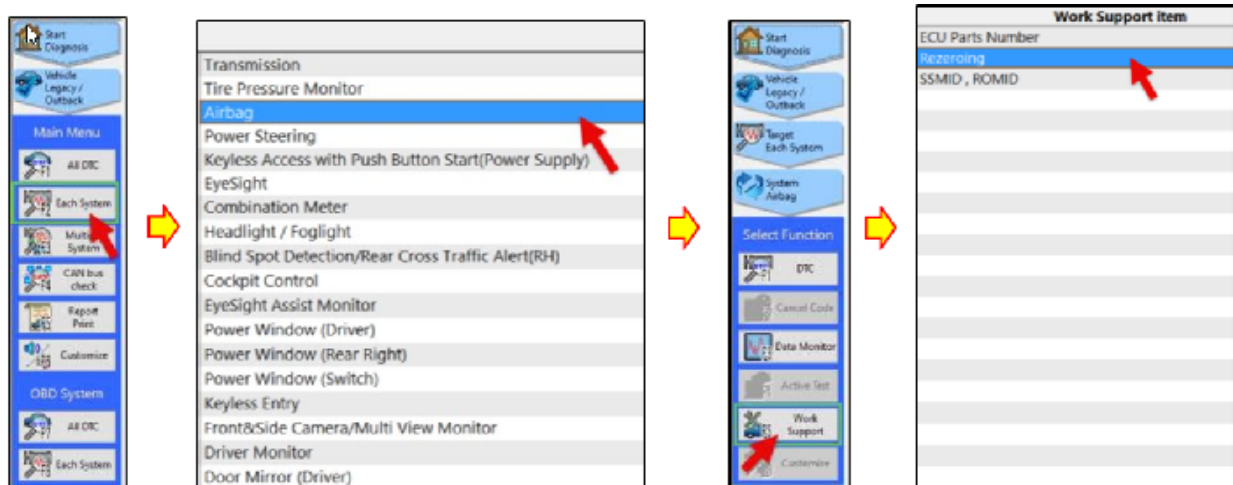
STEP 36: Using the SSM4, perform the “Rezeroing” procedure as per the applicable Service Manual.
