SERVICE BULLETIN

NUMBER: 15-305-22R
DATE: 11/15/22
REVISED: 03/24/25

SUBJECT: Reprogramming File Availability for Optimization of Gen 4.5 Denso CP1.5 Infotainment Systems

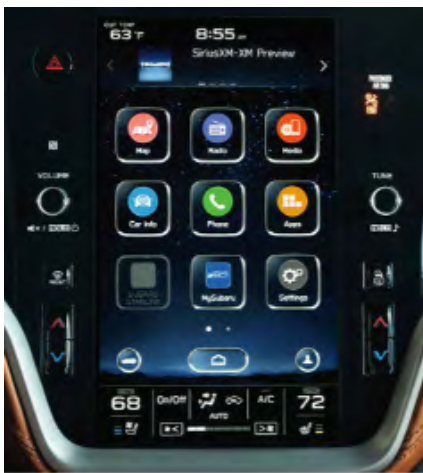
11.6-Inch Display, Mid and High Level Units

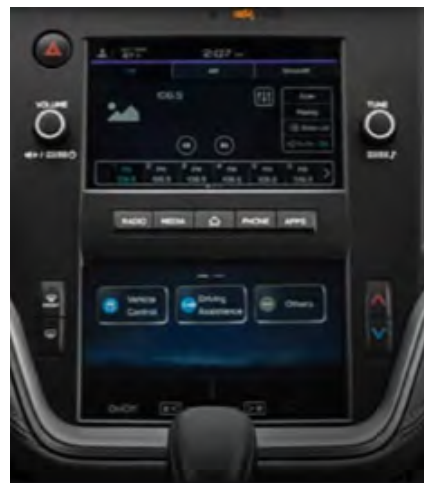
Dual 7.0-Inch Display, Base Level Unit

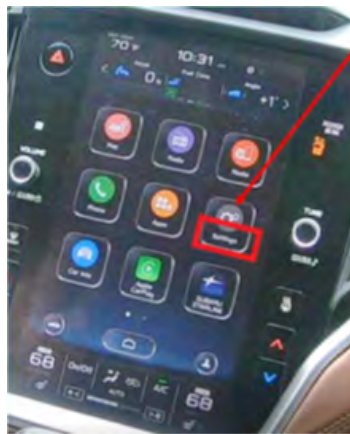
- 1a) After starting the engine and system boot-up completes, from the HOME screen, touch the **Settings** button.

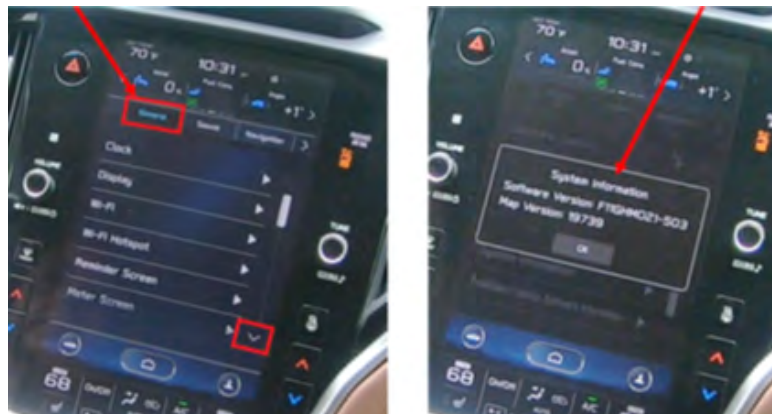
- 1b) Press the **General** button. Use the down arrow to scroll to **System Information** then press to display the System Information / Version information.

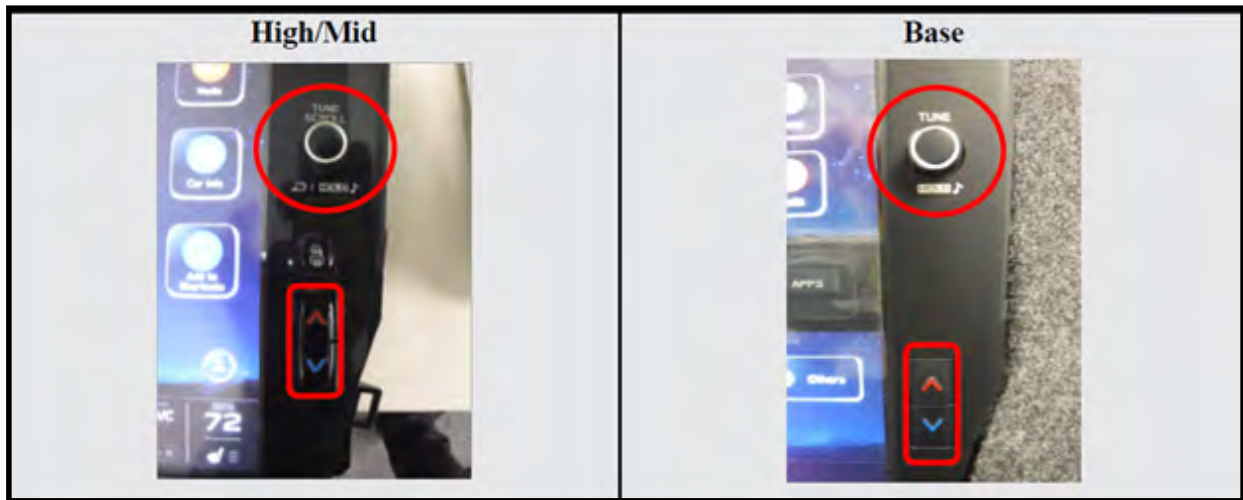
4a) PRESS and HOLD the RIGHT-side temperature control buttons (both up and down) and press the Tune / Scroll knob 6 times then release all to display the Dealership Mode Menu.

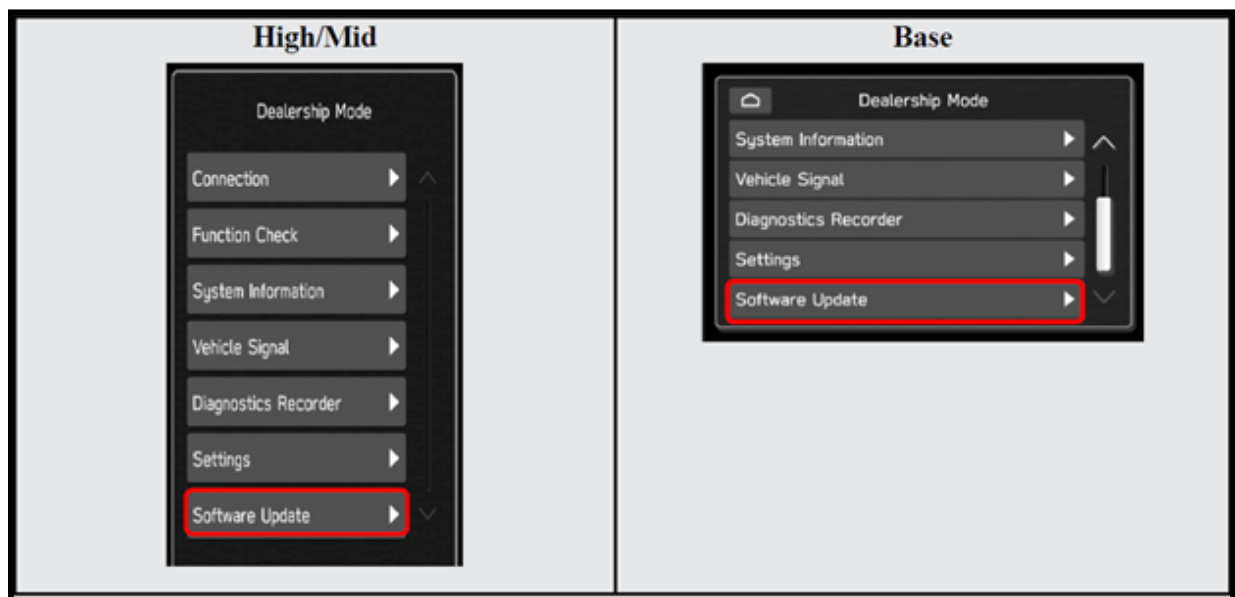
4b) Select **Software Update** from the Dealership Mode menu.

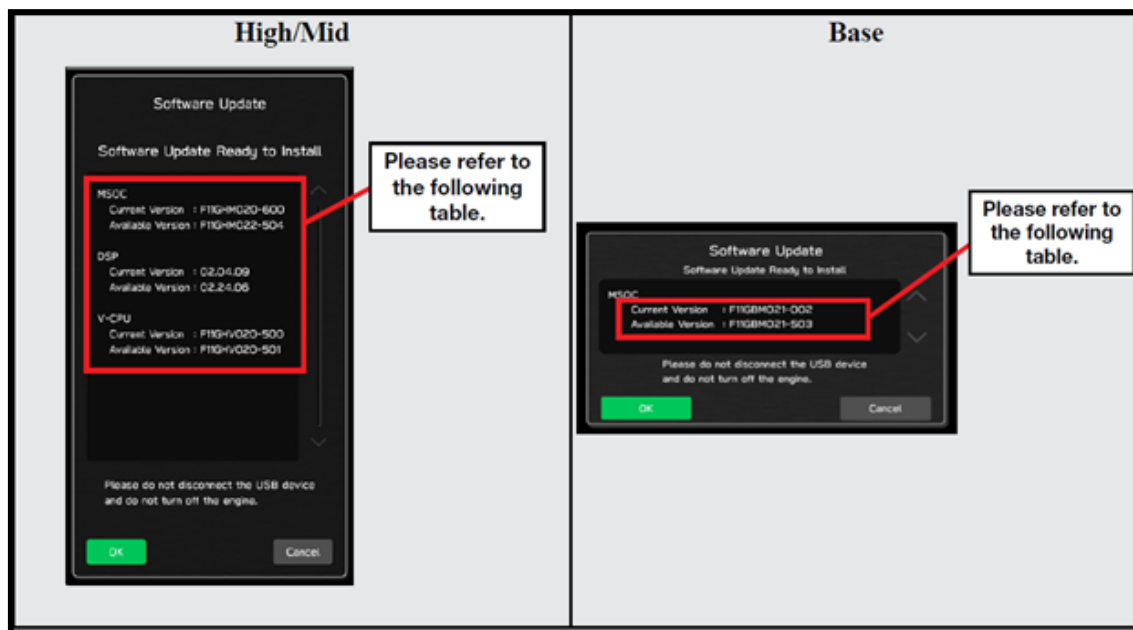
4e) The screen below will be displayed. Press **OK** to start the software update.

NOTE: The actual software version displayed will be different from the picture shown below.

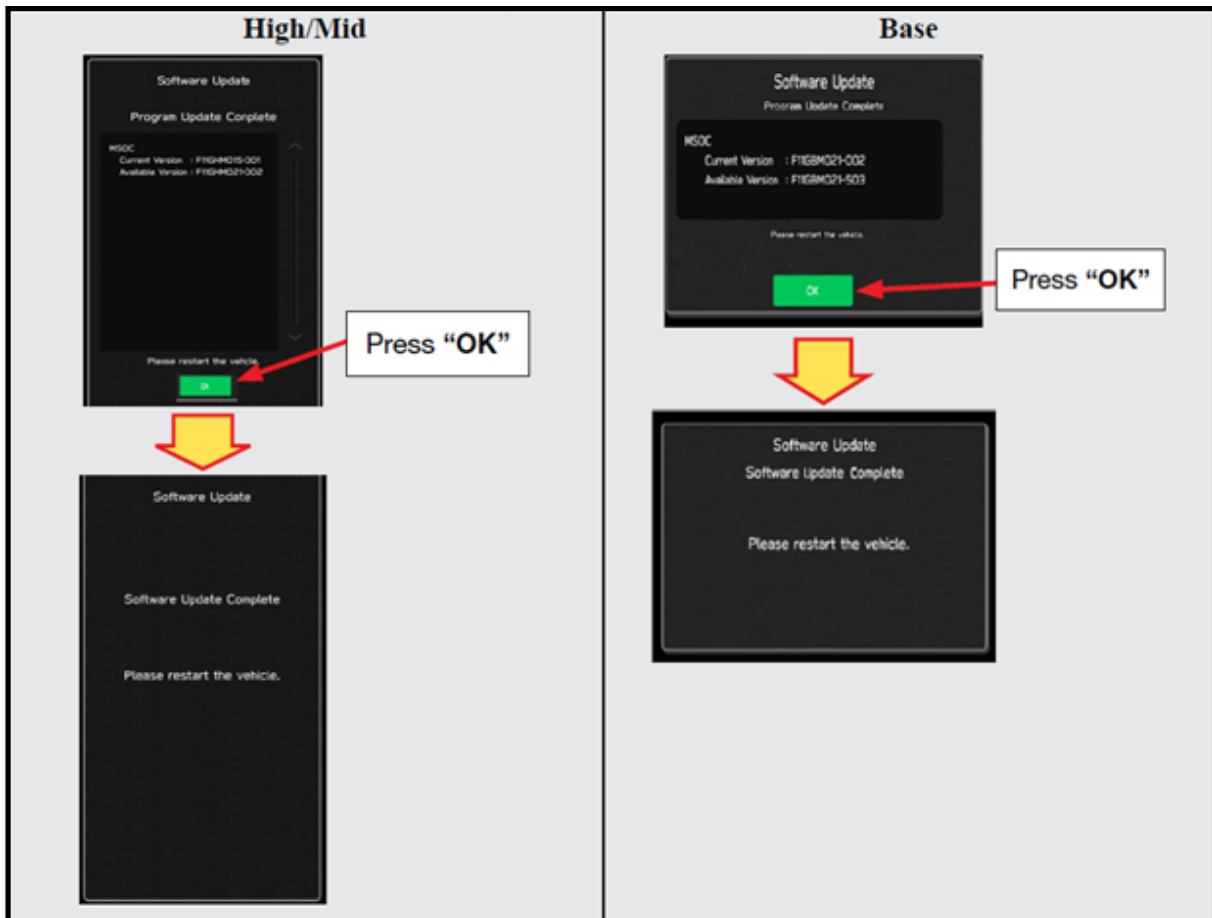
4g) When the software update is complete, the following screen will be displayed (the actual software version will be different).

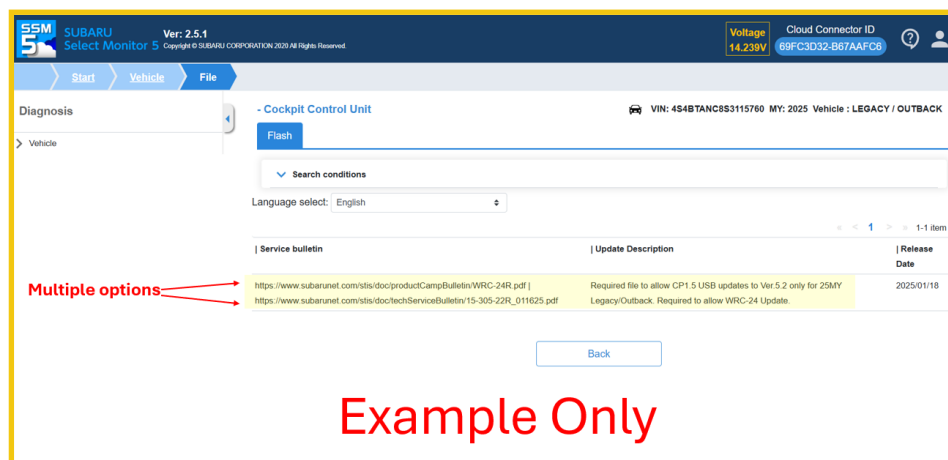
When you have multiple items listed, please select the one applicable to TSB 15-305-22 / Ver 6.0 as illustrated in the picture below.”

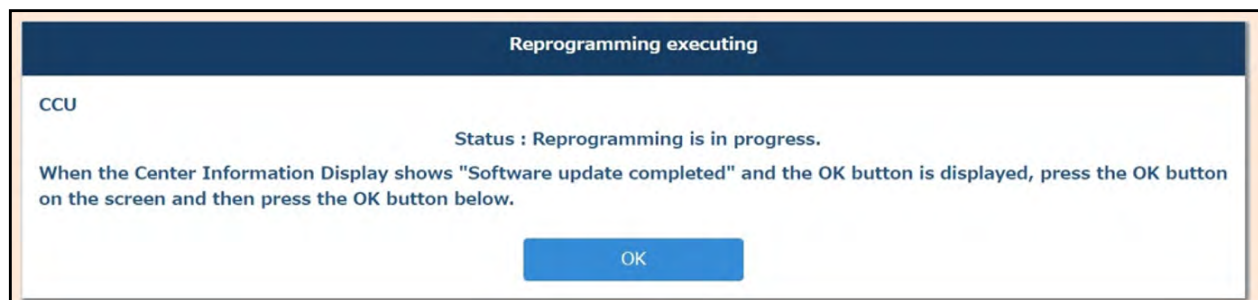
When the following screen is displayed, the software update starts within the CCU.

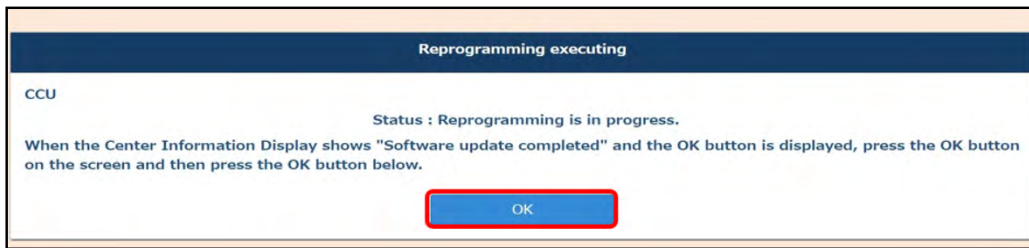
- v. After “Software update complete” appears in the CID, click “OK” on the SSM5 screen.

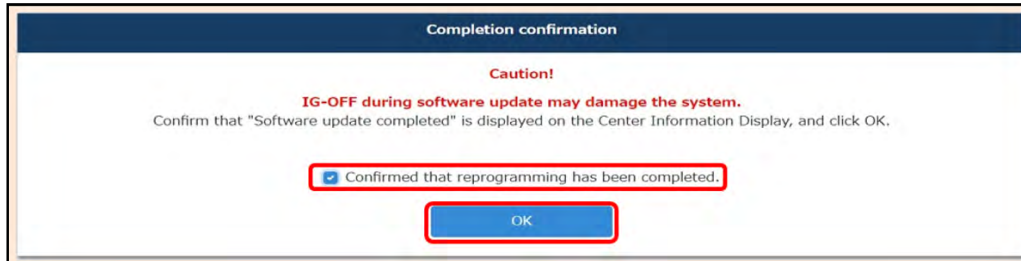
- vi. Confirmation screen will be displayed as shown below. Check the box and click [OK].

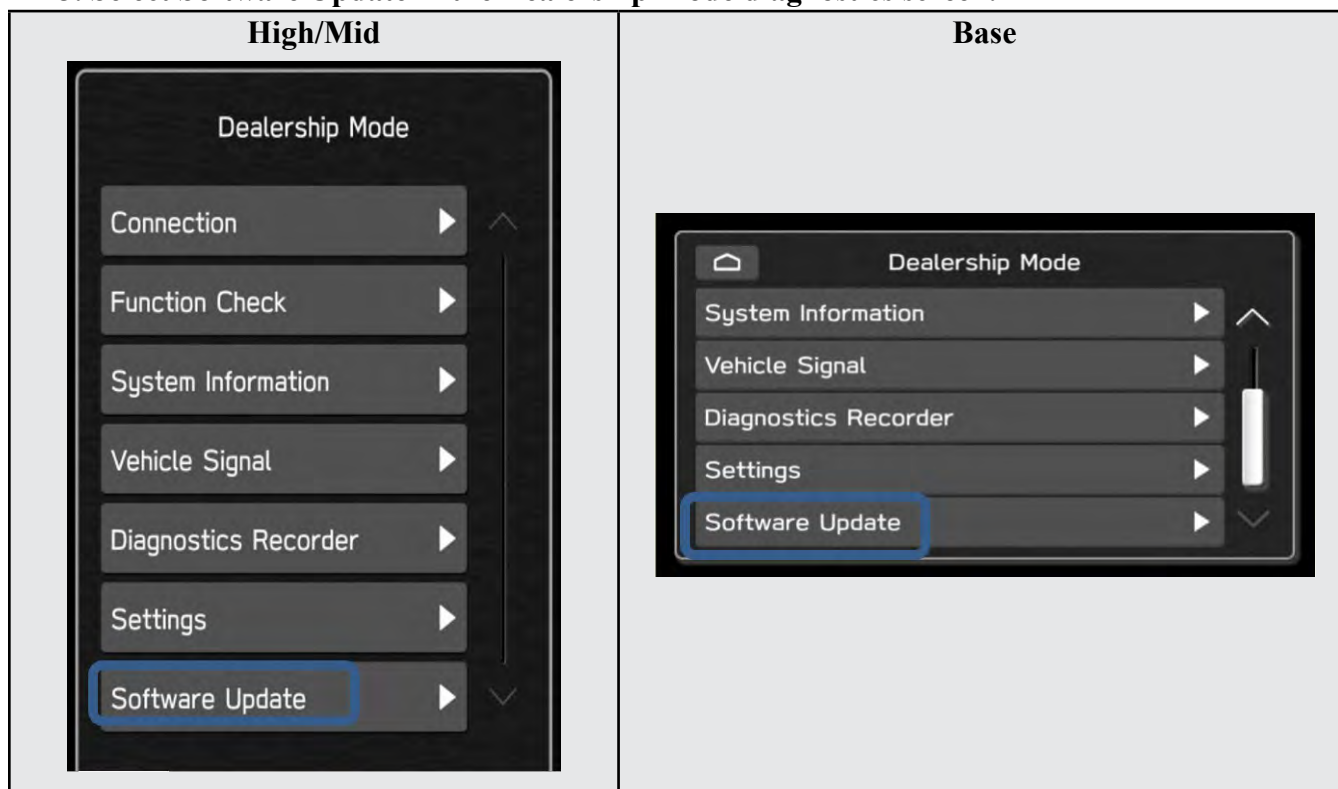
1-3. Select Software Update in the Dealership Mode diagnostics screen.

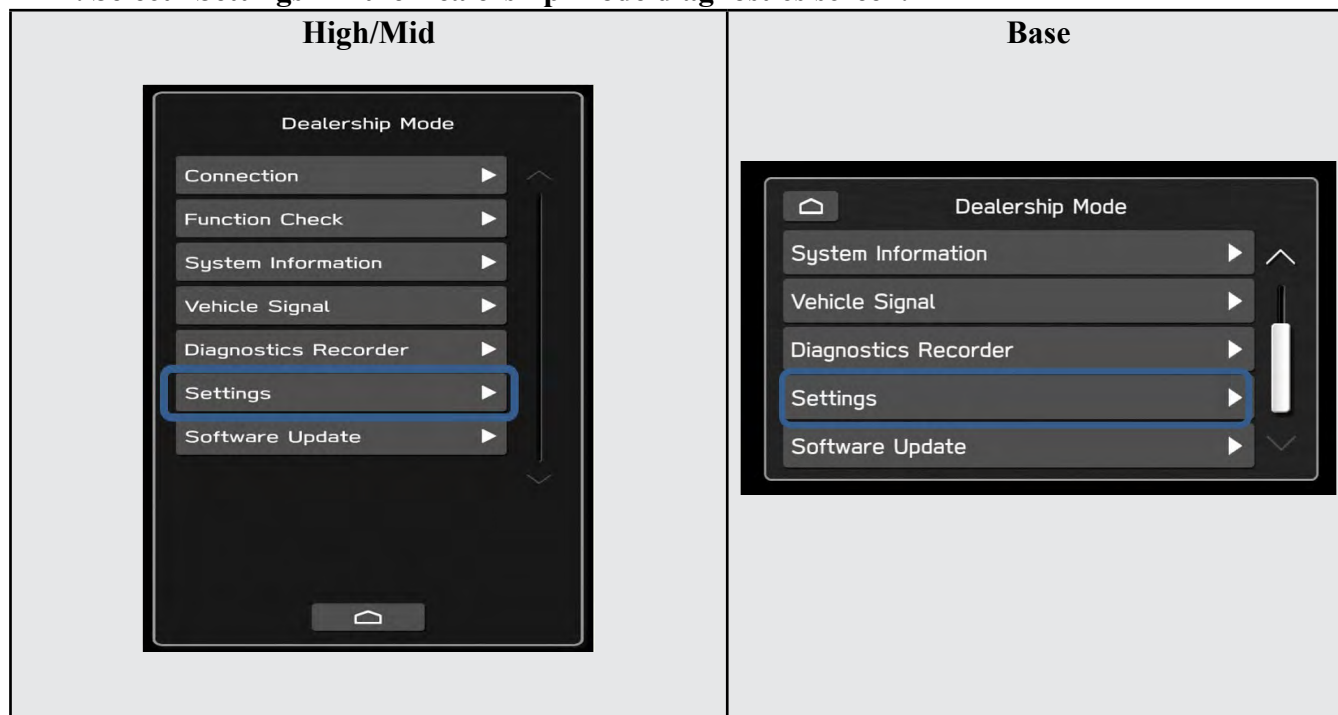
2-1. Select “Settings” in the Dealership Mode diagnostics screen.

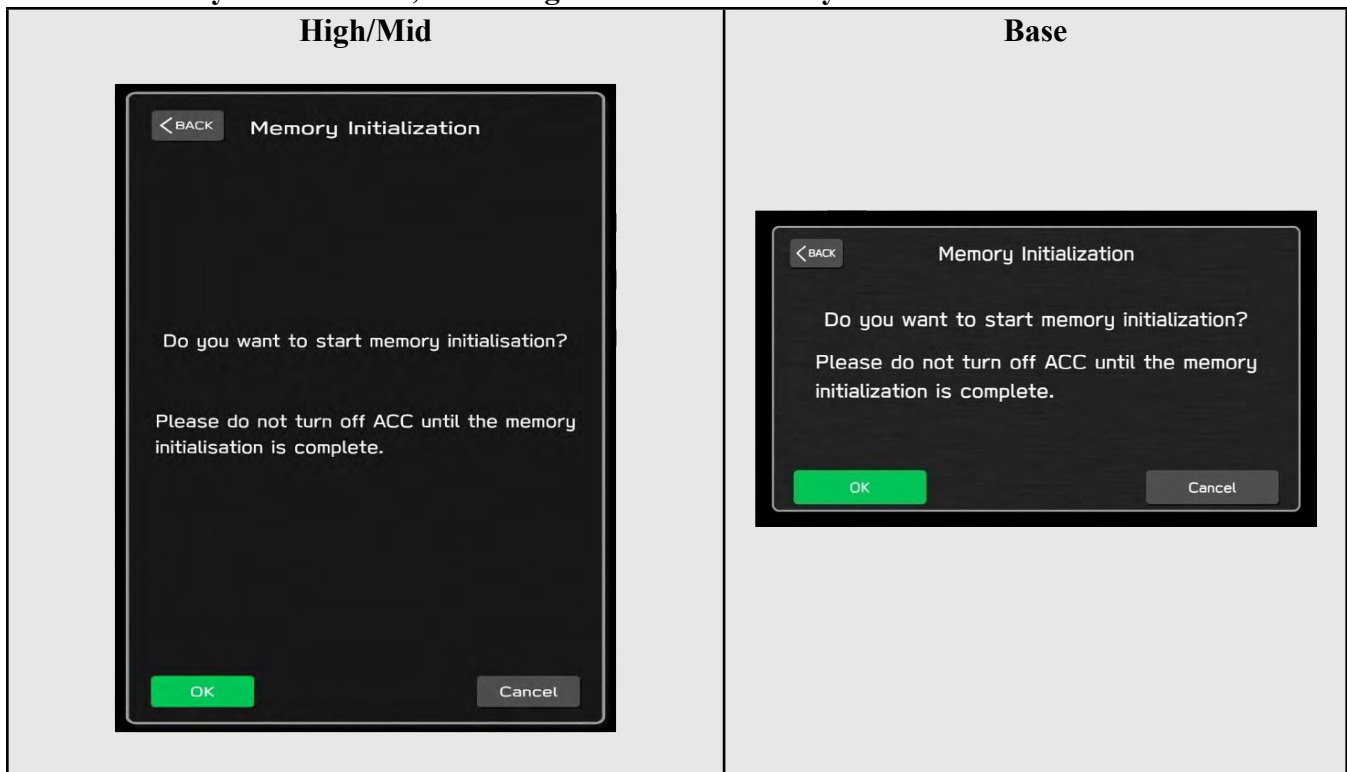
2-3. Select “OK”

After Memory Initialization, all settings are reset to factory default.

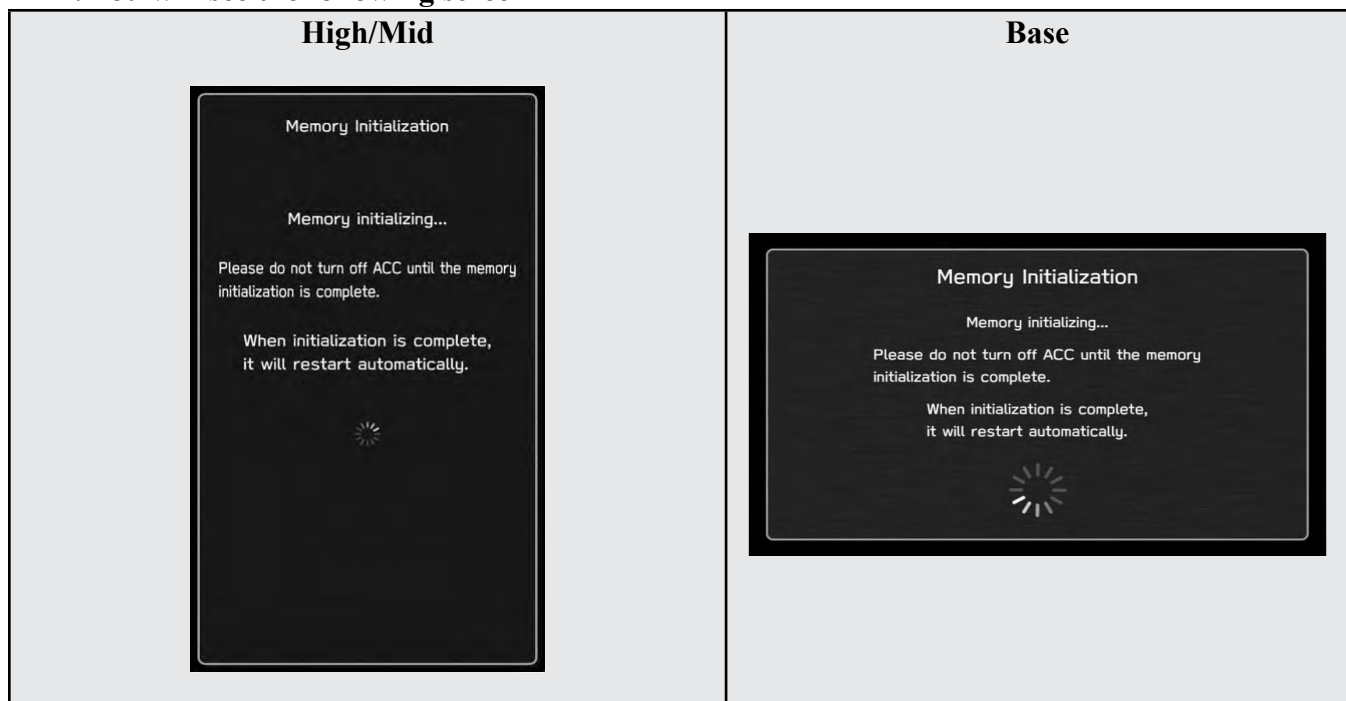
2-4. You will see the following screen

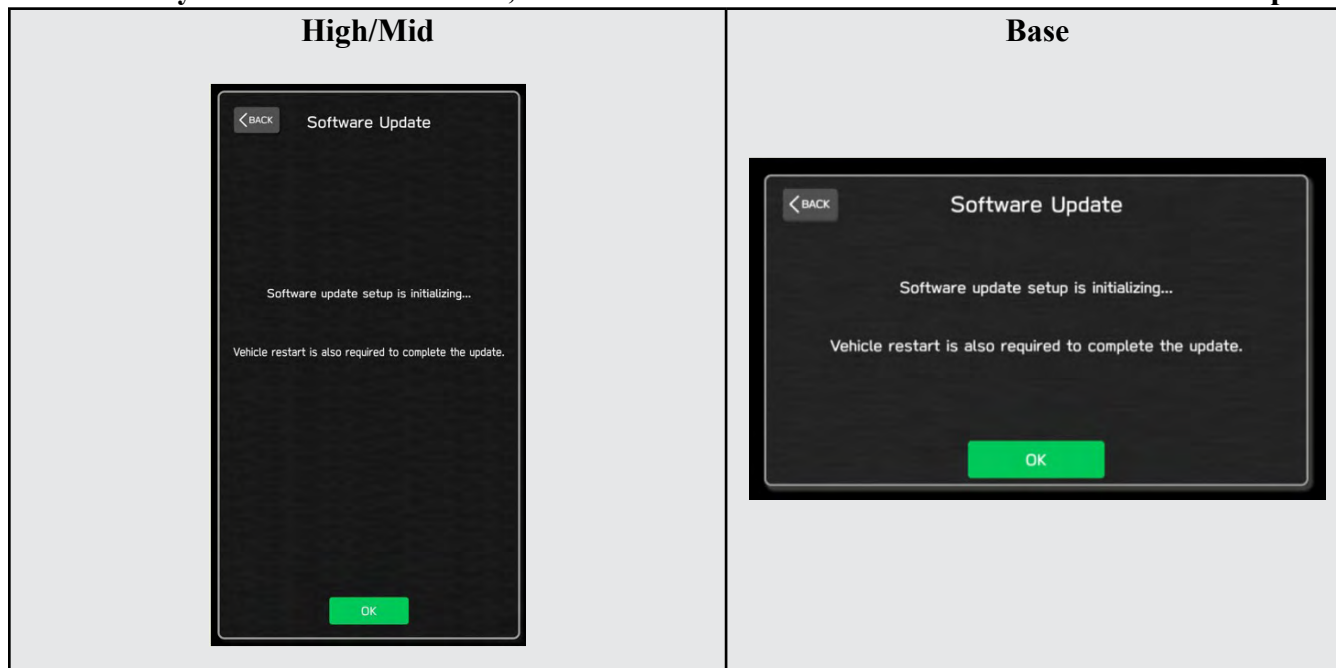
2-7. When you see the screen below, wait for about 15 minutes until the initialization is complete

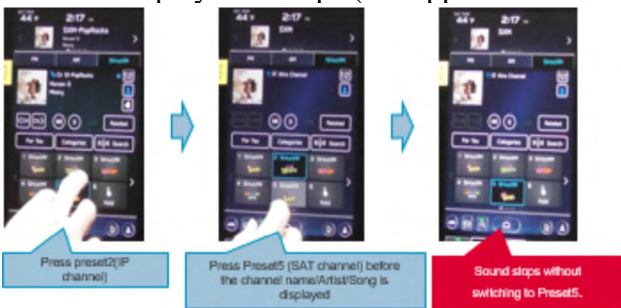
Number	Category	Symptoms to be Improved:
9	SXM	<p>- When switching to the SAT channel (satellite channel) immediately after selecting the IP channel (Internet channel) on the SXM360, song information is not displayed and audio playback stops (not applicable to BASE trim)</p>

<p>Press preset(2)(IP channel) → Press Preset5 (SAT channel) before the channel name/Artist/Song is displayed → Sound stops without switching to Preset5.</p> <p>- If the ignition-off/on operation is performed quickly immediately after ignition-on, the previously viewed channel in SXM may not start playing automatically (It will play by switching the audio source) (not applicable to BASE trim)</p> <p>- When the contract status is Demo, "Your Trial Expires in 0 Days" is displayed on the SXM Setiing screen. The display will be removed when the contract status is Demo (not applicable to BASE trim)</p>

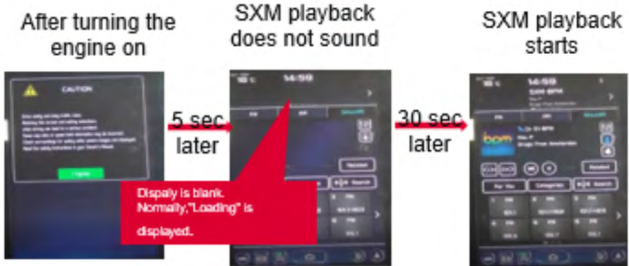
<p>- Registering a channel with blank information in presets results in a preset button with a blank label, and the channel logo is not displayed. Additionally, pressing the preset button with the blank label does not initiate playback of the channel.</p> <p>- After turning the engine on, "Loading" should appear on the channel information screen until SXM playback starts, but it does not appear and remains blank</p>

<p>After turning the engine on → 5 sec later → 30 sec later → SXM playback starts</p> <p>Display is blank. Normally, "Loading" is displayed.</p>

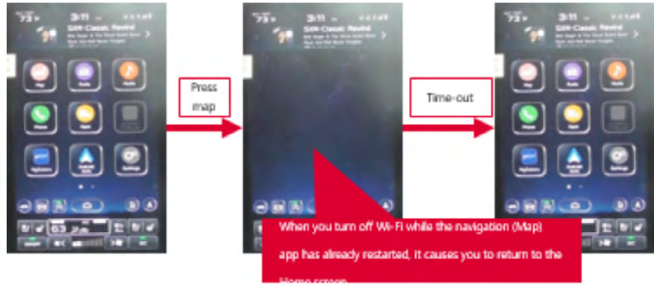
Number	Category	Symptoms to be Improved:
13	Navi Operation	<p>- During map data updates, if you switch off the Wi-Fi function from the Settings screen pressing the Map icon on the Home screen doesn't display the Map screen for a while (only applicable to HIGH trim)</p>

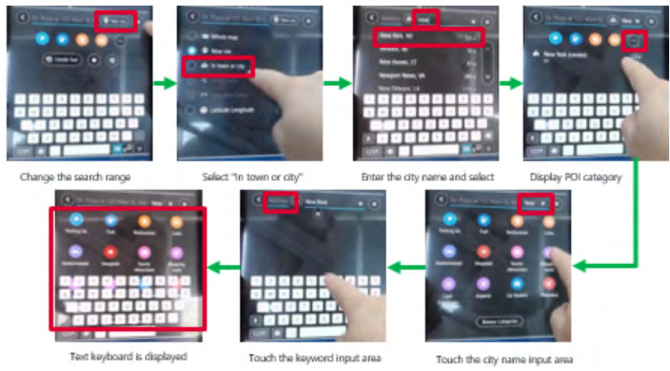
<p>When you turn off Wi-Fi while the navigation (Map) app has already restarted, it causes you to return to the Home screen.</p>
		<p>- Even when pressing the Map icon the map does not appear and it remains stuck on the 'Loading Navigation' message. This issue occurs due to a corrupted file that stores settings and destination history (only applicable to HIGH trim).</p>
		<p>- The text keyboard which should not be displayed appears on top of the list of POI categories (only applicable to HIGH trim) when performing the steps below:</p> <ol style="list-style-type: none"> 1. Narrowing down the search range within a specific city in the navigation destination search. 2. Move to the POI category screen. 3. Touch the city name input area, then the keyword input area, in that order.

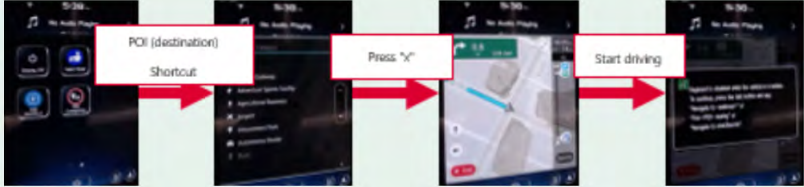
Number	Category	Symptoms to be Improved:
13	Navi Operation	<p>- "Keyboard is disable while the vehile is in motion"" is displayed on the screen when performing the steps below (only applicable to HIGH trim) :</p> <ol style="list-style-type: none"> 1. Press the POI (destination) Shortcut on the home screen to display the list of destinations. 2. Press "x" to clear the list. 3. Start driving with the Map screen displayed.

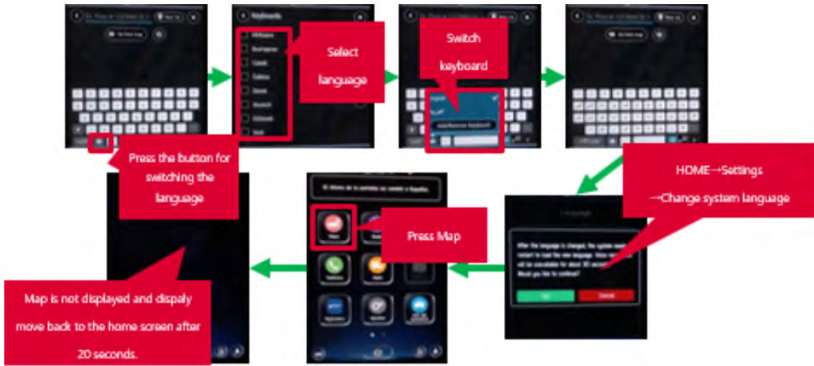
<p>- Map is not displayed when Map is pressed from the home screen if switch- ing the language used for the text input keyboard on the search screen of the navigation application (only applicable to HIGH trim)</p>

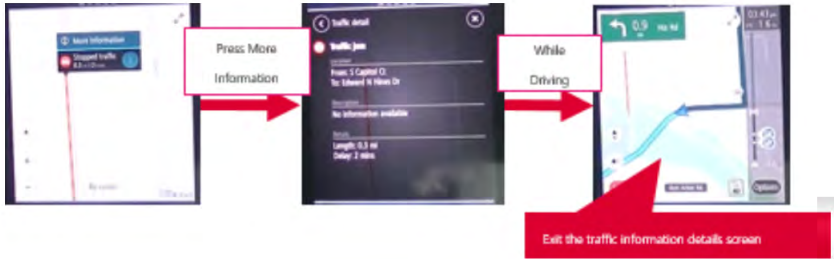
<p>- While parked or driving, touch the traffic information icon on the map or the traffic information icon on the route bar and display the traffic information details screen. If you start driving with this screen displayed, it will exit the traffic information details screen and transitions back to the map screen (only applicable to HIGH trim)</p> <div data-bbox="586 1199 1414 1455">

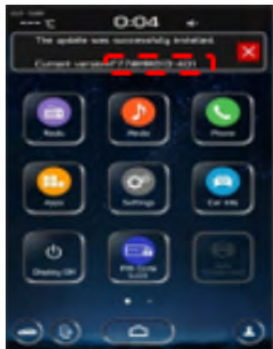
<p>- After the installation of software updates via OTA (Over-the-Air), the "Current Version" field in the popup screen that appears during the next IGN-ON may be blank or empty (not applicable to BASE trim)</p>

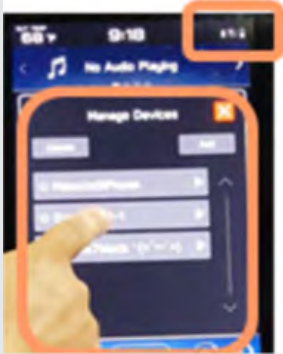
Number	Symptoms to be Improved:
7	<p>Bluetooth connection is disabled with a discrepancy in the display of status bar (showing Bluetooth devices being connected) and the “Manage Devices” screen (showing no Bluetooth devices being connected.)</p>

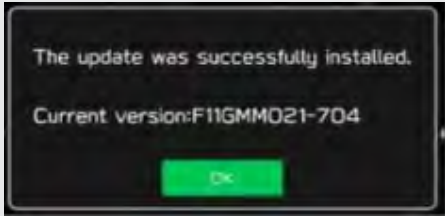
Number	Symptoms to be Improved:
15	<p>Popup of “The update was successfully installed” is not displayed after reboot (IG-OFF and ON) operation of FOTA (Firmware Over The Air) update.</p>

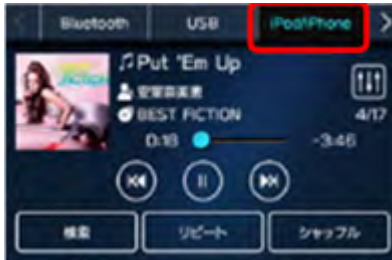
Number	Symptoms to be Improved:
1	<p>iPod/iPhone tab in Media screen cannot be selected, when connected by USB.</p> <p>The symptom occurs when the iPhone is connected to CP1.5 via Bluetooth in parallel to USB connection by error. (It is supposed to be connected either via Bluetooth or by USB.)</p>

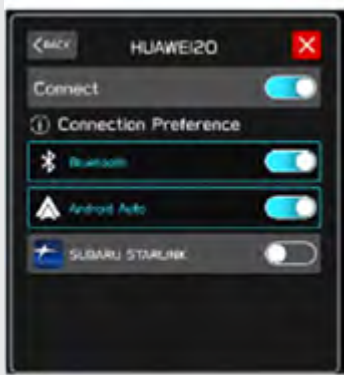
2	<p>On the "Manage Devices" screen Bluetooth cannot be selected as connection preference.</p>

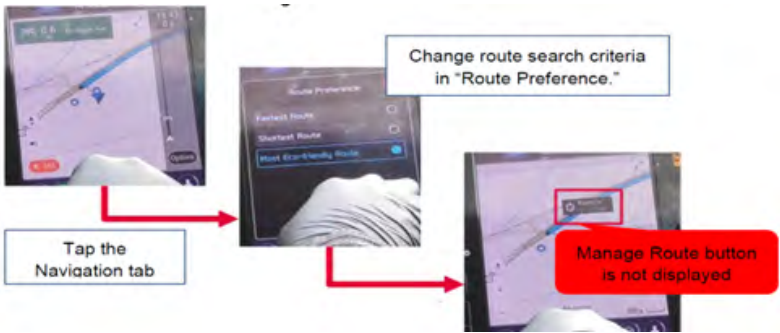
10	Navigation restarts itself, when the letters are rashly entered or deleted using keyboard function to search destination.
11	<p>“Manage Route” button is not displayed when touching the route line on Navigation system, when the route search criteria got changed in the Route Preference Screen after a route had been searched.</p>

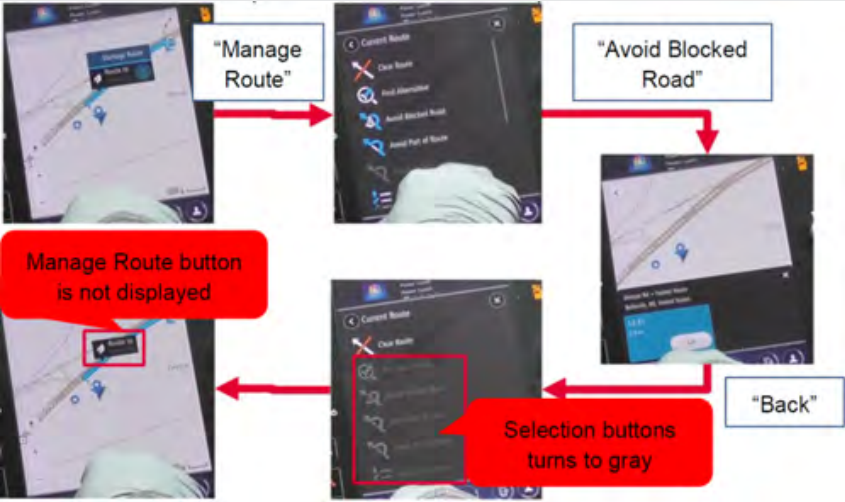
Number	Symptoms to be Improved:
12	<p>“Manage Route” button is not displayed and buttons on the Current Route Screen become unselectable (turns to grayish fill) when the Navigation system is operated in the sequence of “Manage Route” > “Avoid Blocked Road” (in the Current Route Screen) > “Back.”</p>
