# Preview Solution CBR-561-10

## 11L, 13L, And 16L Engine Oil Analysis Specifications - US10 And Newer Emissions

All Mack and Volvo models 2011 to current

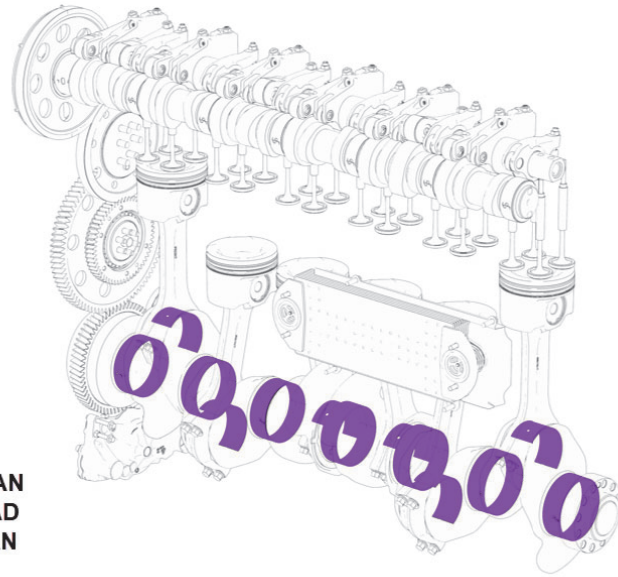
- PB-LEAD
- CU-COPPER
- SN-TIN
- BI-BISMUTH
- MO-MOLYBDENUM
- AL-ALUMINUM
- CR-CHROMIUM
- SI-SILICON
- MN-MANGANESE
- HBN-HEX BORON NITRIDE
- \*CRANK BEARINGS NEW COATINGS CAN INCLUDE ALL OF THE FOLLOWING. LEAD IS MOST LIKELY TO BE OBSERVED IN AN OIL ANALYSIS
