**Emissions Recall 7325C - Hybrid System Warning Light May Turn On - affecting 2024-2025 CX-90 and 2025 CX-70 vehicles**

**CONDITION OF CONCERN**

**REPAIR OUTLINE:** Reprogram the PCM with the Mazda Modular Diagnostic System (M-MDS), using Mazda Diagnostic And Repair Software (MDARS).

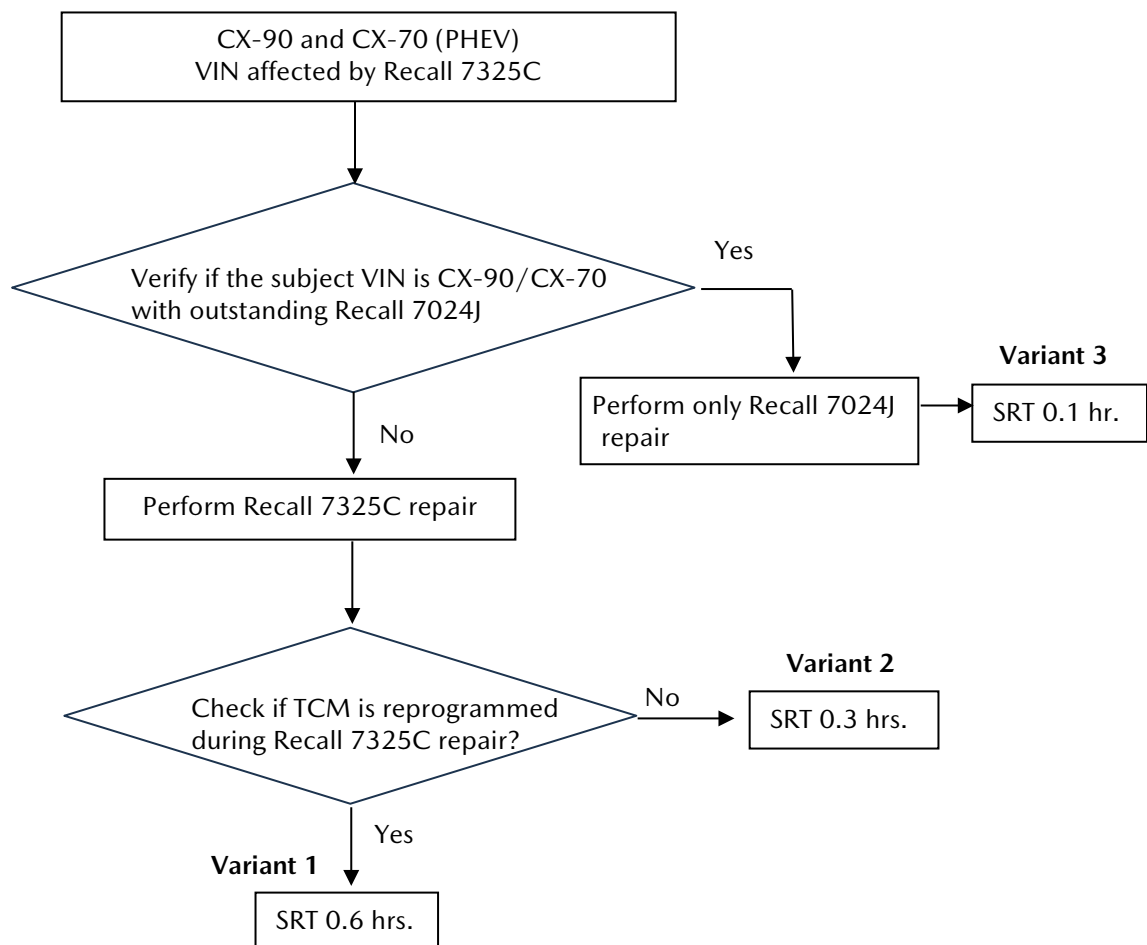
Please follow the instruction in the following flowchart on how to submit warranty claims.

If any subject vehicle is also subject to the Recall 7024J and it has not been performed yet, this Recall 7325C will be completed by performing the Recall 7024J repair. In such cases, it is only necessary to submit the warranty claim to close the Recall 7325C.
