SIB 61 02 25

DELIVERY STOP: REPLACE POWER CONTROL UNIT

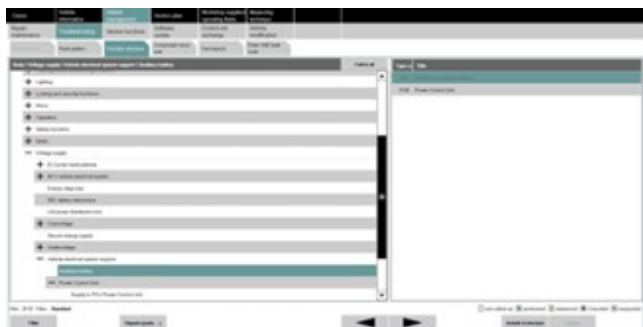
3. Next, evaluate the additional Li-Ion AUX battery with ISTA test module “**ABL-DIT-AT6121_DSSLTO_EARS**”, via the path below.

- Vehicle management
- Troubleshooting
- Function Structure
- Body
- Voltage Supply
- Vehicle electrical system support
- Auxiliary battery
- Lithium-ion auxiliary battery
