**Location:** Powertrain / High Voltage

**Topic:** McLaren P1 GEN 2 Battery Software and Charging Limitations

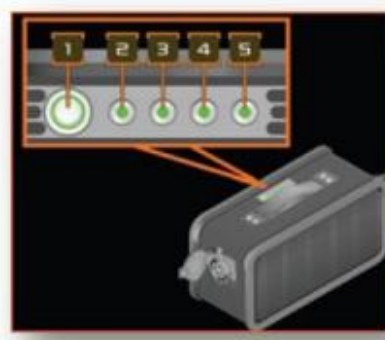
The following table shows the expected LED status and colour when the charger is operating correctly and all pre-conditions are met.						
	Charger Status	Cable and Connector Status	12V Battery Status	Vehicle Status	HV Battery Status	User Action Required / Explanation
Charger Initializing	Pulsing Green	Off	Off	Off	Off	Charger will need some time to complete initialization checks. In extremely hot ambient the charger may need additional time to cool itself prior to charging.
Charger Disconnected	Solid Green	Flashing Amber	Off	Off	Off	Check the charge connector is fully inserted to the vehicle.
12V Battery Voltage Recovery	Solid Green	Solid Green	Pulsing Green	Off	Off	12V voltage is being recovered. No HV charging (HV charging will commence once 12V battery voltage has been recovered).
Check Vehicle	Solid Green	Solid Green	Pulsing / Solid Green <sup>1</sup>	Flashing Amber	Off	Apply parking brake and/or switch vehicle ignition off.

<sup>1</sup> Pulsing/Solid Green on the 12V battery status means that the LED will pulse if the 12V battery is not yet charged. When the 12V battery is charged, the LED will be illuminated solid green. Contact your McLaren Retailer if a fault is indicated on the charger by a red LED.

LED Colour	Meaning
None (LED off)	Not powered
Solid green	OK / complete
Pulsing green	In progress
Flashing amber	User action required
Flashing red	Fault detected
