25PBB: New Medium Duty and Model 567 Exterior Lighting Programming

25PBB / NHTSA #: 25V041 / Transport Canada #: 2025-036

Safety Recall – New Medium Duty and Model 567 Exterior Lighting Programming

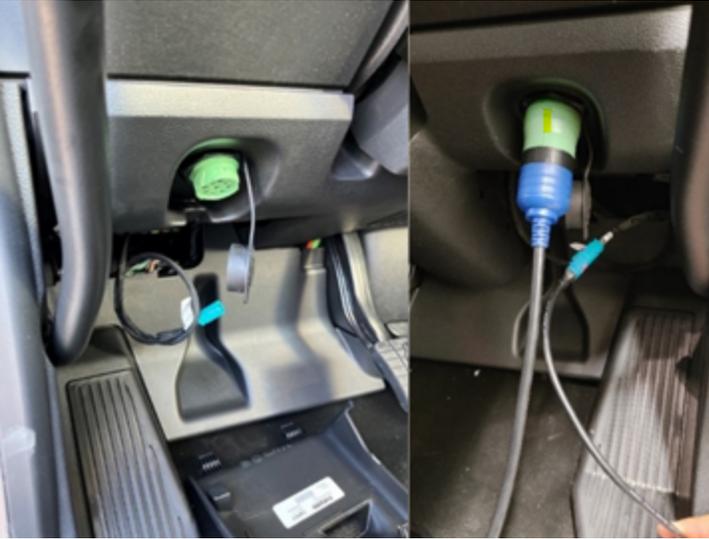
- a. Connect DAVIE4 using NEXIQ adapter and 9-pin diagnostic connector.
- b. Connect ethernet cable

- c. Download updated software for VECU3, CSG2 and DD following the prompts in DAVIE4.
- d. Program VECU3, CSG2 and DD with updated software.

3. Update software for VECU3, CSG2, and DD using DAVIE4.
