Topic	Software update for the rear door control modules - 00BB and 00BC - 25MY (SC24/25)
Market area	Bentley: worldwide (2WBE),China 796 VW Import Comp. Ltd (Vico), Beijing (6796)
Brand	Bentley
Transaction No.	2075311/9
Campaign number	ED18
Note	
Type	
US code

### New Continental GT and New Continental GTC

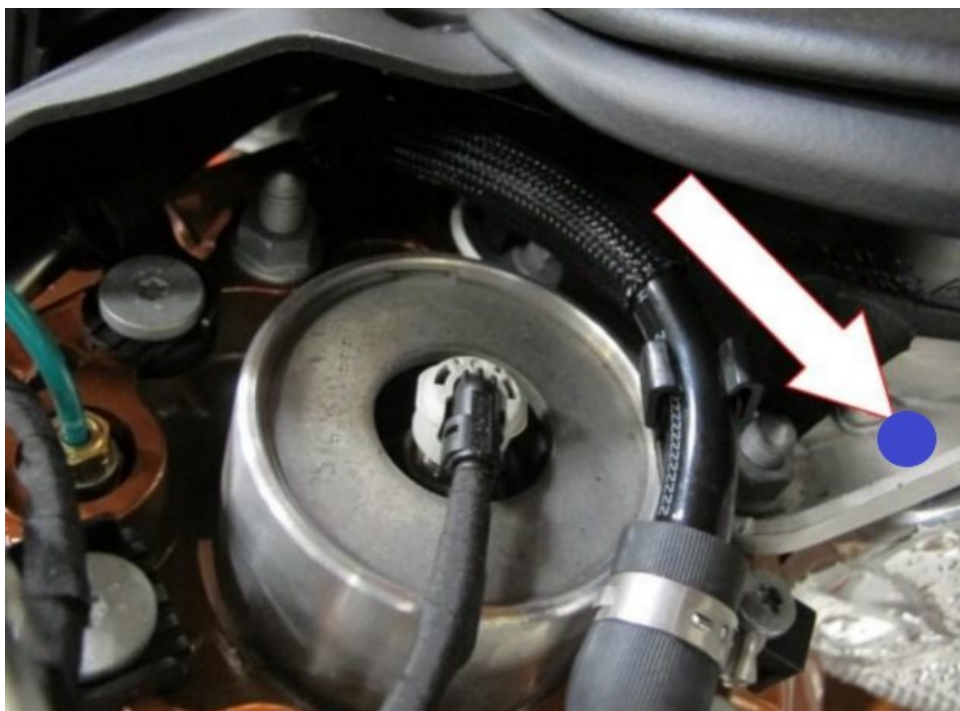
Figure 4

Blue paint completion mark on the engine partition brace

If the vehicle is not already listed as repaired in "Repair history" (in Elsa pro), check for the presence of the blue paint completion mark as shown within the Identification section

14) Referring to the Identification section - Apply a blue paint completion mark on the engine partition brace (Figure 4)
