Service Bulletin

Bulletin No.: 24-NA-244
Date: March, 2025

Subject: Diagnostic Tip on Cold Start Rough Idle - DTC P050D Set

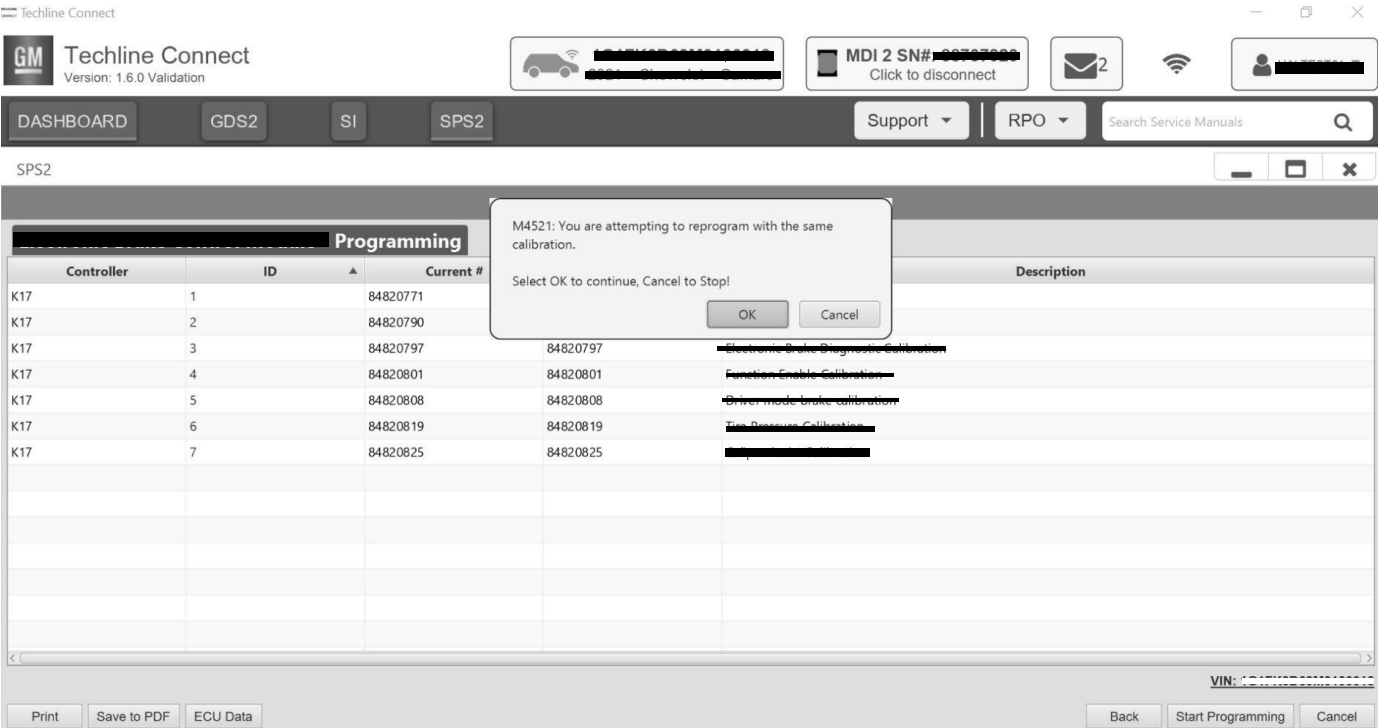
5644477

Important: Techline Connect screens shown above.

Important: If the same calibration/software warning is noted on the TLC Summary screen, select OK and follow screen instructions. After a successful programming event, the WCC is located in the Service Programming System dialogue box of the SPS Summary screen. No further action is required. Refer to the Warranty section of the bulletin.

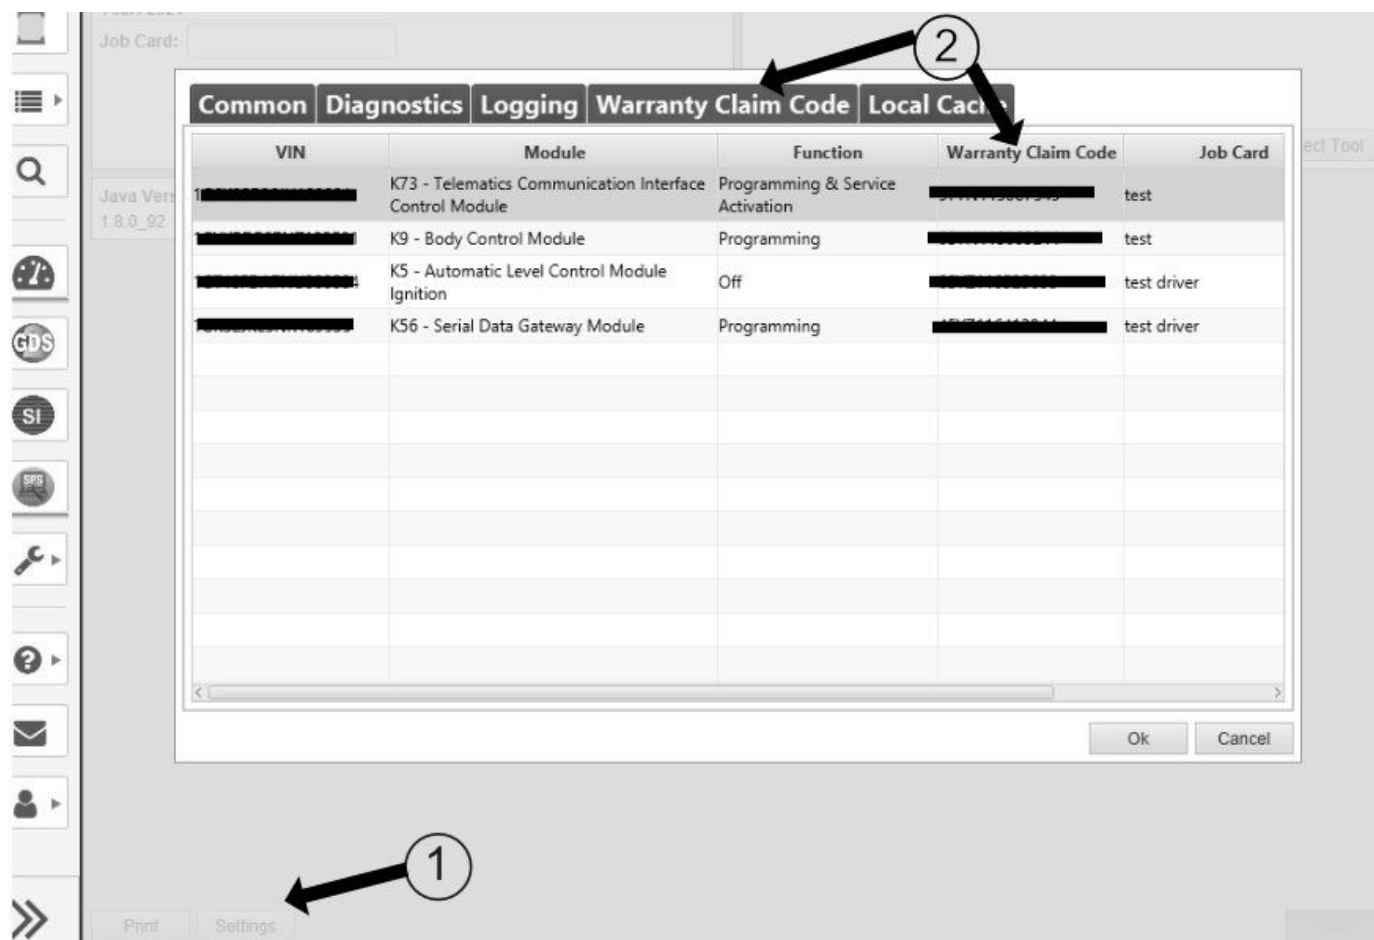
6125774

If the Warranty Claim Code was not recorded on the Job Card, the code can be retrieved in the SPS2 system as follows:

The VIN, Warranty Claim Code and Date/Time will be listed on a roster of recent programming events. If the code is retrievable, dealers should resubmit the transaction making sure to include the code in the SPS Warranty Claim Code field.
