<p>JX</p> <p>Technical Service Bulletin</p>	<p>GROUP</p> <p>BODY ELECTRICAL</p>	<p>NUMBER</p> <p>25-BE-007G</p>
	<p>DATE</p> <p>APRIL 2025</p>	<p>MODEL(S)</p> <p>SEE BELOW</p>
<p>SUBJECT: FRONT RADAR SOFTWARE UPDATE FOR DTC C1620</p>

Description: Certain 2021-2023MY GV80 (JX1), 2022-2023MY GV70 (JK1), 2021-2023MY G80 (RG3) and 2023MY G80 Electrified (RG3 EV) vehicles may exhibit a warning light with DTC C162078 due to improper detection of steel structures.

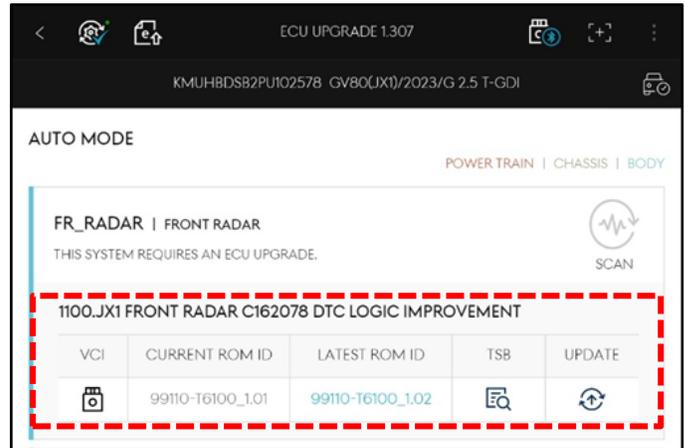
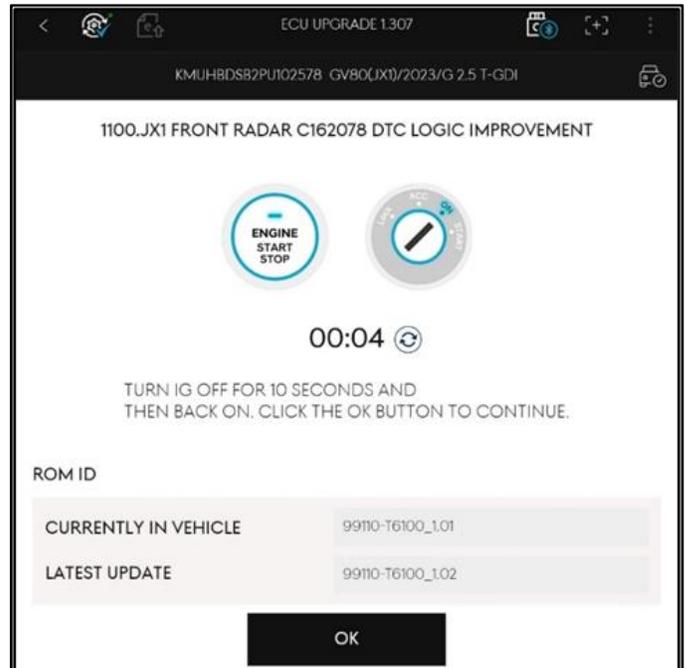
3. After the ECU update process shows 100% complete, follow the prompts on the screen to cycle the ignition **OFF** for at least **10 seconds** to reset the control unit (certain models may take up to **30 seconds**).

Use the **Refresh** button to reset the timer.

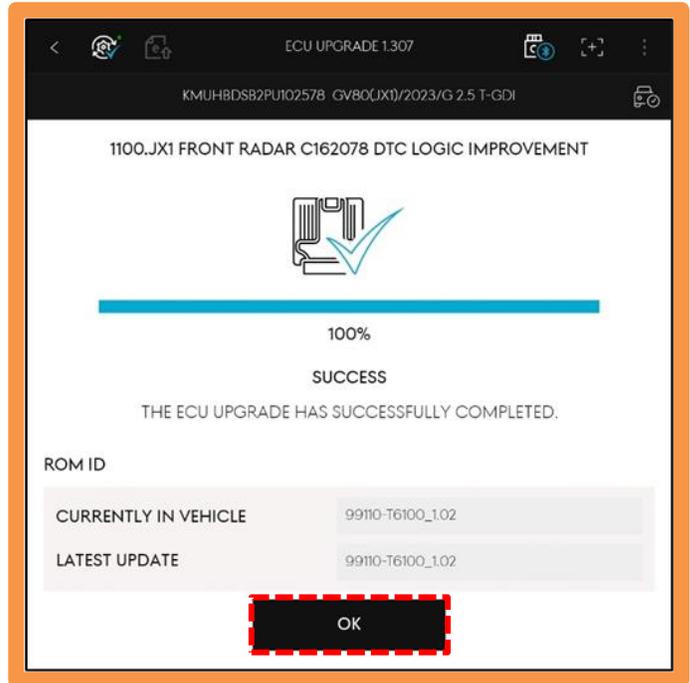
Take a screenshot of the ECU update complete screen using your tablet and upload to STUI.

NOTE 3: This TSB includes Repair validation photo(s). Op times include VIN, Mileage, and photo capture of the “ECU update complete” screen as outlined in the Digital Documentation Policy.

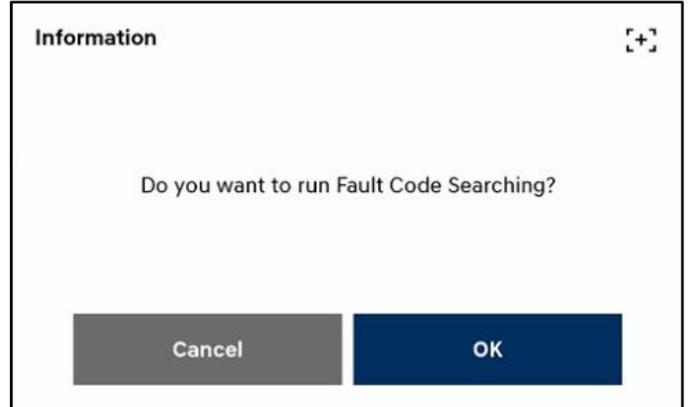
5. Perform an **All Systems Fault Code** search and erase DTC history that had incidentally occurred from the ECU update.

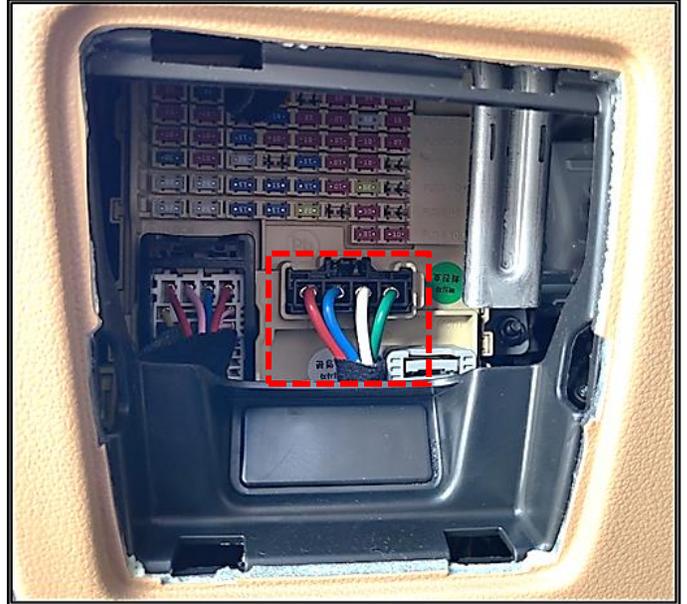
6. Disconnect the power connector of the indoor fuse box, wait at least **5 seconds**, then reconnect it.

Alternatively, disconnect the negative (-) **12V** battery terminal, wait **5 seconds**, then reconnect it.

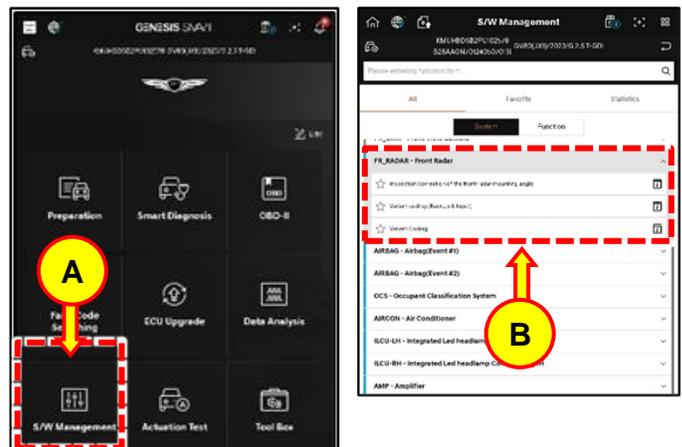
1. Select **S/W Management** (A) then select **Front Radar** (B).

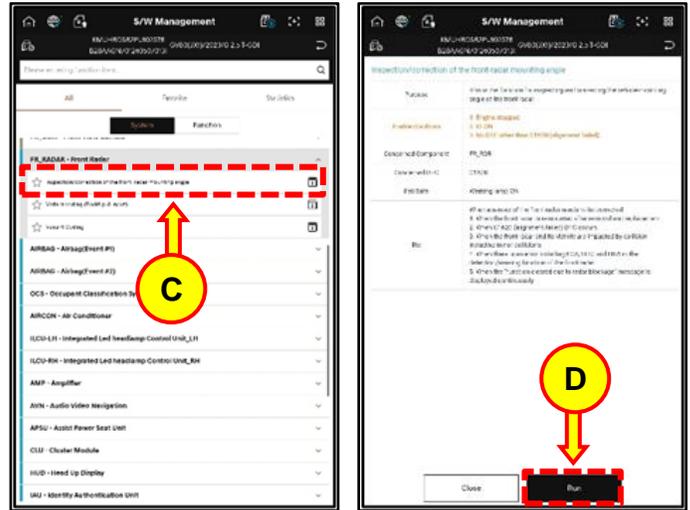
2. Select **Inspection/correction of the front-radar mounting angle (C)** then **Run (D)**.

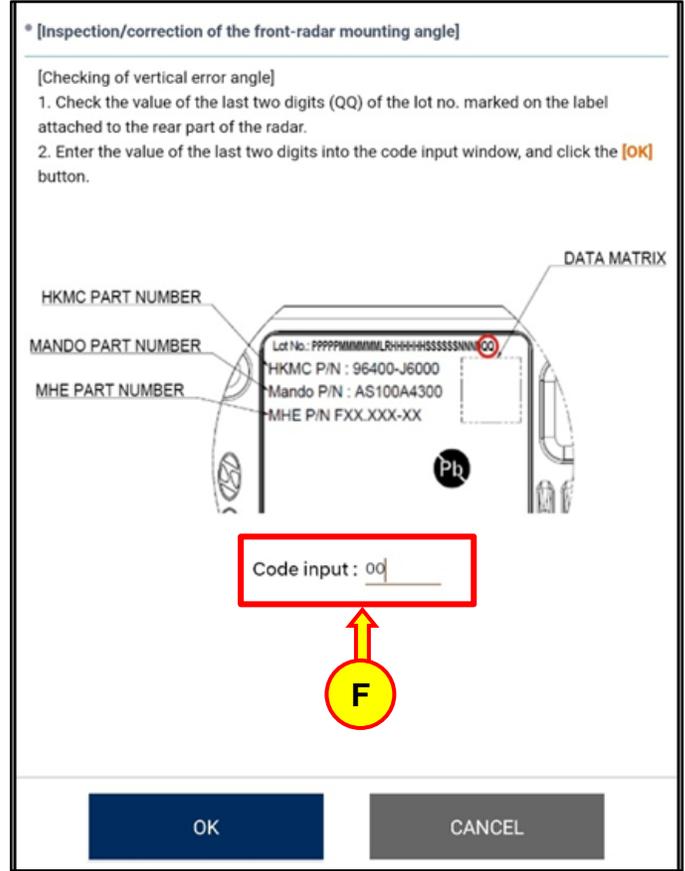
3. Review the correction procedure and preconditions before selecting **OK (E)**.

1. Engine stopped
2. IG ON
3. No DTC other than C1620 (alignment failed).

- 4. Input "00" (F) into the code input field.

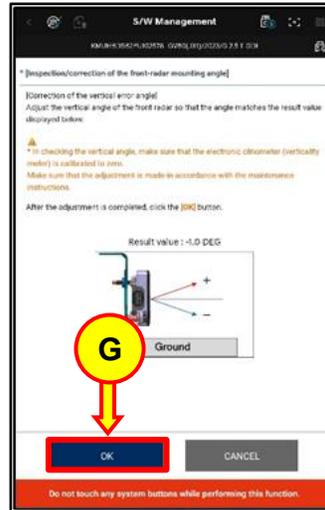
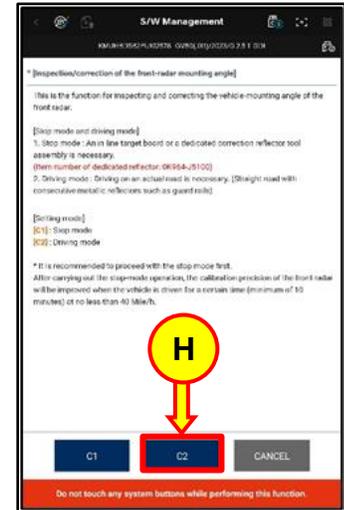
- 5. Select OK (G) then select C2 (H).

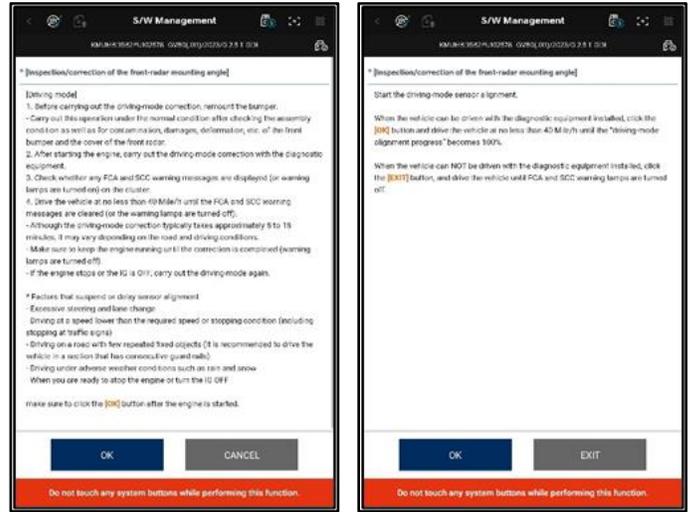
6. Follow the preparation steps to perform the **Driving Mode (C2)** calibration.

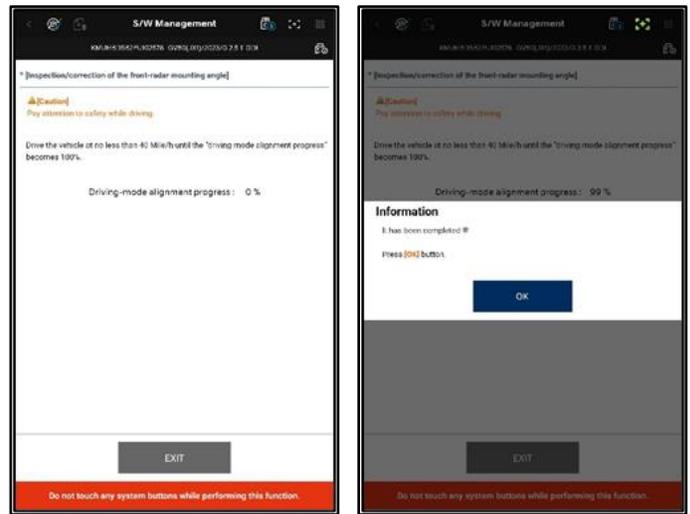
7. Calibration progress will be shown on the screen until it is successfully completed.

Vehicle needs to be driven more than **40 MPH** until the progress reaches **100%**.

The cluster will display Forward Safety & Master warning lights until the calibration is completed.
