Service Bulletin

Bulletin No.: 24-NA-176

Subject: Turn Signal Over Cancelling

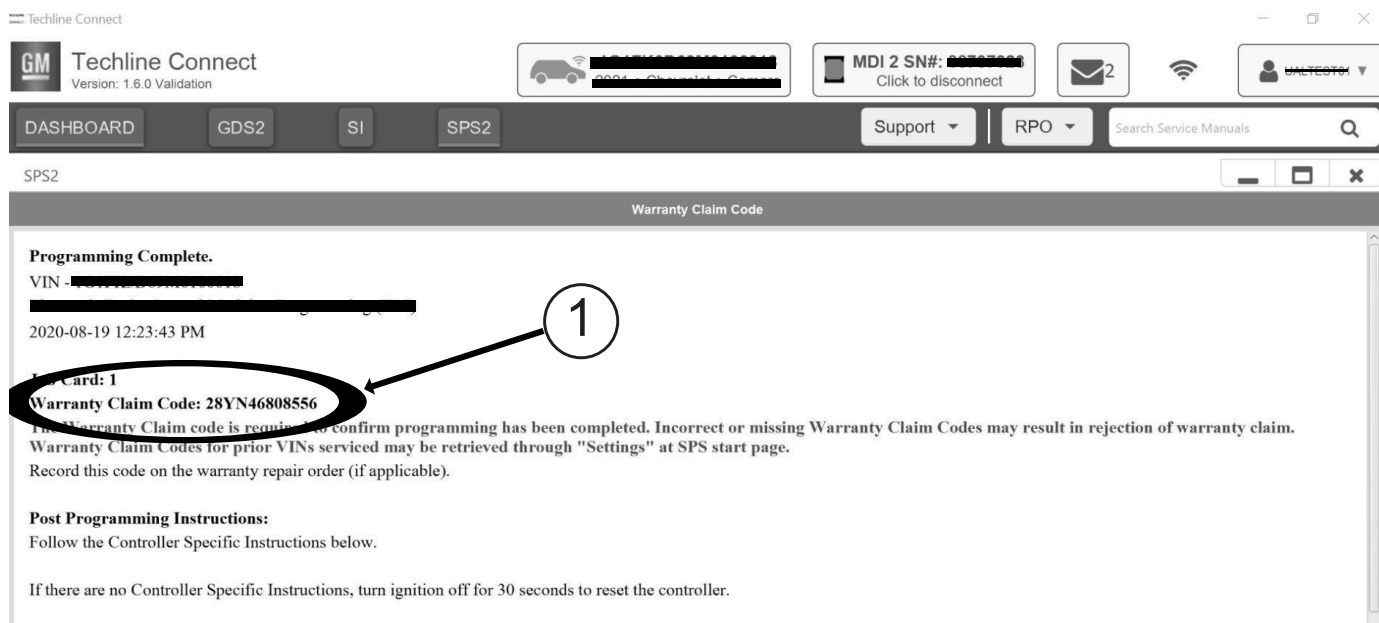
5644478

Note: The screenshot above is an example of module programming and may not be indicative of the specific module that is being programmed. Module selection and VIN information have been blacked out.
