GROUP	MODEL
ELE	2024-2025MY EV9 (MV1)
NUMBER	DATE
380	April 2025

TECHNICAL SERVICE BULLETIN

VEHICLE-TO-EVERYTHING (V2X) SOFTWARE UPGRADE

This bulletin provides information to install the Vehicle-to-Everything 'V2X' function enhancements by upgrading the software of the Vehicle Charging Management System 'VCMS', Rear Motor Control Unit 'R_MCU', Vehicle Control Unit 'VCU' and Battery Management Unit 'BMU' systems on some 2024-2025MY EV9 (MV1) vehicles produced from September 25, 2023 through October 15, 2024, that have been unable to be updated using the Over-The-Air (OTA) method. The V2X technology allows EV9 vehicles to interact with other devices such as Vehicle-to-Home 'V2H' and Vehicle-to-Grid 'V2G' technology which enables bidirectional charging, where the EV's battery can be used as a mobile energy storage unit, providing power to the grid or a home backup power source. Follow the procedure outlined in this publication to install the software upgrade to the four (4) required systems, 1) 'VCMS', 2) 'R_MCU', 3) 'VCU' and 4) 'BMU'. Refer to [SST081](#) for software upgrade instructions using Kia Diagnostic System (KDS) tablet and VCI-II and confirm the Upgrade Event Number/Nam

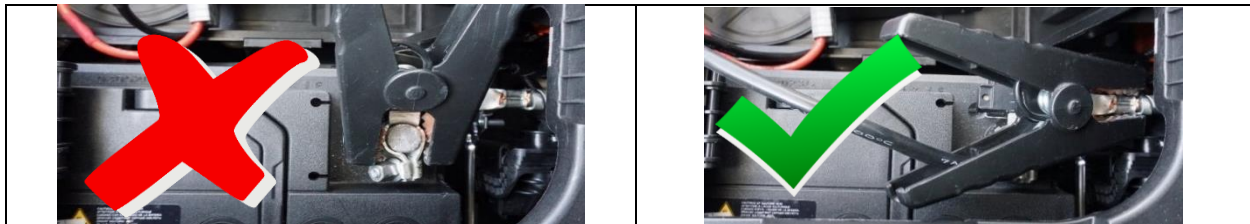
Connect the negative (-) terminal to the battery as shown below.

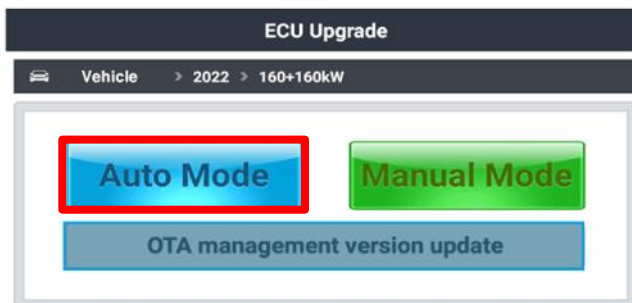
The required software must be installed by selecting the **'Auto Mode'** ECU Upgrade option.

Note: In some case, the 'Manual Mode' installation option may be required **ONLY if** the 'Auto Mode' function fails or is otherwise noted above.

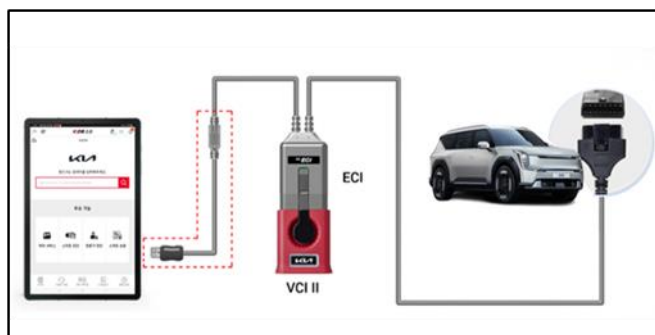
Ensure the ECI cable is configured by referring to the ['KDS Configuration for ECI Cable Usage'](#).

Connect the ECI DLC connector to the OBD-II connector, located under the driver's side of the instrument panel.

Connect the ECI USB -C connector to the KDS tablet.

Connect the VCI II to the ECI OBD-II connector.

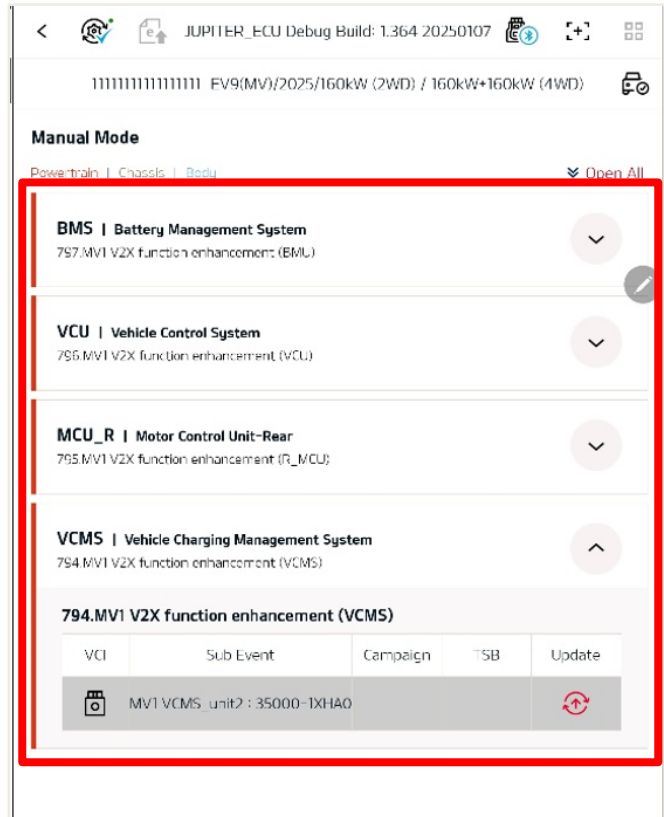
1. 794.MV1 V2X Function Enhancement (VCMS)
2. 795.MV1 V2X Function Enhancement (R_MCU)
3. 796.MV1 V2X Function Enhancement (VCU)
4. 797.MV1 V2X Function Enhancement (BMU)

Verify the affected vehicle Calibration Identification of the applicable ECU ROM ID and reference the Information Table on page 3 as necessary.
