GROUP	MODEL
TRA	2020MY Telluride (ON)
NUMBER	DATE
089 (Rev 1, 04/10/2025)	April 2020

TECHNICAL SERVICE BULLETIN

SUBJECT: **TCM MIL ON DTC P074100 LOGIC IMPROVEMENT**

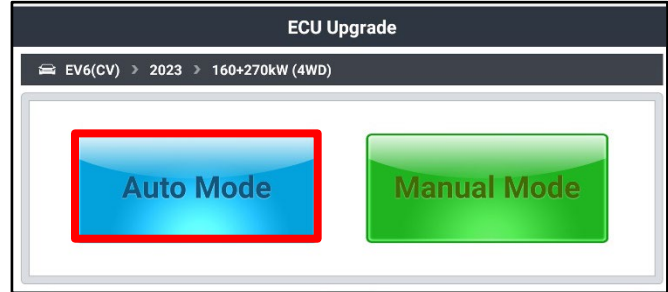
The required software must be installed by selecting the **'Auto Mode'** ECU Upgrade option.

Note: In some case, the 'Manual Mode' installation option may be required **ONLY** if the 'Auto Mode' function fails or is otherwise noted above.

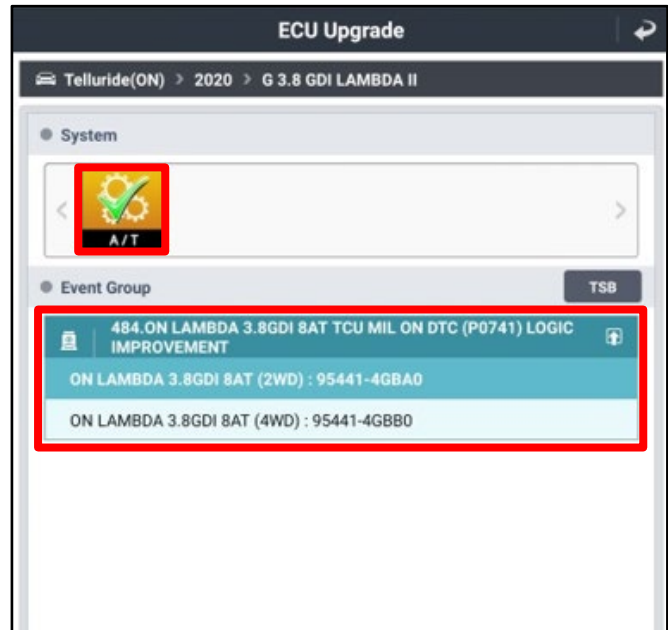
Select the applicable **'A/T'** system module and the Event Group.

- **484. ON LAMBDA 3.8GDI 8AT TCU MIL ON DTC (P0741) LOGIC IMPROVEMENT**

Verify the affected vehicle Calibration Identification of the applicable ECU ROM ID and reference the Information Table on page 3 as necessary.
