HYUNDAI

Technical Service Bulletin

| GROUP CAMPAIGN | NUMBER 25-01-028H |
| DATE APRIL 2025 | MODEL(S) SANTA FE HYBRID (MX5A HEV) |

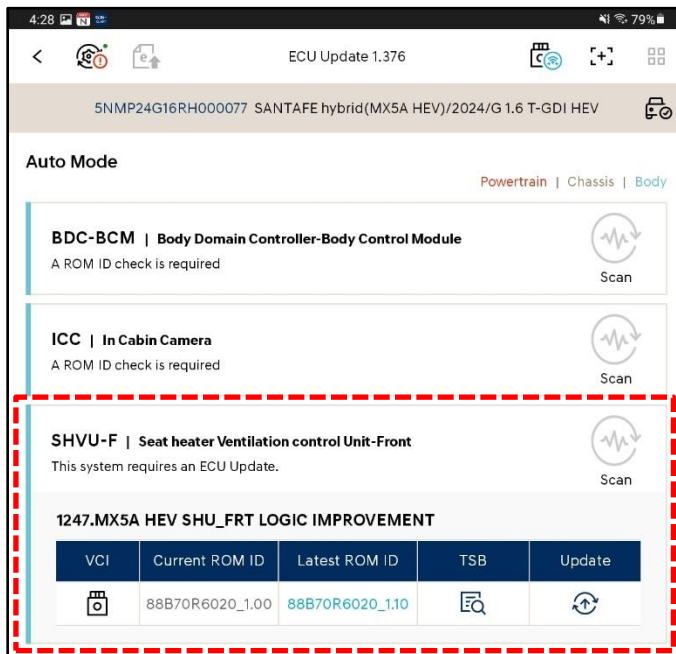
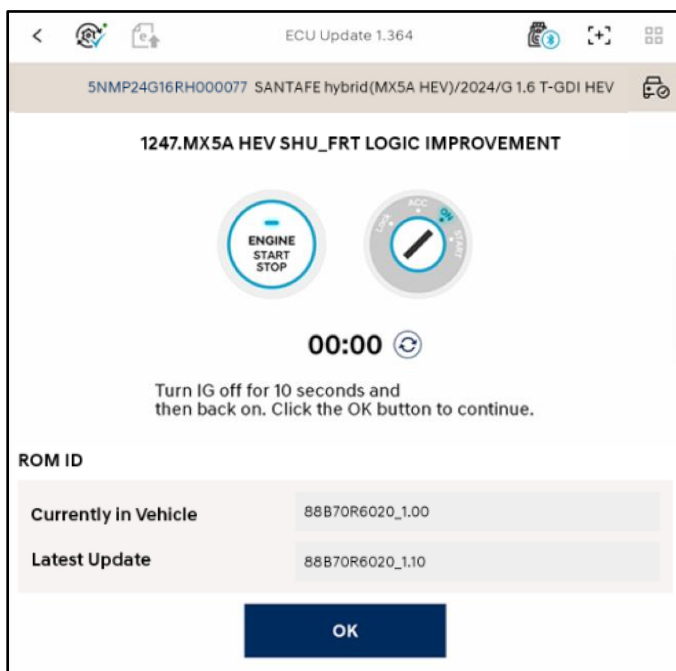
- After the ECU update process shows 100% complete, follow the prompts on the screen to cycle the ignition **OFF** for at least **10 seconds** to reset the control unit (certain models may take up to **30 seconds**).

Use the **Refresh** button to reset the timer.

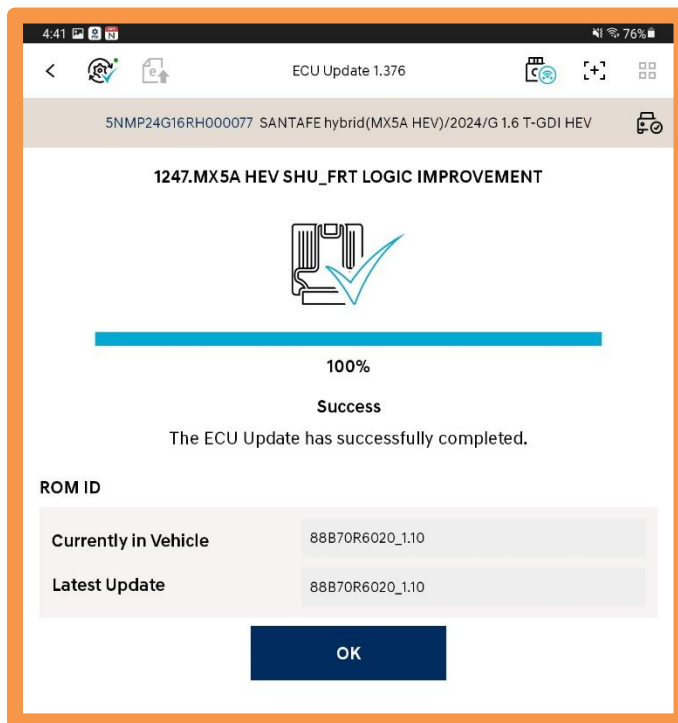
4.

Take a screenshot of the ECU update complete screen using your tablet and upload to STUI.

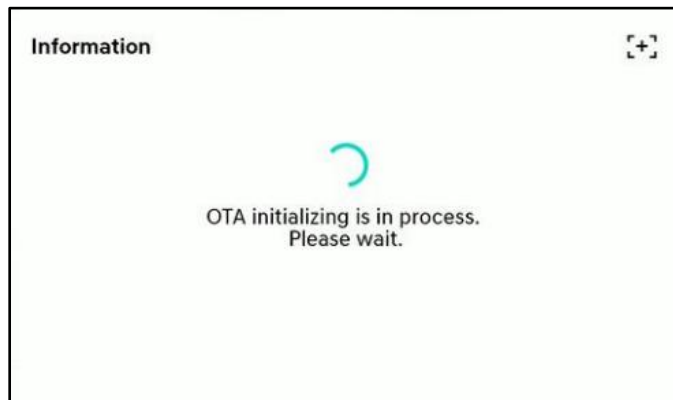
5. After clicking **OK**, the OTA Initialization process will begin.

- If OTA initialization performs automatically, then proceed with the service procedure.
- If the OTA initialization fails, **connect GDS-Smart > S/W Management > Central Communication Unit (CCNF) > OTA Initialization**

Follow the instructions on the screen.

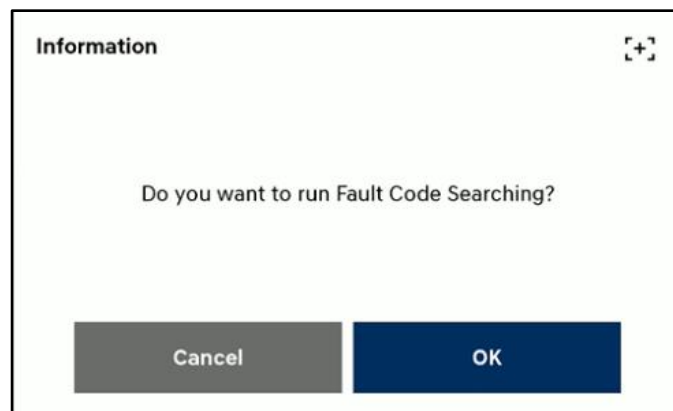
6. Perform an **All Systems Fault Code** search and erase DTC history that had incidentally occurred from the ECU update.

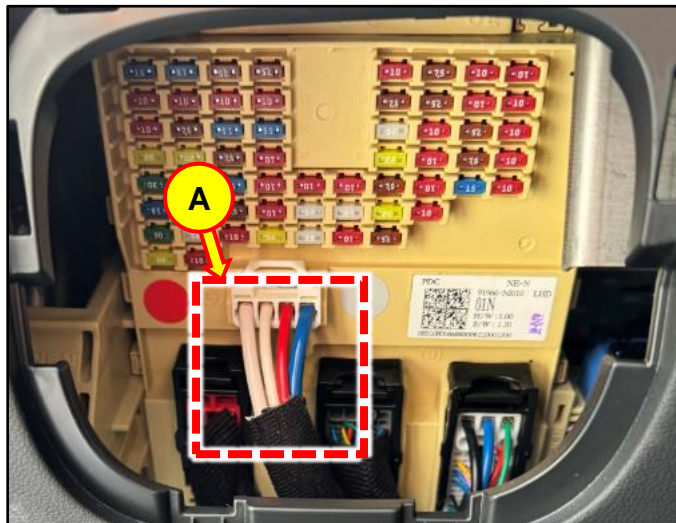
7. Disconnect the power connector (A) of the indoor fuse box, wait at least **5 seconds**, then reconnect it.

Alternatively, disconnect the negative (-) **12V** battery terminal, wait **5 seconds**, then reconnect it.

If the update fails, please remove the power connector or the battery (–) connector from the indoor fuse box for at least **5 seconds** and reassemble it to retry the update.
