Technical Service Bulletin (TSB)
Lumbar Seat Inoperable

REFERENCE:	TSB: 08-123-25 GROUP: 08 - Electrical	Date:	April 25, 2025	REVISION:	—
VEHICLES AFFECTED:	2025 (DT) RAM 1500 Pickup This bulletin applies to vehicles built on or after March 15, 2024 (MDH 0315XX) and on or before October 24, 2025 (MDH 1024XX) equipped with one of the following radios: <ul style="list-style-type: none"> Uconnect 5 Nav W 12.0" (Sales Code UPQ). Uconnect 5 Nav W 14.4" (Sales Code UPW). 			MARKET APPLICABILITY:	
				<input checked="" type="checkbox"/> NA	<input type="checkbox"/> MEA
				<input type="checkbox"/> SA	<input type="checkbox"/> IAP
				<input type="checkbox"/> EE	<input type="checkbox"/> CH
CUSTOMER SYMPTOM:	Customers may experience the following: <ul style="list-style-type: none"> All lumbar seat controls inoperable. 				
CAUSE:	Radio software

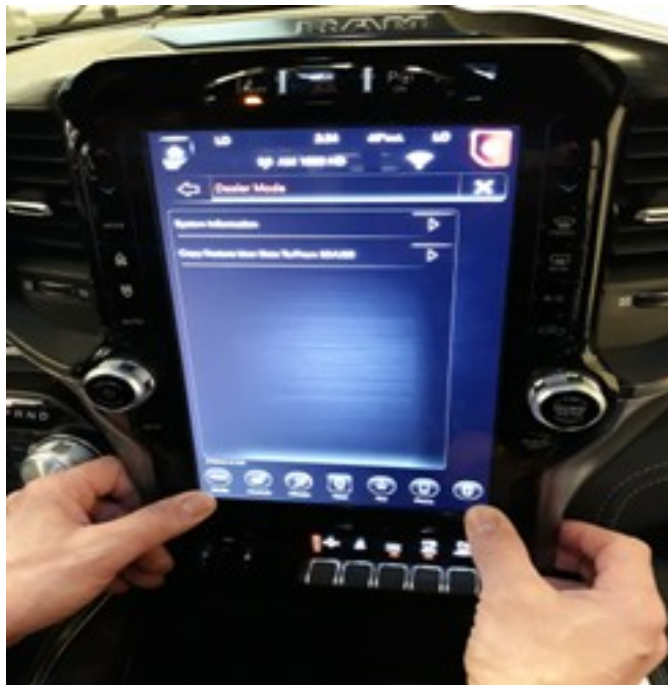
2. Verify if the radio has the latest software already installed by using the radio touch screen and simultaneously place both thumbs on the corners of the touch screen and hold for approximately six seconds or until the “Dealer Mode” screen is displayed [Fig. 1](#).

Fig. 1
Finger Position On Touch Screen
