GROUP	MODEL
CHA	2020-2022MY Telluride (ON) AWD
NUMBER	DATE
128	April 2025

TECHNICAL SERVICE BULLETIN

SUBJECT: **4WD COUPLING NOISE/VIBRATION LOGIC IMPROVEMENT**

This bulletin provides information to upgrade the 4-Wheel Drive “4WD” system software on certain 2020-2022MY Telluride (ON) vehicles produced from January 9, 2019, through September 1, 2022. The affected vehicles may exhibit a noise, vibration, shudder, and/or chattering from the 4WD coupling assembly while turning at low speeds (10-15 mph) due to continuous vehicle operation in harsh conditions (e.g., very high or low ambient temperatures). Follow the procedure outlined in this publication to update the ‘4WD’ system software on the applicable vehicle AFTER the issue has been diagnosed to be located at the 4WD coupling assembly. Refer to [SST081](#) for software upgrade instructions using Kia Diagnostic System (KDS) tablet and VCI-II and confirm the Upgrade Event Number/Name, ROM ID Information, and Manual Mode passwords (if applicable) on the applicable vehicle.

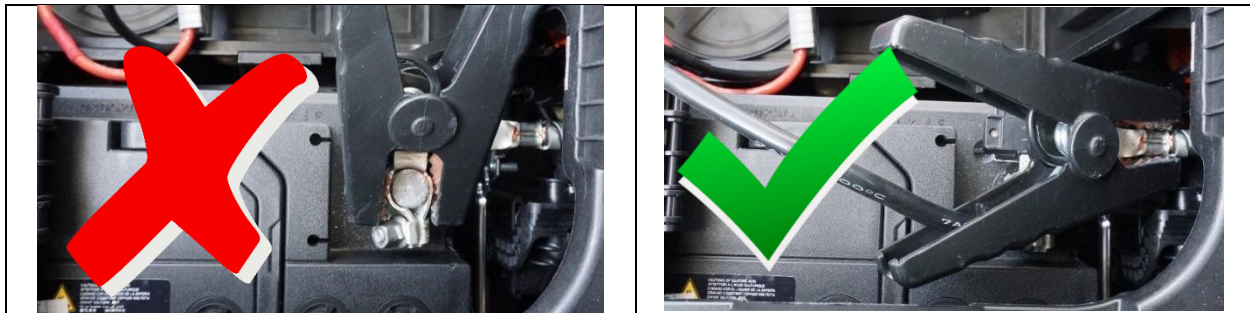
[Connect the negative \(-\) terminal to the battery as shown below.](#)

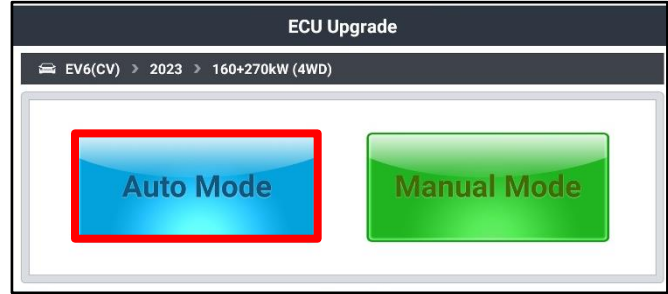
The required software must be installed by selecting the **'Auto Mode'** ECU Upgrade option.

Note: In some case, the 'Manual Mode' installation option may be required **ONLY** if the 'Auto Mode' function fails or is otherwise noted above.

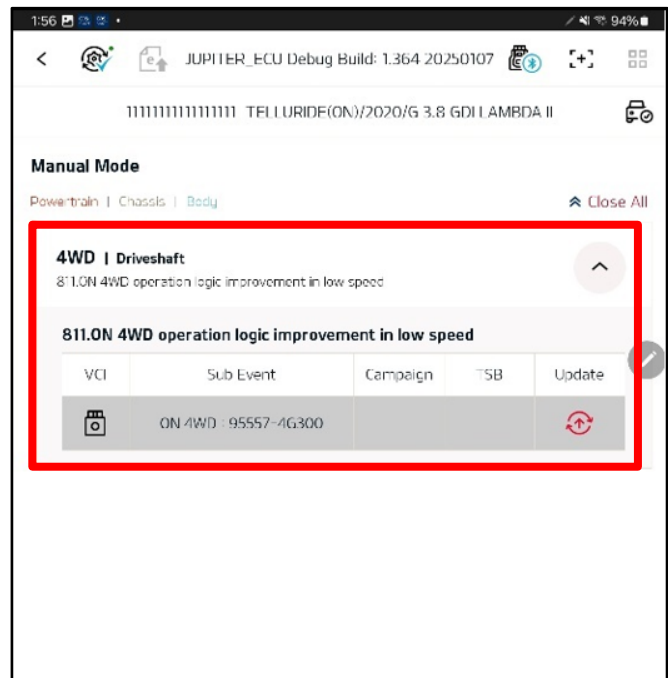
Select the applicable **'4WD'** system module and the Event Group.

- **811.ON 4WD Operation Logic Improvement in Low Speed**

Verify the affected vehicle Calibration Identification of the applicable ECU ROM ID and reference the Information Table on page 3 as necessary.
