Section B: Repair Procedure

Reprogram BCM by MDARS

REPAIR PROCEDURE MAZDA SERVICE PROGRAM MSP63

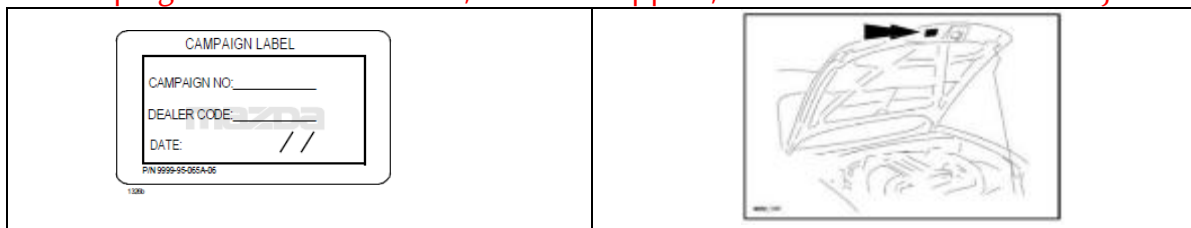
eMDCS - Warranty Vehicle Inquiry Results

1. If the vehicle is in the range above and MSP63 is in OPEN status in eMDCS, proceed to Step 2. If the vehicle does not have an OPEN MSP63 status, return the vehicle to the customer or inventory.
2. Perform an eMDCS Warranty Vehicle Inquiry and inspect the vehicle for a Campaign Label with MSP63 attached to the vehicle's hood, driver door or firewall.

NOTE: Always be sure to verify the campaign number as the vehicle may have multiple campaign labels on the hood, radiator support, and firewall or driver door jamb.

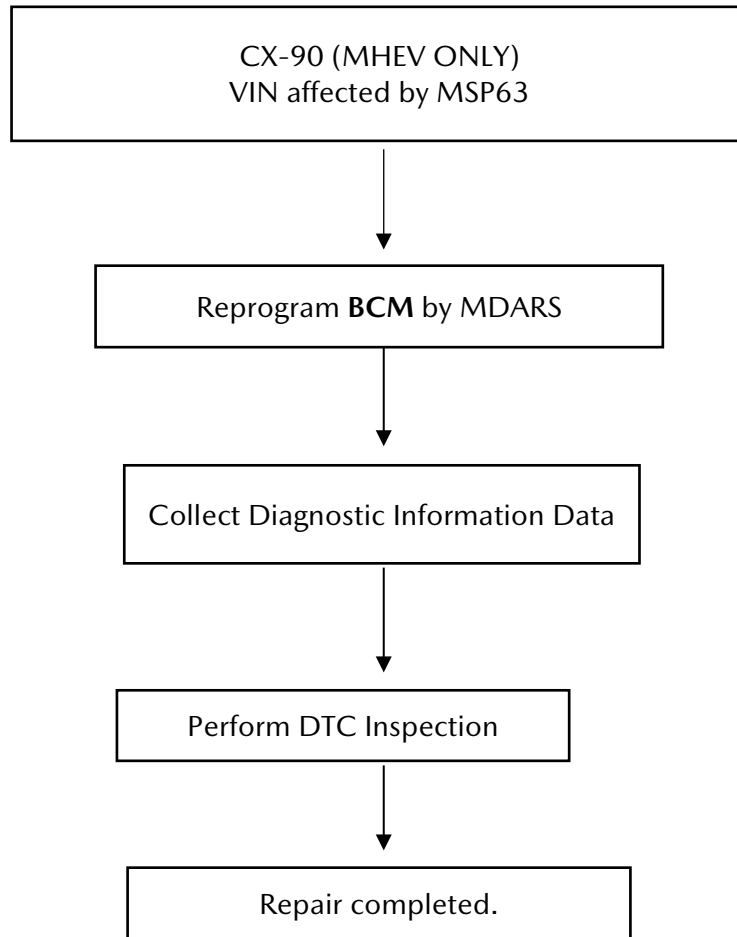
Section A: Flow Chart

NOTE: This Flow Chart needs to be followed strictly

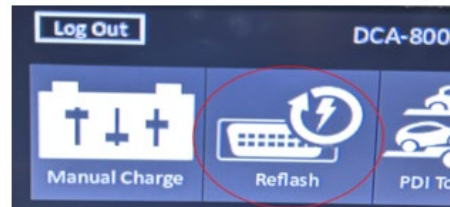
During reprogramming, connect the battery charger to the vehicle to stabilize voltage fluctuation. If missing, it may cause damage to ECUs due to decreasing voltage.

7th generation vehicle will control to turn on headlights forcibly during reprogramming due to change CAN communication. **Please use the "Reflash" setting in the charger, which will keep the voltage stable. The setting voltage must be between 12 -13V.**

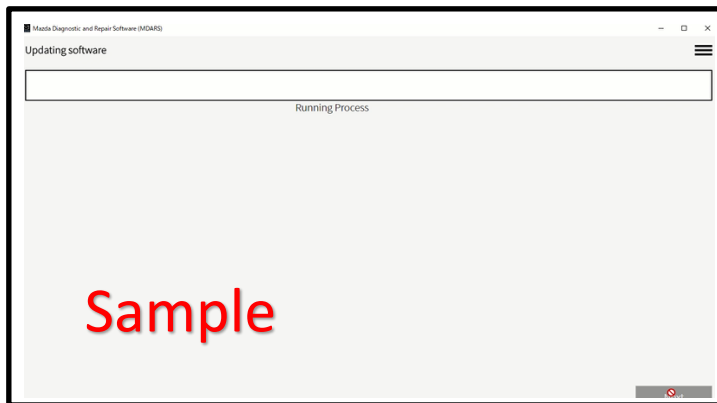
(2) This is the screen while the software is being updated. The progress bar does not change for about 60 seconds.

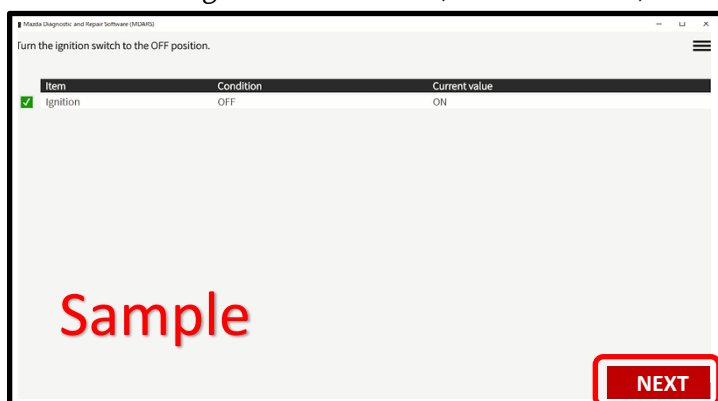
(3) During reprogramming, "Turn Ignition Switch to the OFF Position" may display on the MDARS several times. Turn the ignition switch OFF, check the box, and select "Next".

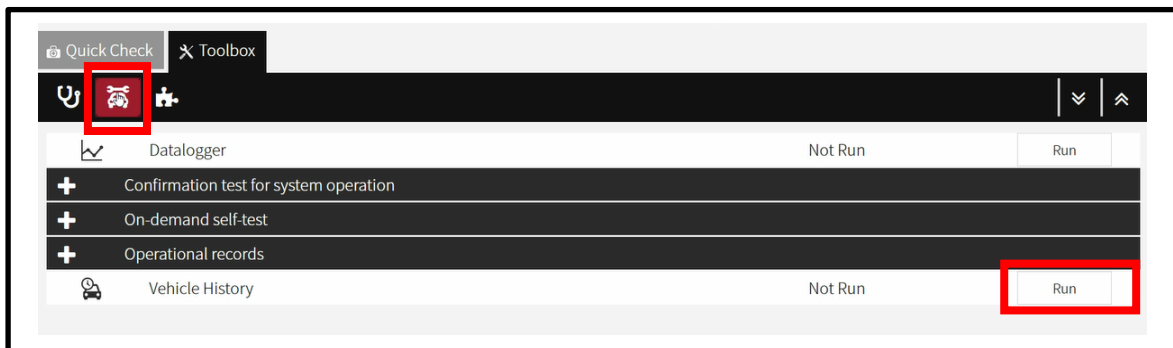
- (7) Open the vehicle history on toolbox tab.

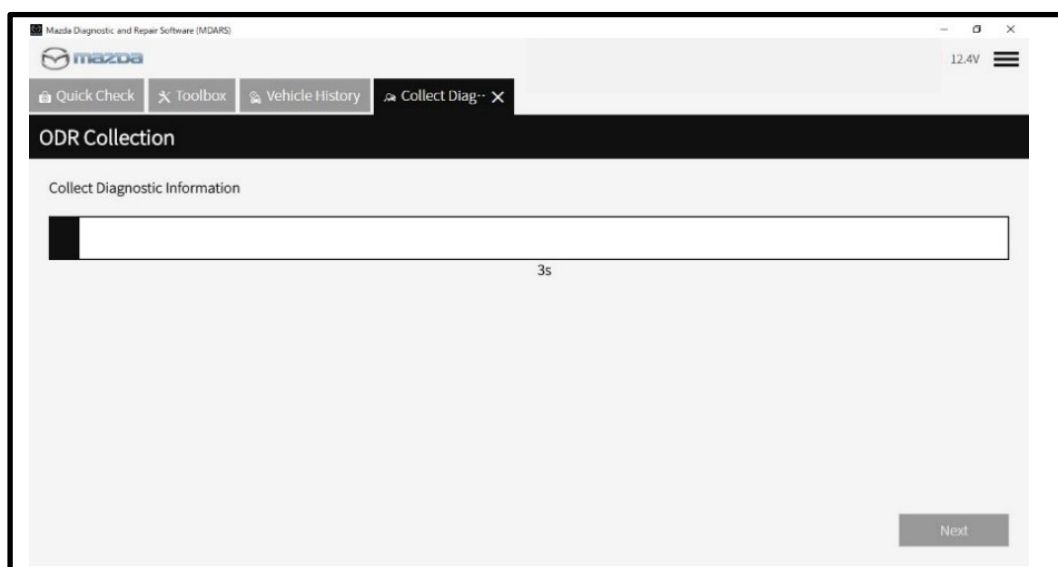
(3) It takes around 60 seconds.
