Field campaign

Topic	Softwate Update Rear Door Control Module Update (00BB and 00BC) Continental GT/GTC 25MY (SC24/25)
Market area	Bentley: worldwide (2WBE),China 796 VW Import Comp. Ltd (Vico), Beijing (6796)
Brand	Bentley
Transaction No.	2075311/12
Campaign number	ED18
Note	
Type	
US code

25MY Continental GT and New Continental GTC

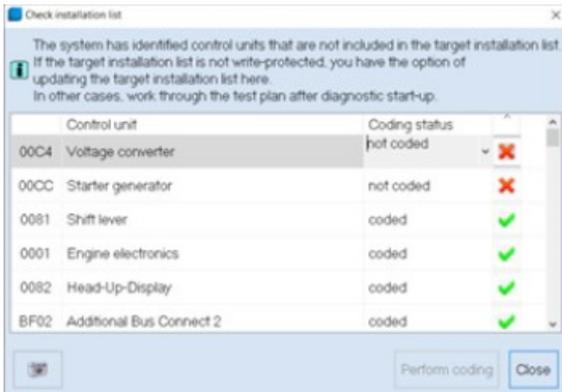
Figure 1

If a 'Check installation list' pop-up appears, select 'close' (Figure 1)

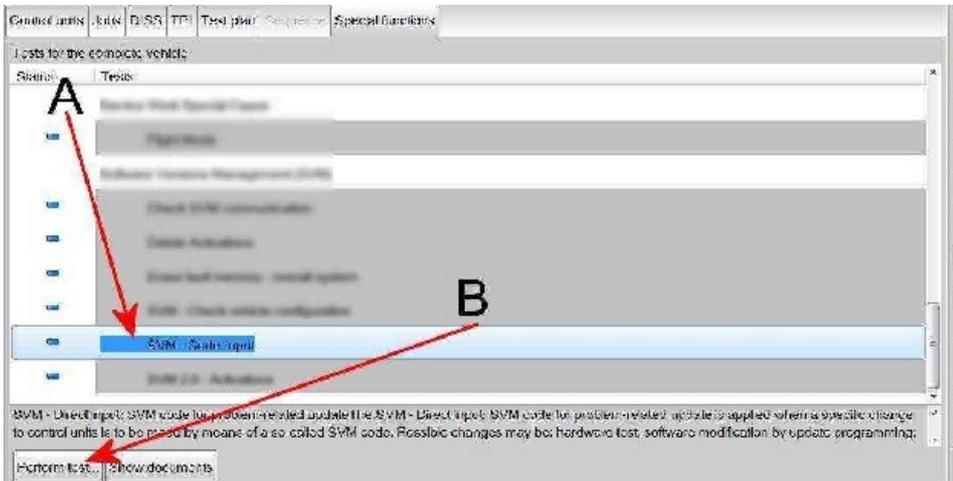
2) Referring to Figure 2 - Within the Special functions tab - Select SVM - Code Input (Point A)

- Select Perform test (Point B)

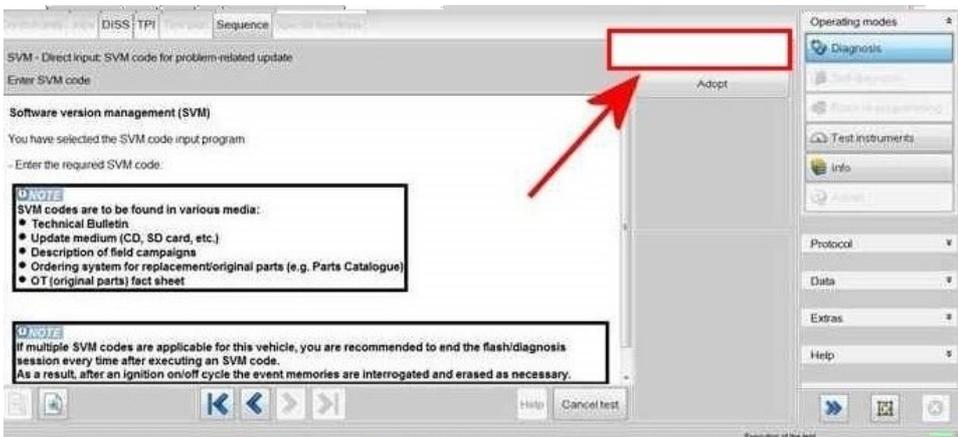
3) Referring to Figure 3 - Enter the SVM code 372WDD01

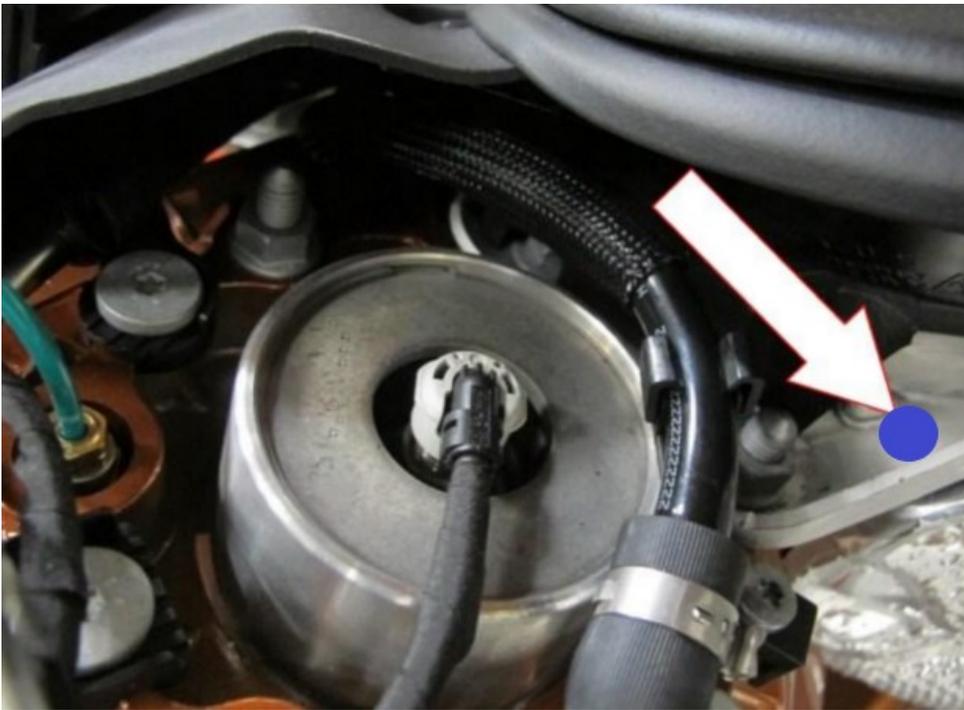
Figure 4

14) Referring to the Identification section - Apply a blue paint completion mark on the engine partition brace (Figure 4)

Blue paint completion mark on the engine partition brace

If the vehicle is not already listed as repaired in "Repair history" (in Elsa pro), check for the presence of the blue paint completion mark as shown within the Identification section
