GENERAL MOTORS
DCS7209
URGENT - DISTRIBUTE IMMEDIATELY

Subject: REVISION: N242487960-01 – Service Update
BCM DTC U1962 May Not Properly Clear
2024 Model Year Added

Models: 2024-2025 Chevrolet Corvette

N242487960 BCM DTC U1962 May Not Properly Clear

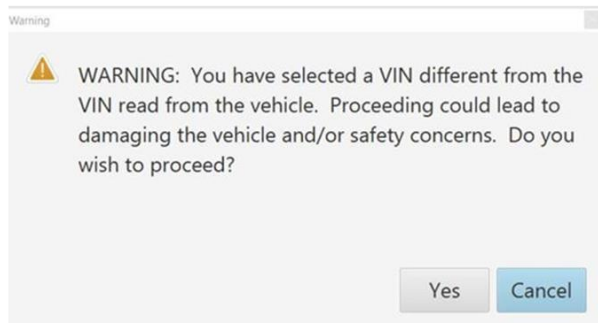
5877000

Important: If the vehicle VIN DOES NOT match, the message below will be shown.

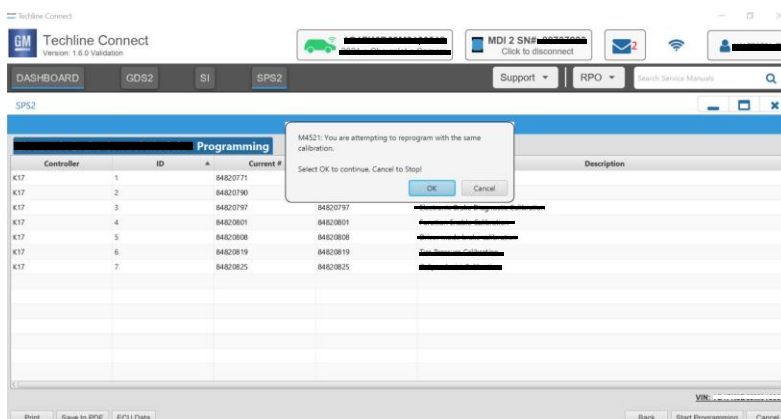
5644477

Important: Techline Connect screens shown above.

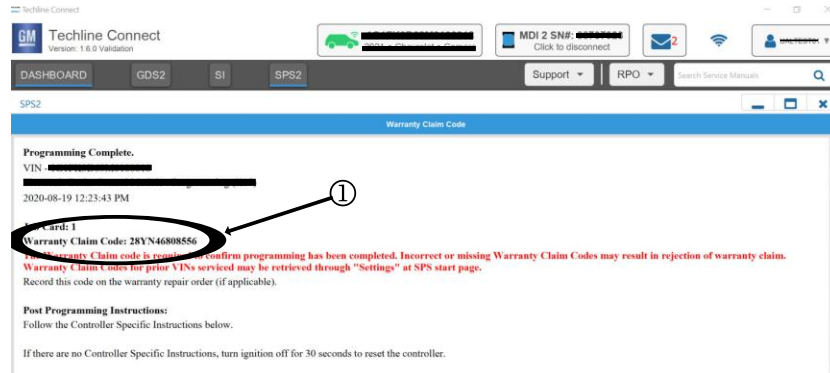
5644478

1. Reprogram the Body Control Module. Refer to *K9 Body Control Module: Programming and Setup* in SI.

Note: The screenshot above is an example of module programming and may not be indicative of the specific module that is being programmed. Module selection and VIN information have been blacked out.

Important: If the same calibration/software warning is noted on the TLC Summary screen, select OK and follow screen instructions. After a successful programming event, the WCC is located in the Service Programming System dialogue box of the SPS Summary screen. No further action is required. Refer to the Warranty section of the bulletin.
