Technical Service Bulletin

SUBJECT:		NO: TSB-25-54-003REV	
ABNORMAL NOISE FROM DYNAMIC SOUND YAMAHA ULTIMATE 12 SPEAKERS - REVISED		DATE: April 2025	
		MODEL: Outlander	
CIRCULATE TO:	<input type="checkbox"/> GENERAL MANAGER	<input checked="" type="checkbox"/> PARTS MANAGER	<input checked="" type="checkbox"/> TECHNICIAN
<input checked="" type="checkbox"/> SERVICE ADVISOR	<input checked="" type="checkbox"/> SERVICE MANAGER	<input checked="" type="checkbox"/> WARRANTY PROCESSOR	<input type="checkbox"/> SALES MANAGER

This bulletin provides instructions to reprogram the primary speaker amplifier.

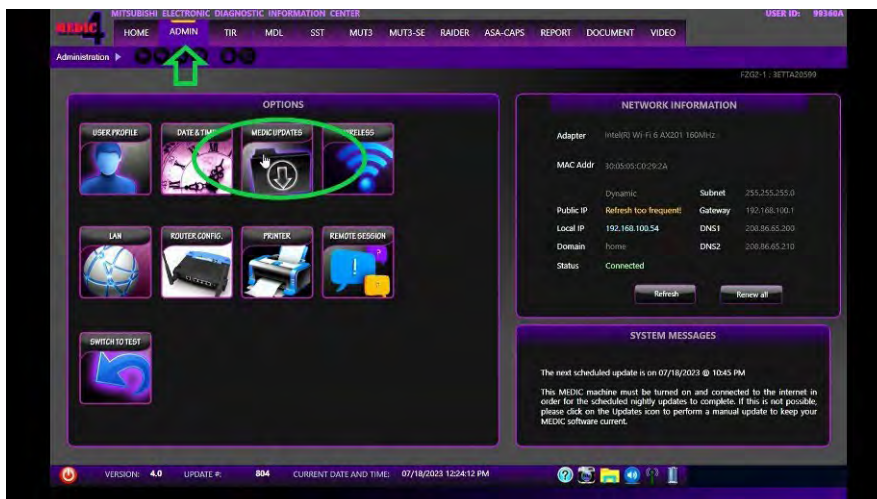
3. Select the MEDIC 3.5/4 Admin tab and click on "Updates".

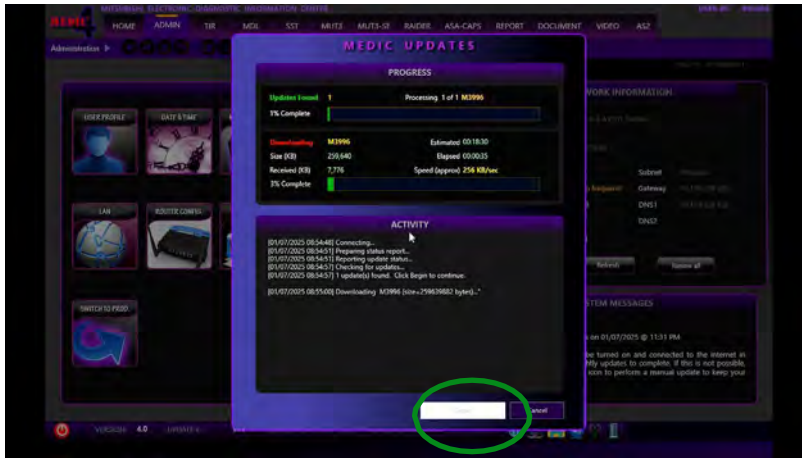
4. If the MEDIC update screen advises updates are available, click the "Begin" button. After all updates are complete, **GO TO THE REPROGRAMMING PROCEDURE.**

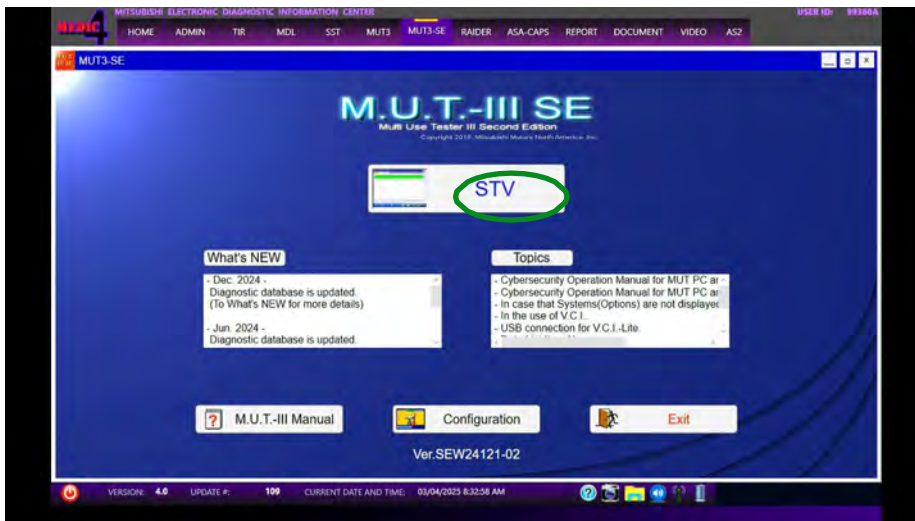
5. STANDALONE MUT-3 SE SCAN TOOL VIEWER (STV) ONLY: (MEDIC 3.5 USERS – GO TO THE REPROGRAMMING PROCEDURE). Verify that your MUT-3 SE has the most current version of the reprogramming database from the MUT-3 SE Main Page.

- a. Press the STV button.

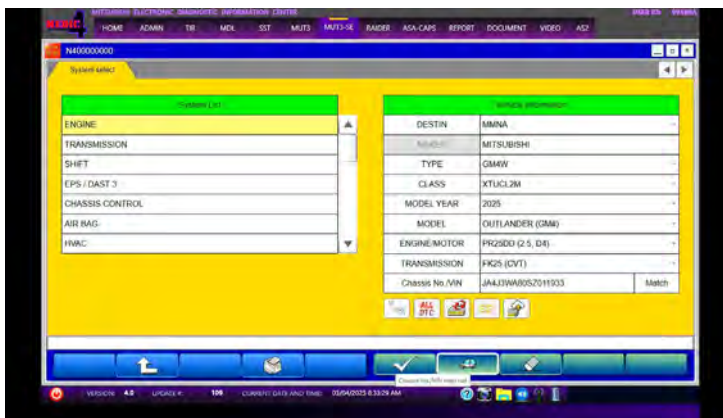
- a. Press the "car icon" for Chassis No/VIN read out.

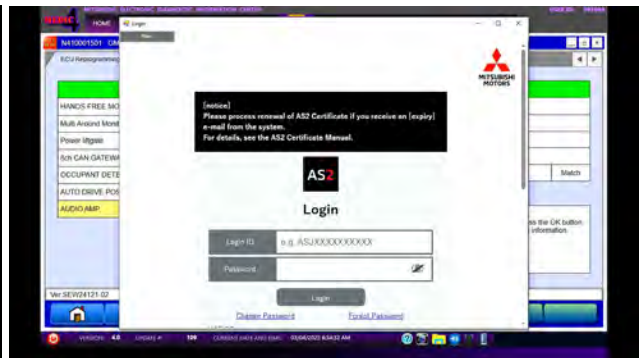
e. CGW Mode Change will appear. Login to AS2. CGW Mode Change will appear again.

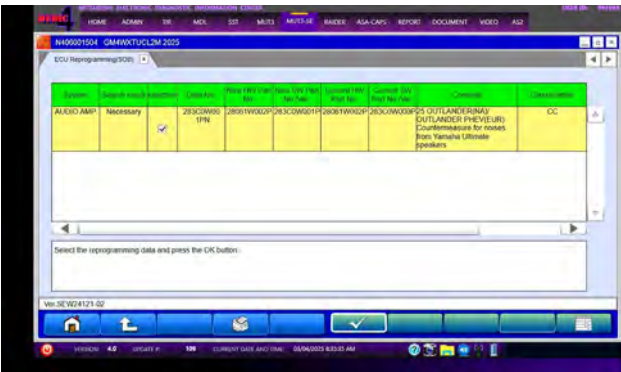
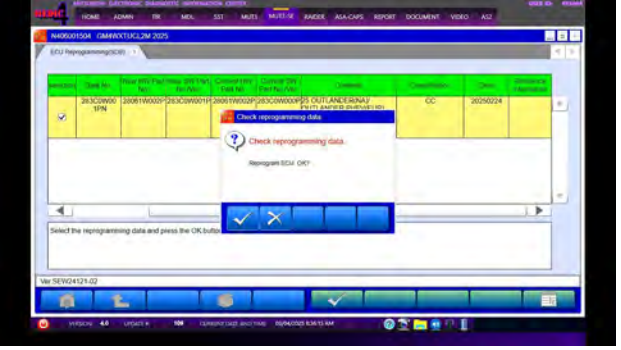
g. Click in the "selection" box and verify the software. Press the "OK" button.

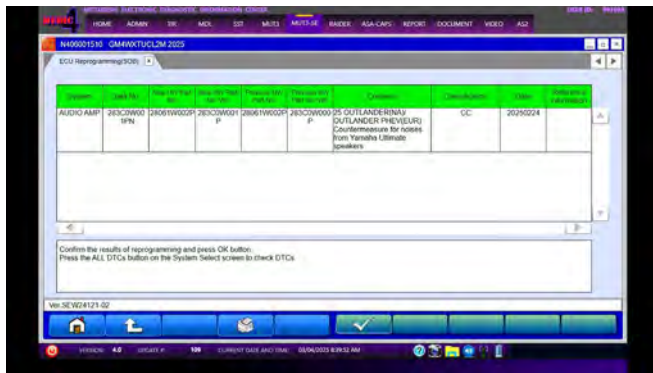
- h. Confirm the reprogramming results and press the "OK" button. Press the ALL DTCs button on the System Select screen to check DTCs. Press the "OK" button to begin.

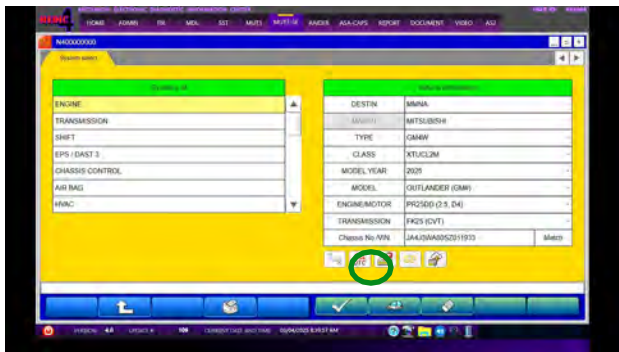
- i. Place the push-button switch in the "OFF" position for 10 seconds. Then place the push-button ignition switch back to the "ON" position.
- j. Press the ALL DTCs button on the System Select screen to check DTCs. Press the "OK" button to begin.
