*Coach Control System Time Loss*

Number: FT-ESB-0035

1.0 Description of Affected Products: Coaches with a Silverleaf LR130

2.0 Issue: Coach control system can potentially lose up to 2 hours of time overnight.

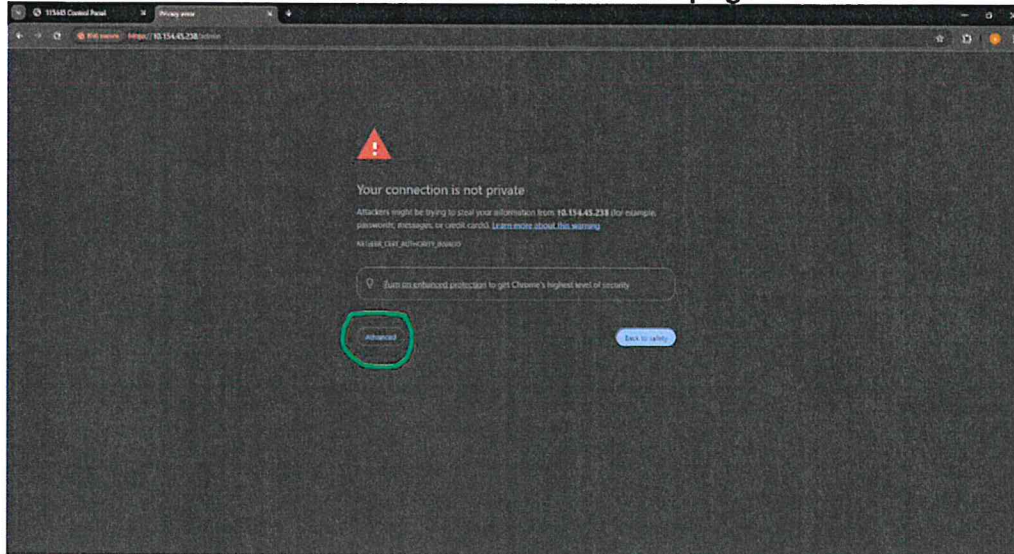
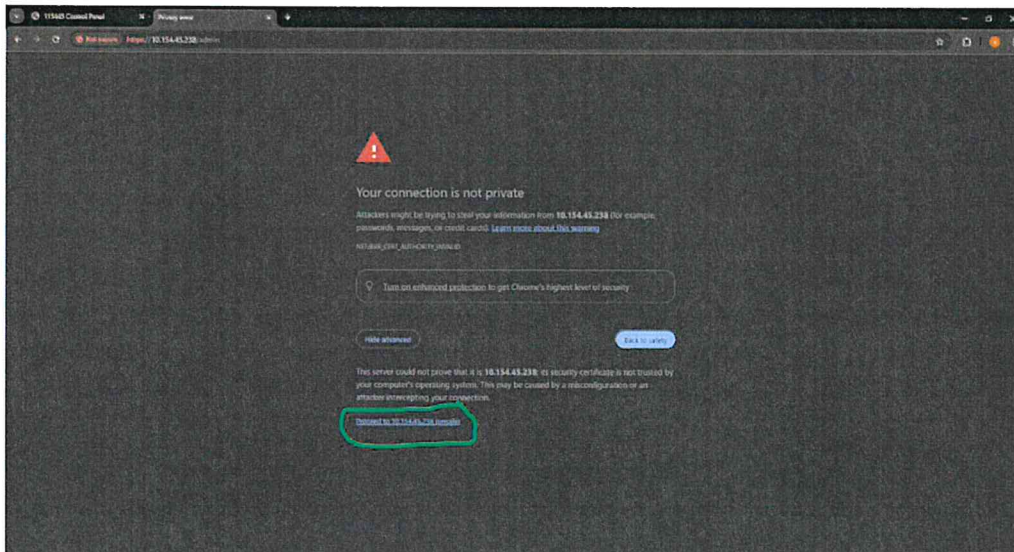
6.5 The browser will display some form of a “connection not secure” message. Select Advanced then Proceed to... at the bottom of the page.

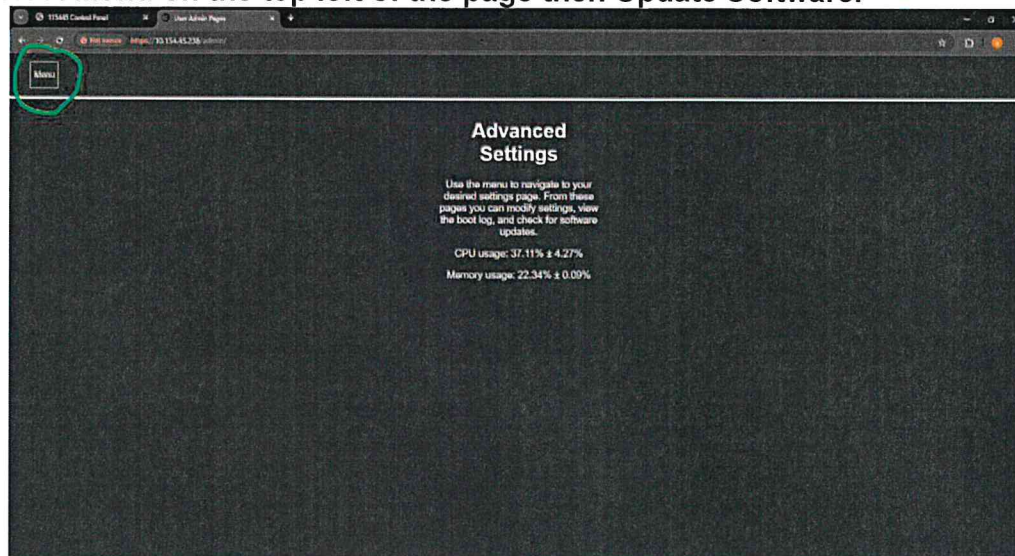
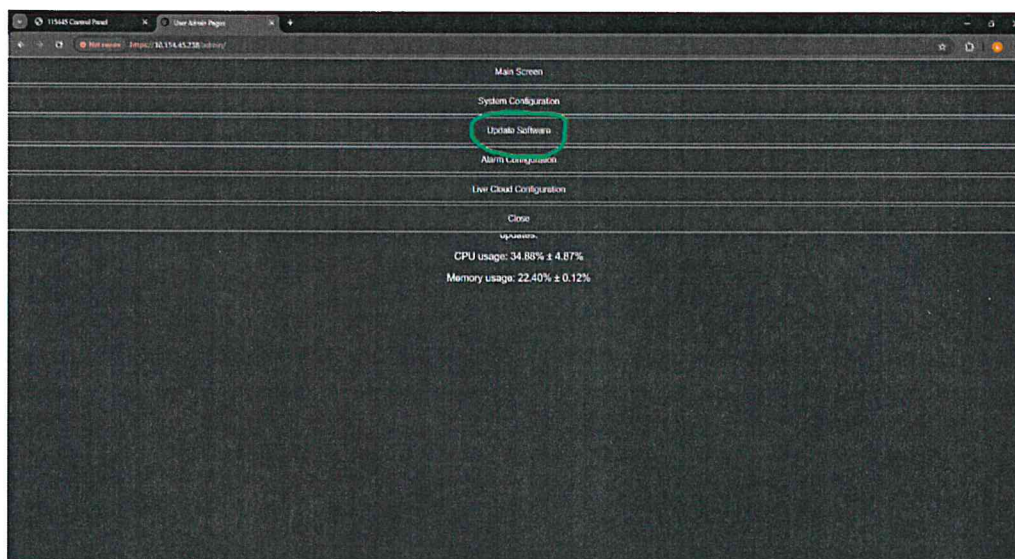
6.6 Select Menu on the top left of the page then Update Software.

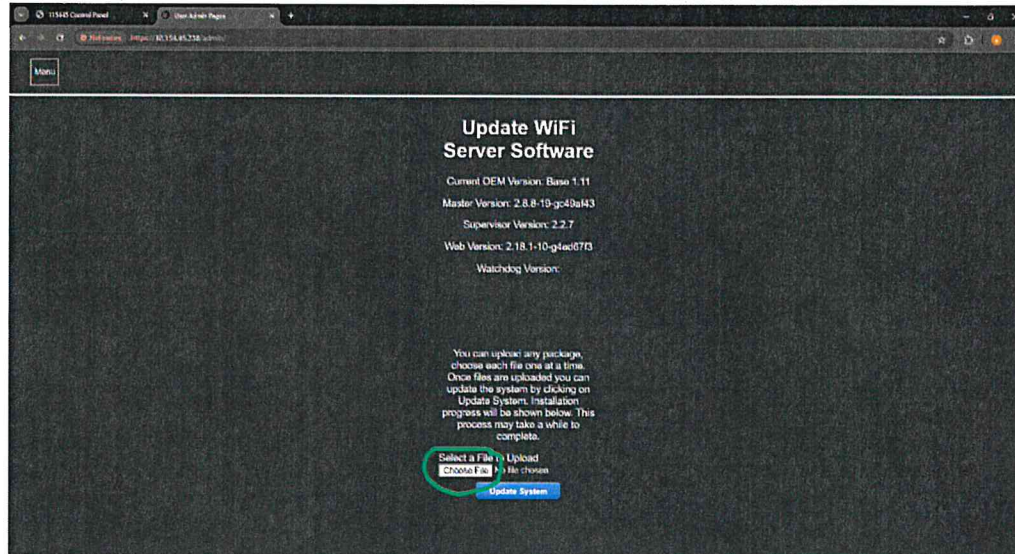
6.7 Select Choose File, browse to where the zip file is located on your device, and select it.

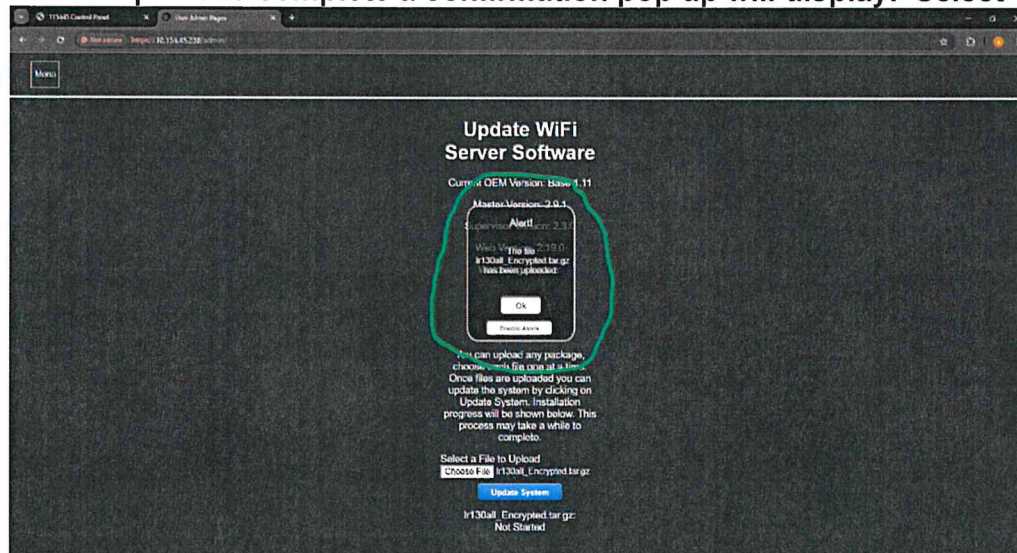
6.8 Once the upload is complete a confirmation pop up will display. Select OK.

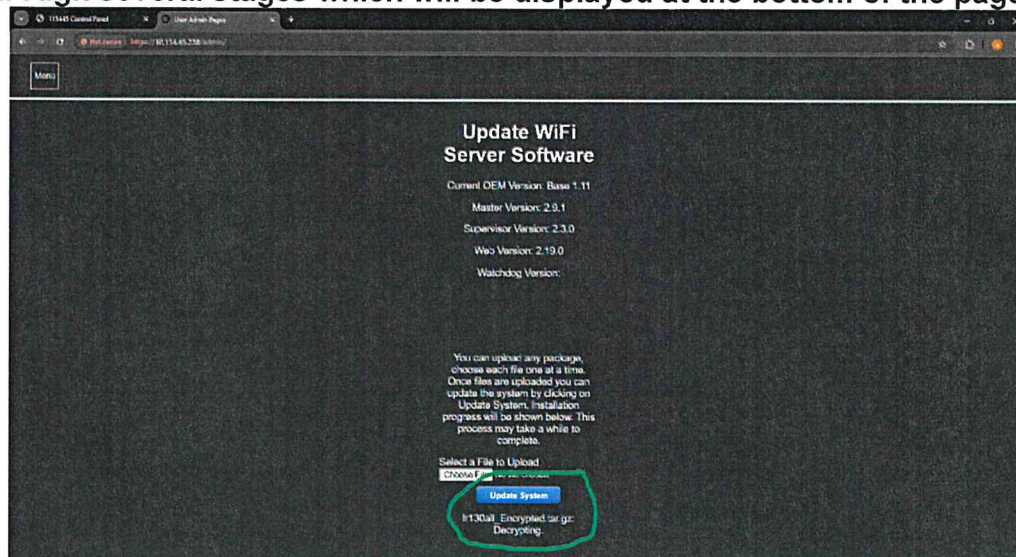
**6.9 Select Update System at the bottom of the page. The LR130 update process will go through several stages which will be displayed at the bottom of the page.**

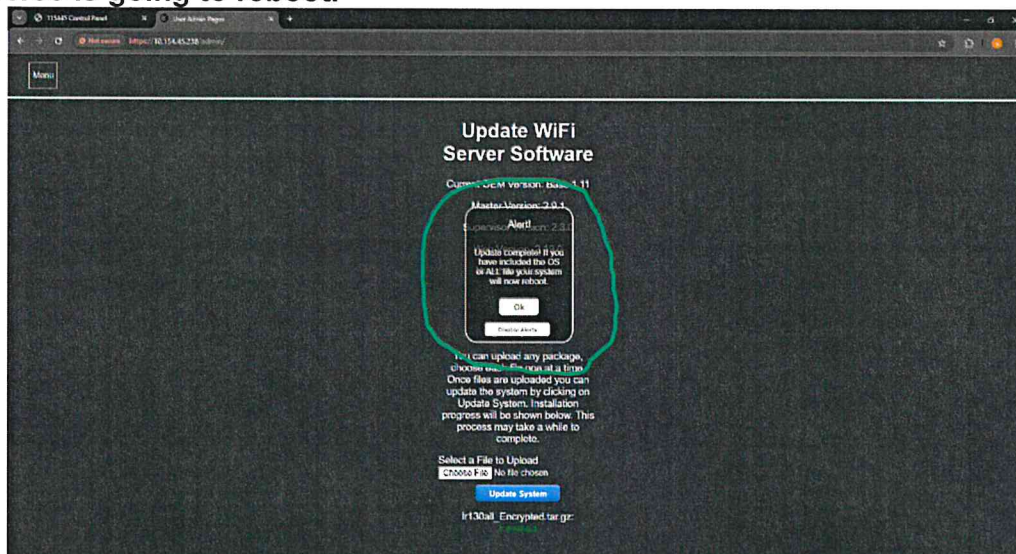
**6.10 Once the update is complete a confirmation pop up will display stating that the LR130 is going to reboot.**
