REFERENCE:	TSB: 08-123-25 REV. A GROUP: 08 - Electrical	Date:	April 29, 2025	REVISION:	08-123-25
VEHICLES AFFECTED:	2025 (DT) RAM 1500 Pickup This bulletin applies to vehicles built on or after March 15, 2024 (MDH 0315XX) and on or before October 24, 2025 (MDH 1024XX) equipped with one of the following radios: <ul style="list-style-type: none"> Uconnect 5 Nav W 12.0" (Sales Code UPQ). Uconnect 5 Nav W 14.4" (Sales Code UPW). 			MARKET APPLICABILITY: <input type="checkbox"/> NA <input type="checkbox"/> IAP <input type="checkbox"/> SA <input type="checkbox"/> CH <input type="checkbox"/> EE <input checked="" type="checkbox"/> **MEA **	
CUSTOMER SYMPTOM:	Customers may experience the following: <ul style="list-style-type: none"> All lumbar seat controls inoperable. 				
CAUSE:	Radio software

This bulletin involves updating the radio software level from 31.42 to U35.26.

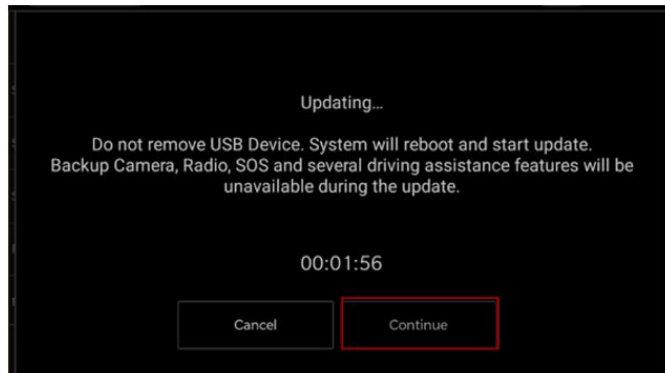
18. Press the “**Continue**” on the display screen Fig. 5.

Fig. 5
Software Updating
