Title:	Command Zone Over-The-Air Programming (OTAP) Updates

Number:	SB_735	Release Date:	04/29/2025	
Revision Number:	Not Applicable	Revision Date:	Not Applicable	
Chassis Type:	ALL			
Component Description:	Command Zone Display, Control Unit, & Telematics Control Unit

This bulletin provides a procedure by which to apply an Over-The-Air Programming (OTAP) software update to applicable Command Zone devices installed in Pierce custom chassis apparatus with a CL-714 series Display and with Telematics Control Unit version 7.0.3 or greater.

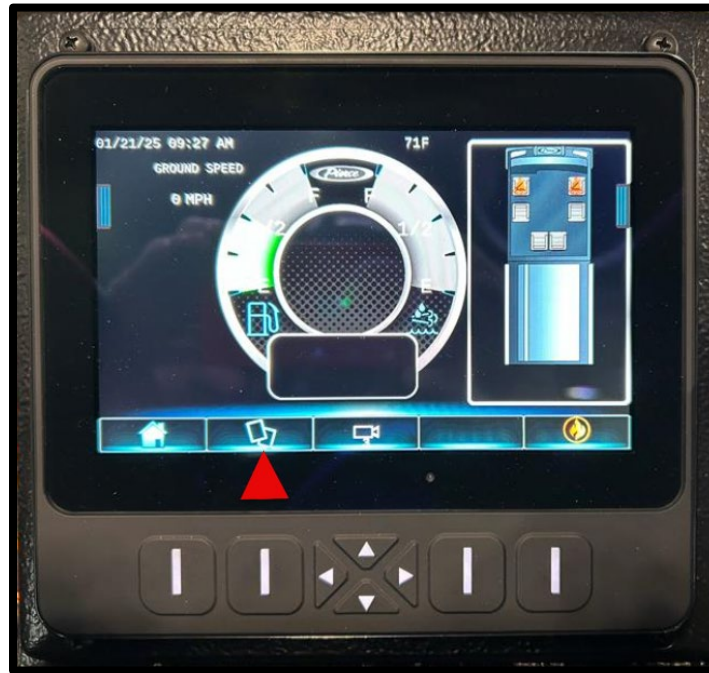
1. On the apparatus, turn the Battery Master switch **ON**.
2. The Ignition switch should remain **OFF**.
3. On the Command Zone Display, press the '**Additional Pages**' icon or the corresponding select key:

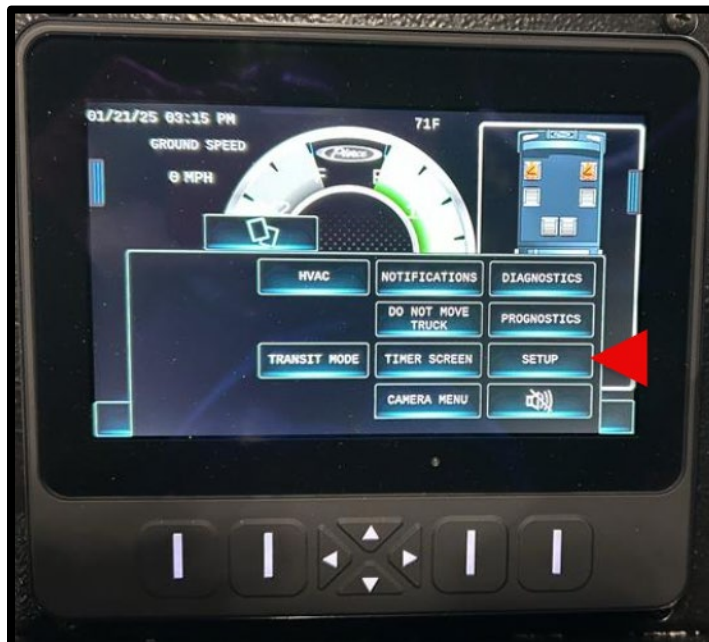
4. On the next screen, press the "**SETUP**" button.

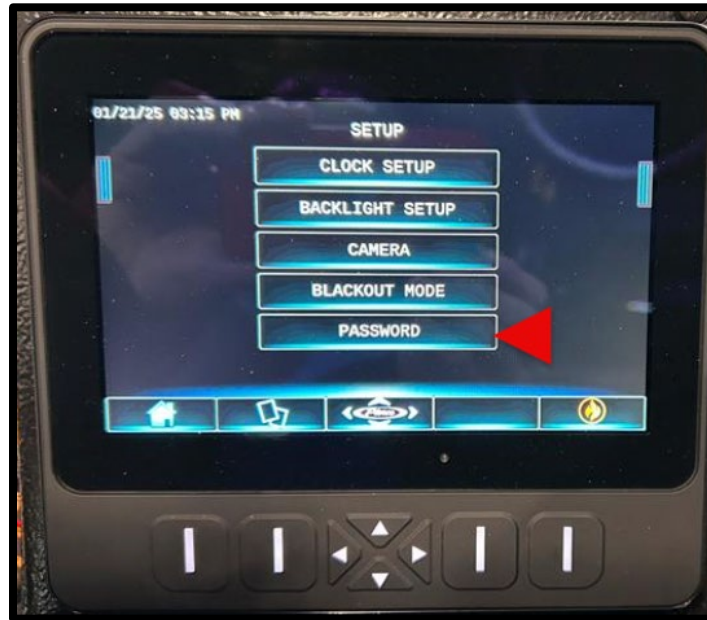
5. Press the **"PASSWORD"** button.

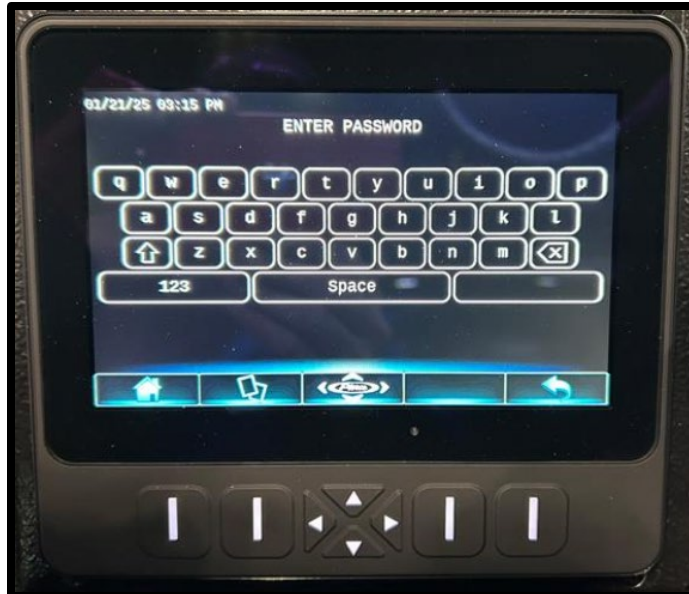
7. Enter the **Administrator password** for the truck. If required, please contact your Pierce authorized dealer or Pierce Customer Support for assistance.

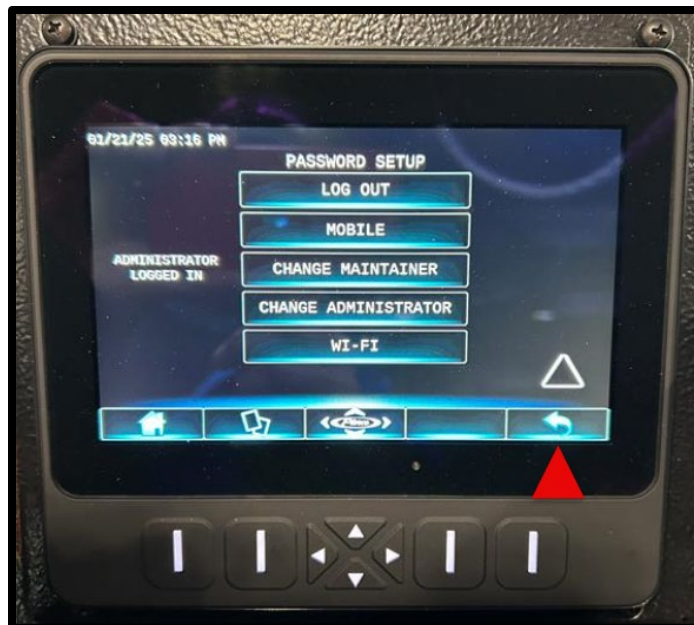
8. After logging in, press the **BACK ARROW** to refresh the page.

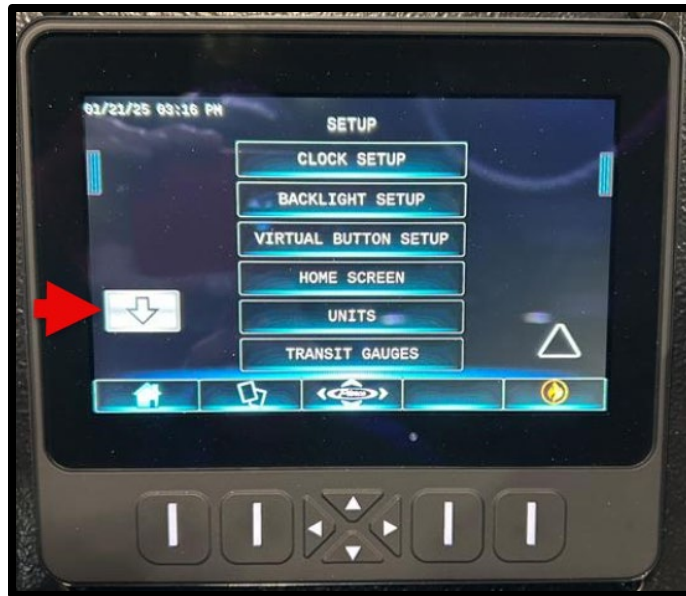
9. Scroll down through the available SETUP menu items until you see the **“PACKAGE UPDATE”** button by using the down arrow button on the lefthand side.

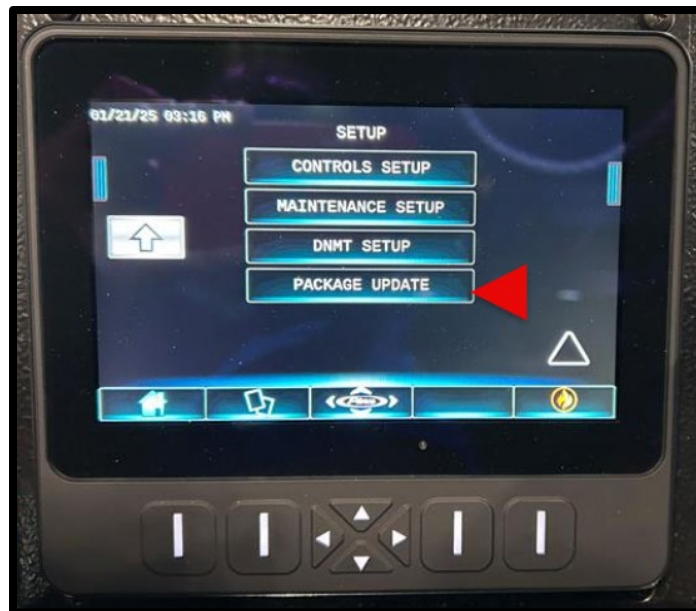
10. Press the **“PACKAGE UPDATE”** button.

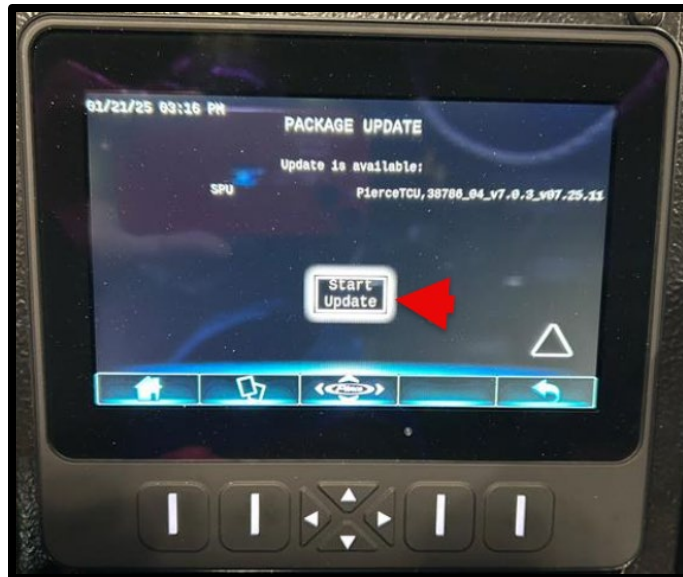
11. If an update is available, it will be shown. Press the **“Start Update”** button.

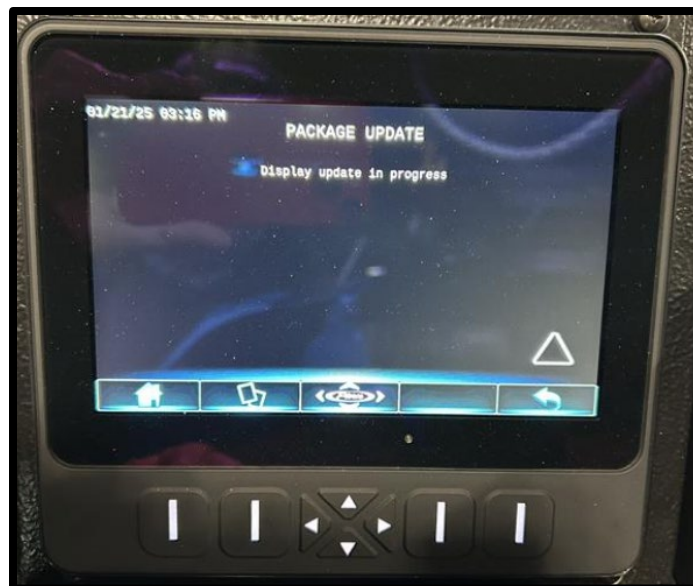
12. The “System Update” process will then begin.

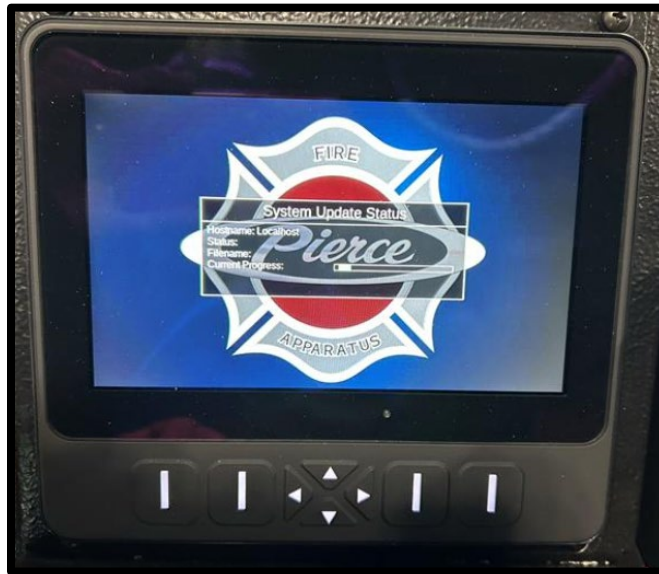
13. The “System Update Status” page will appear on the Display. This page will provide the installer with feedback regarding installation status.

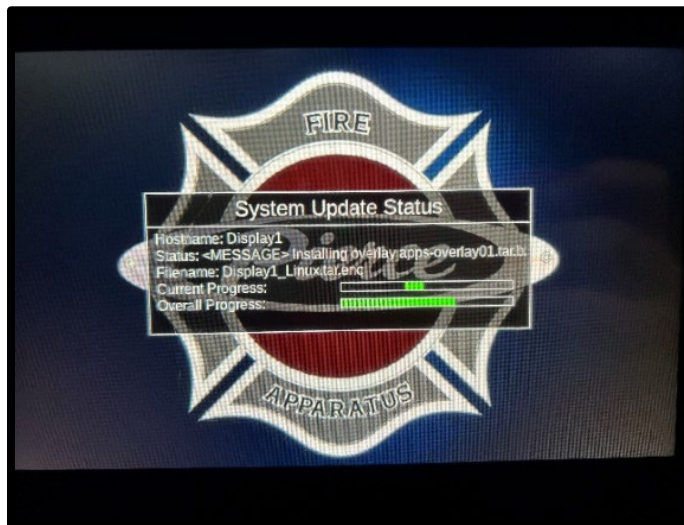
c. The Display update is applied last:

15. When the installation is nearing completion, the Display screen will appear to restart (flash on and off) three (3) times.

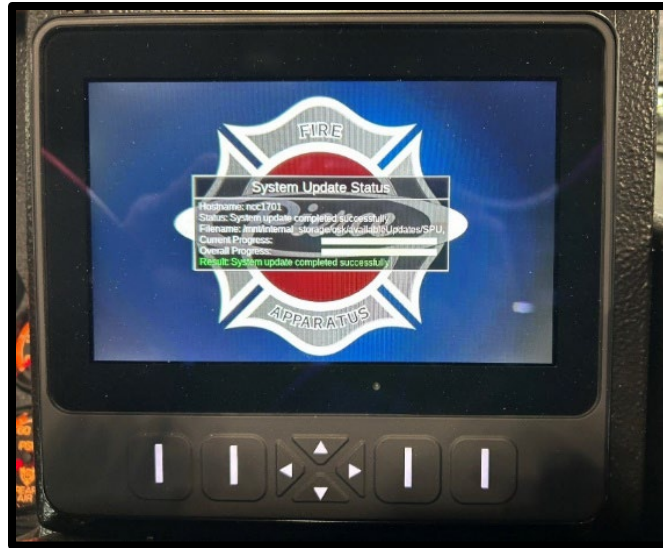
16. Once the Display restart cycle is completed, verify that the Display shows “**Result: System update completed successfully**”.

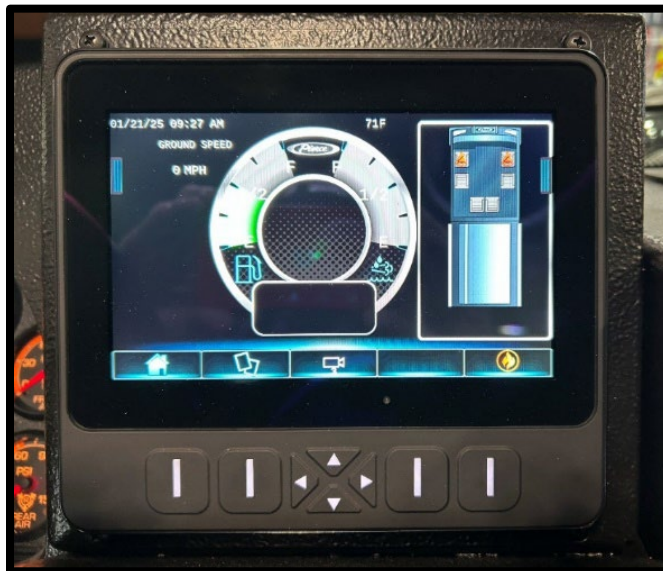
17. The Display should then return to the ‘**home**’ screen/page: after two minutes on the home screen/page, the update is successfully completed.
