GROUP	MODEL
ELE	2024-2025MY Seltos AWD (SP2)
NUMBER	DATE
374	May 2025

## TECHNICAL SERVICE BULLETIN

SUBJECT: **AWD COUPLING ACTUATOR LOGIC IMPROVEMENT (SA605)**

This bulletin provides information to upgrade the 4-Wheel Drive (“4WD”) system software on certain 2024-2025MY Seltos (SP2) vehicles equipped with All-Wheel Drive (“AWD”) produced from February 14, 2023 through October 08, 2024. The affected vehicles may experience an interruption of supplementary power to the rear wheels, while normal motive power continues to be available to the front wheels, accompanied by the warning message “Check AWD/4WD System” on the instrument cluster and with the Malfunction Indicator Lamp (MIL) illuminated with DTCs P195800 and P196000 stored. To address this concern, follow the procedure outlined in this publication to update the 4WD system software on the applicable vehicle. Refer to [SST081](#) for software upgrade instructions using Kia Diagnostic System (KDS) tablet and VCI-II and confirm the Upgrade Event Number/Name, ROM ID Information, and Manual Mode passwords (if applicable) on the applicable vehicle.

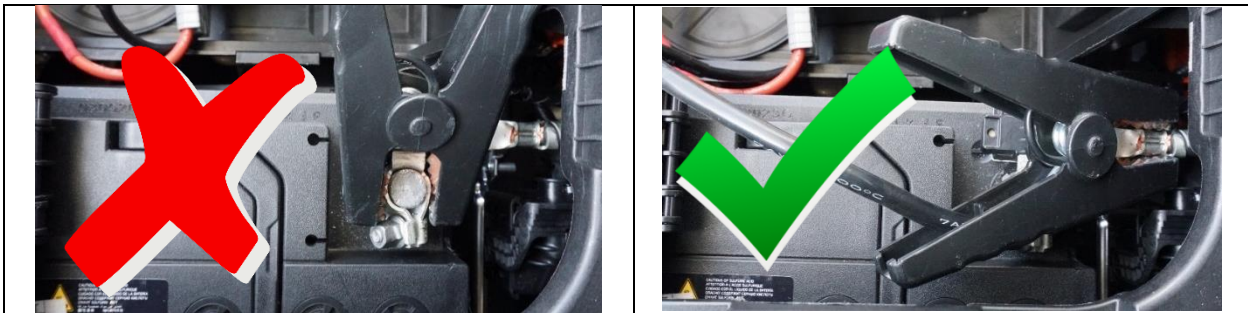
[Connect the negative \(-\) terminal to the battery as shown below.](#)

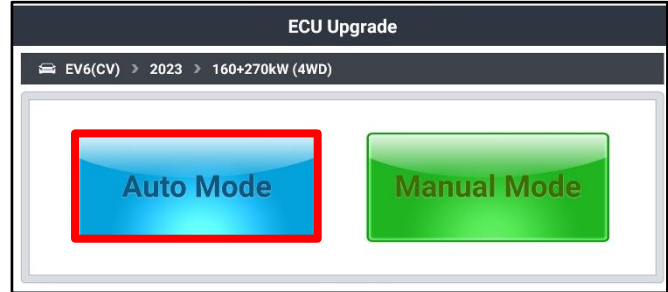
The required software must be installed by selecting the **'Auto Mode'** ECU Upgrade option.

**Note:** In some case, the 'Manual Mode' installation option may be required **ONLY** if the 'Auto Mode' function fails or is otherwise noted above.

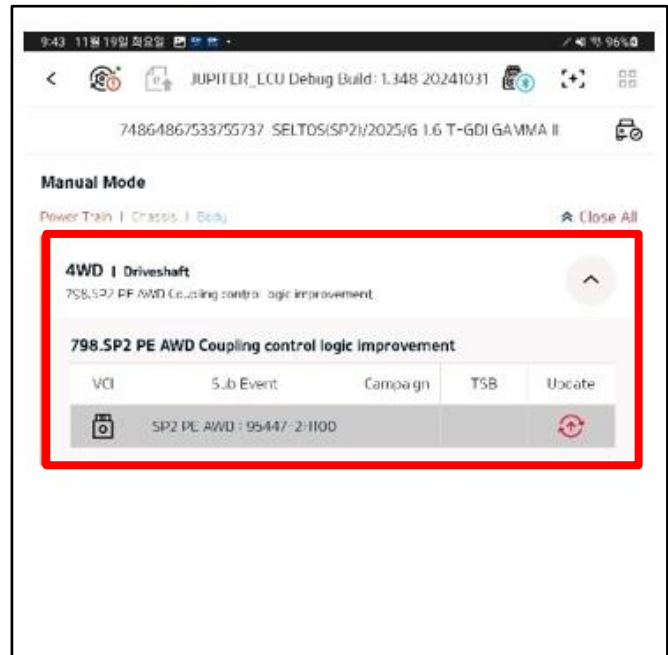
Select the applicable **'4WD'** system module and the Event Group.

- **798.SP2 PE AWD Coupling Control Logic Improvement**

Verify the affected vehicle Calibration Identification of the applicable ECU ROM ID and reference the Information Table on page 3 as necessary.
