## S-Series™

### 2.0 Grayhill Display and T27 Telematics Control Unit (TCU) Update

**Bulletin Name:** FDM-SVC-027

This bulletin provides instruction for replacing a Micronet display with an updated Grayhill overhead display and T27 TCU.

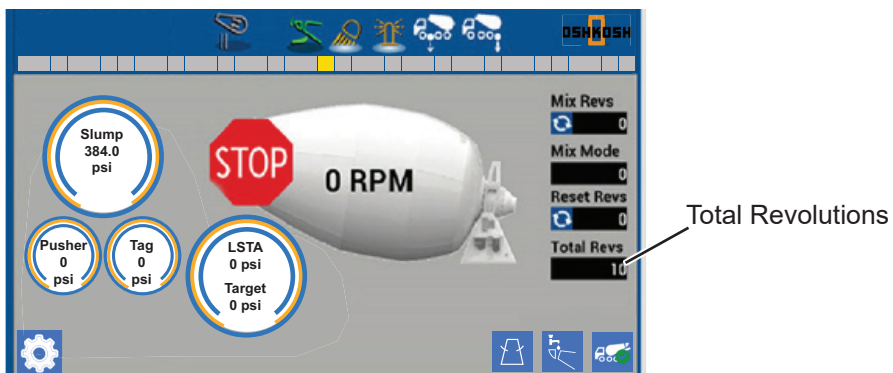
Figure 2

2. Record total drum revolutions. See Figure 2.

- b. Verify/enter vehicle option selections recorded in Step 1.  
*Settings -> Options*
- c. Set time to appropriate time zone, daylight savings status, and preferred format (12 vs 24 hour).
- d. Verify/enter lifetime drum revs recorded in Step 2.
- e. Verify/enter lifetime gallons recorded in Step 3.

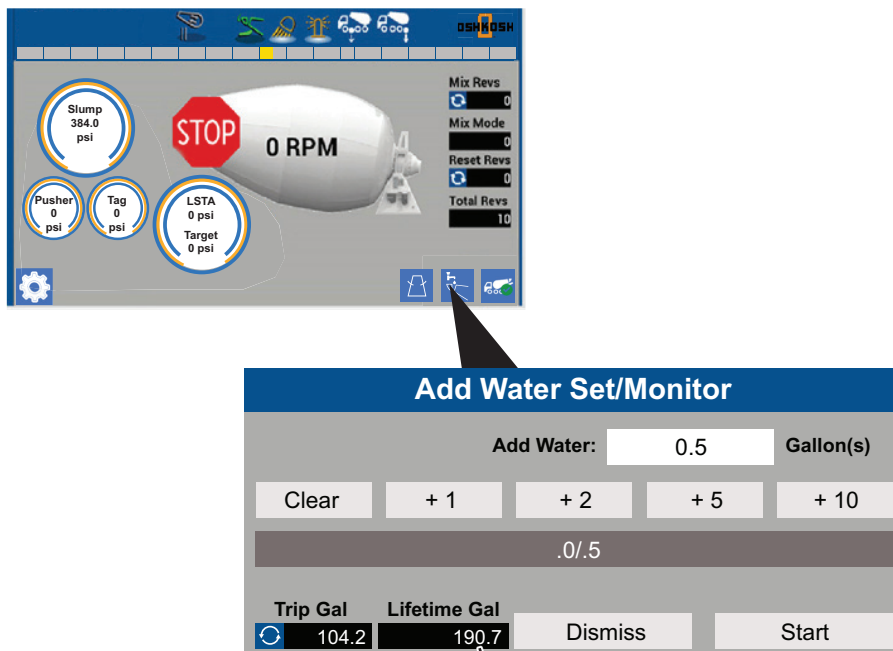
Lifetime Gallons  
Figure 3

3. Record lifetime gallon value. See Figure 3.

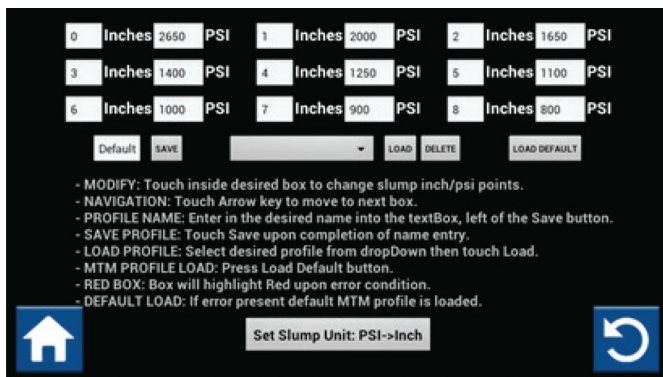
Figure 4

4. Record slump profiles. See Figure 4.

f. Create slump profiles to match slump profiles recorded in Step 4.

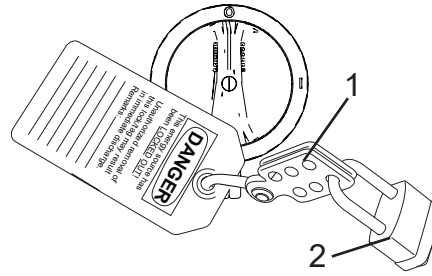
Figure B

6. The vehicle's BATTERY DISCONNECT switch is located on the left-hand side of the battery box. Use the battery disconnect switch when performing any maintenance so the vehicle cannot accidentally be started.

- a. Turn the battery disconnect switch (Figure A, Item 1) counterclockwise so the hole on the switch aligns with the hole in the bracket (Figure A, Item 2).
- b. Install the safety lockout device ring (Figure B, Item 1) through the holes on the battery disconnect switch and the bracket.
- c. Install a padlock (Figure B, Item 2) onto the safety lockout device ring, lock it, and put the key in your pocket. If more than one person is working on the vehicle, each person must install his or her own padlock.

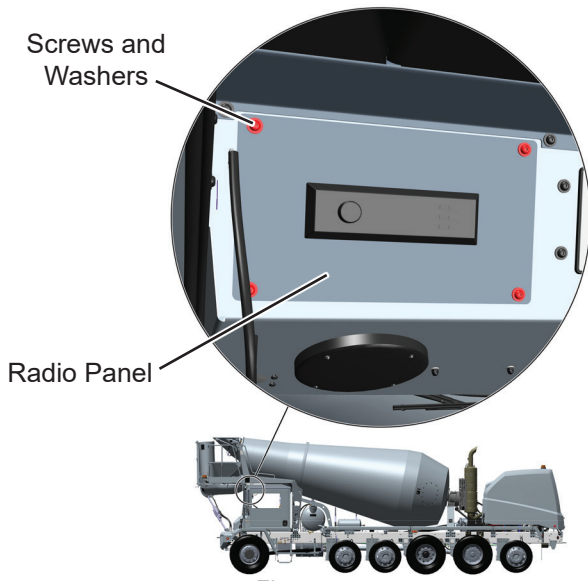
Figure 5

7. Remove four screws and washers securing radio panel to overhead console. See Figure 5. Save screws and washers for reinstallation of radio panel.
8. Disconnect harness connector and antenna cable from back of radio. Set radio panel aside.

- 54. Reconnect harness connector and antenna to back of radio.
- 55. Reinstall radio panel to overhead console with four screws and washers removed in Step 7. See Figure 25. Final tighten screws to 75 in lbs.

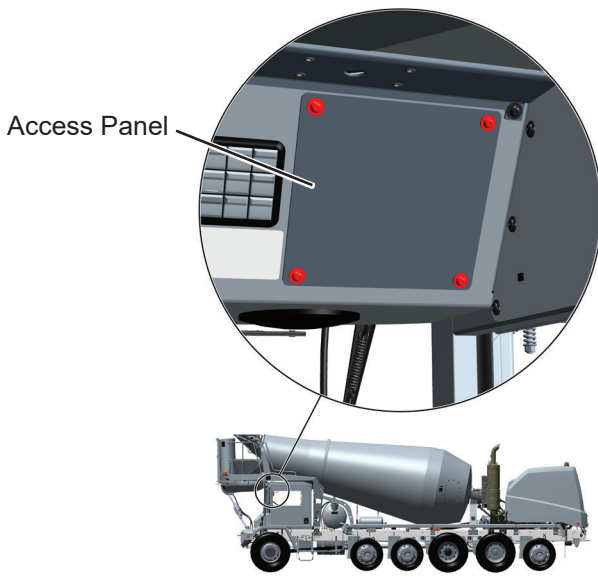
Figure 6

9. Remove four screws and washers securing overhead console access panel. See Figure 6. Save screws and washers for reinstallation of access panel.

53. Reinstall overhead console access panel with four screws and washers removed in Step 9. See Figure 24. Final tighten screws to 75 in lbs.

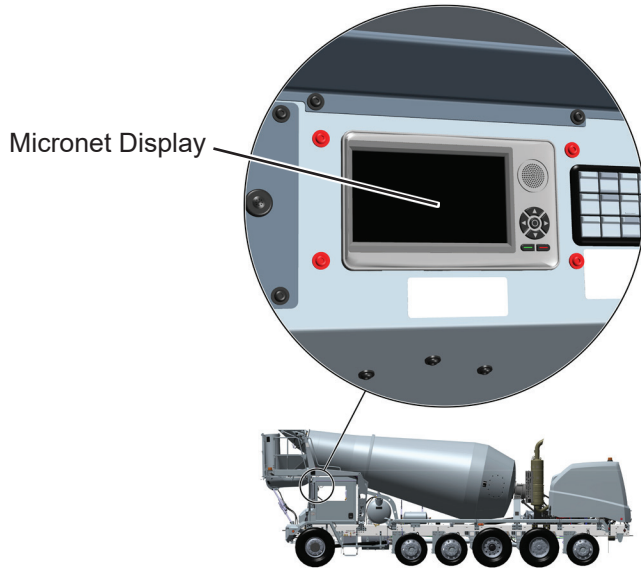
10. Remove four screws and washers securing Micronet display panel to overhead console. See Figure 7. Save screws and washers for reinstallation.
11. Disconnect five cables connected to Micronet display and remove display and bracket from overhead console.
12. Remove four screws and washers securing Micronet display to mounting bracket. Save screws and washers for installation of Grayhill display to new mounting bracket. The Micronet display and mounting bracket will not be reused.

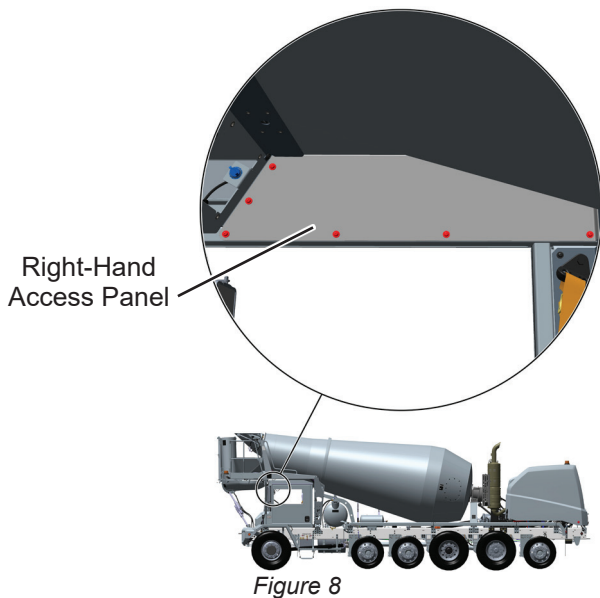
13. Remove seven screws and washers securing right-hand access panel to overhead console. See Figure 8. Save screws, washers, and access panel for reinstallation.

52. Reinstall right-hand access panel with seven screws and washers removed in Step 13. See Figure 23. Final tighten screws to 75 in lbs.

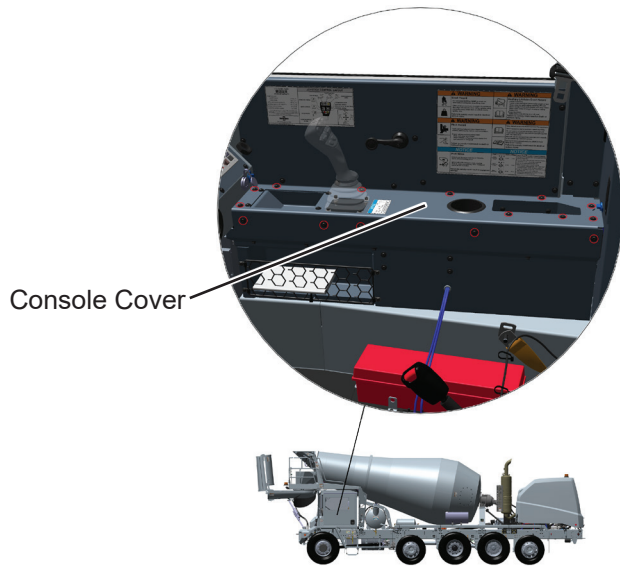
Figure 9

14. Remove fifteen screws and washers securing side console cover. See Figure 9. Save screws, washers, and side console cover for reinstallation.
15. Disconnect connector C18 from joystick and remove side console cover. Set cover aside for reinstallation later.

30. Reinstall console cover with fifteen screws and washers removed in Step 14. See Figure 16. Final tighten screws to 75 in. lbs.

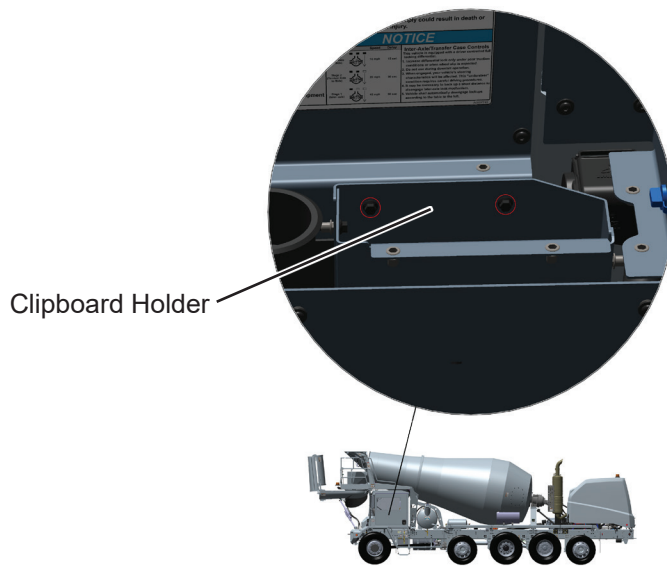
Figure 10

16. Remove two screws and washers securing clipboard holder. See Figure 10. Save screws and washers for reinstallation of clipboard holder side console cover.
17. Remove clipboard holder from side console and set aside for reinstallation later.

27. Close and secure cab electrical cabinet door.
28. Reinstall clipboard holder with two screws and washers removed in Step 16. See Figure 15. Final tighten

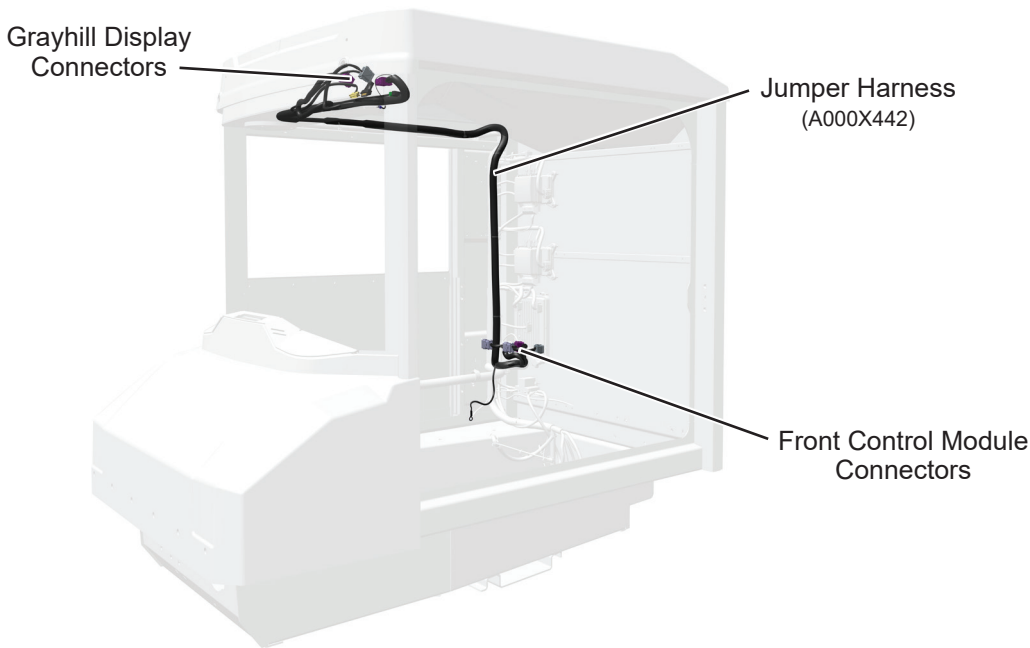
Figure 11

19. Install jumper harness (A000X442) starting in upper raceway. See Figure 11. Route front control module connectors C155A and C155B end of harness into electrical cabinet and down to front control module (FCM).

20. Route display connectors C1529, C1530, and C1538 end of harness into overhead console. See Figure 11.

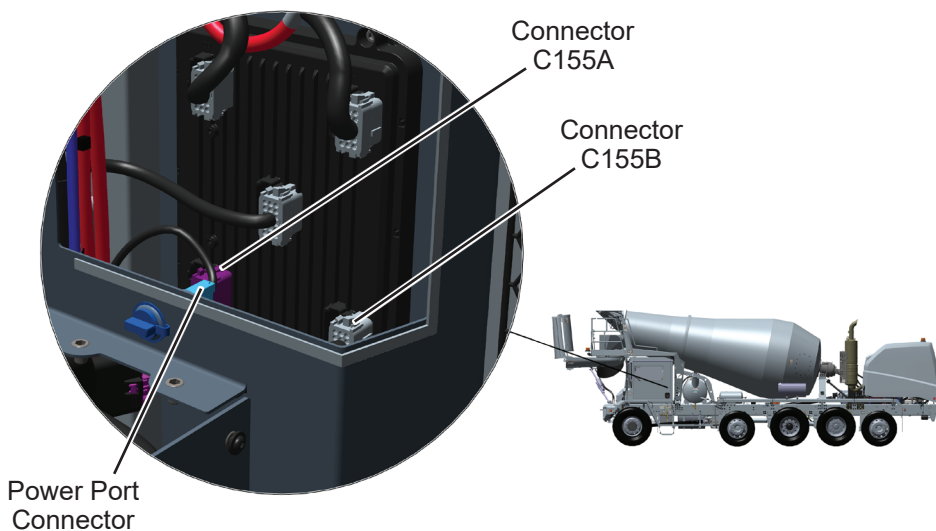
Figure 12

21. Disconnect cab harness connectors C155A and C155B from FCM. See Figure 12.

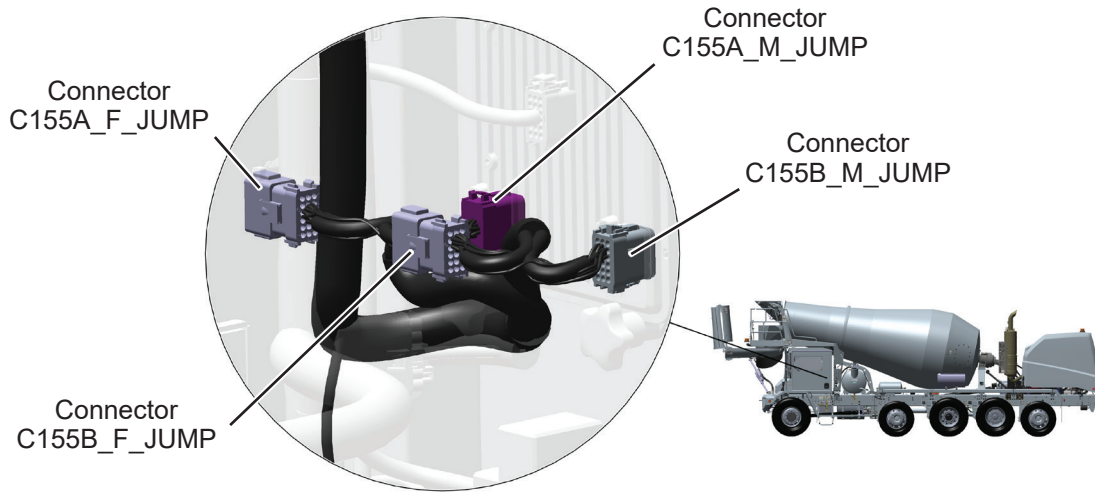
Figure 13

22. Connect cab harness connector C155A removed in Step 21 to jumper harness connector C155A\_F\_JUMP. See Figure 13.

23. Connect cab harness connector C155B removed in Step 21 to jumper harness connector C155B\_F\_JUMP. See Figure 13.
24. Connect jumper harness connector C155A\_M\_JUMP to FCM A. See Figure 13.
25. Connect jumper harness connector C155A\_M\_JUMP to FCM B. See Figure 13.

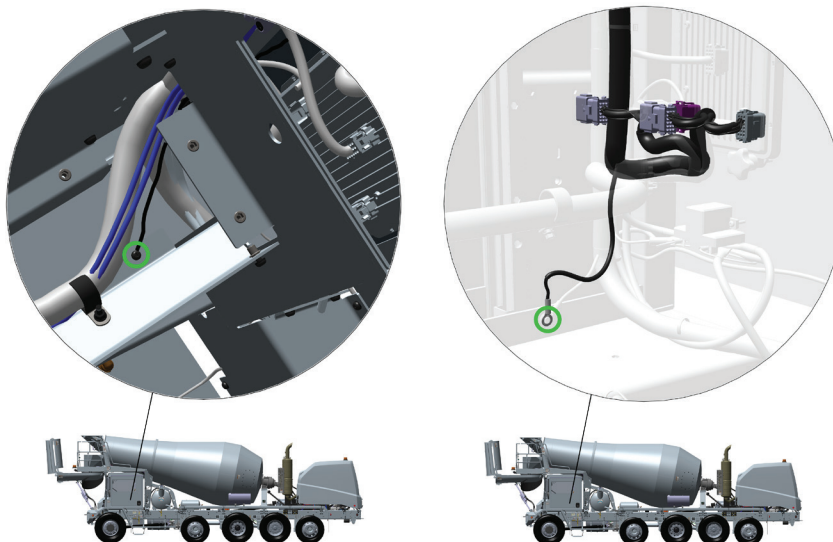
26. Route jumper harness ground through bottom of electrical cabinet into side console. See Figure 14

- a. Loosen and remove existing console hex bolt. See Figure 14.
- b. Remove paint from around where hex bolt was removed.
- c. Attach jumper harness ground wire terminal to hex bolt and reinstall hex bolt.

- a. Loosen and remove existing ground bolt with ground connections and nut. See Figure 14.
- b. Add jumper harness ground wire to ground bolt and existing ground connections.
- c. Reinstall ground bolt and nut. Final tighten ground bolt and nut to 35 ft. lbs.

Prior to SN 809269

SN 809269 and later

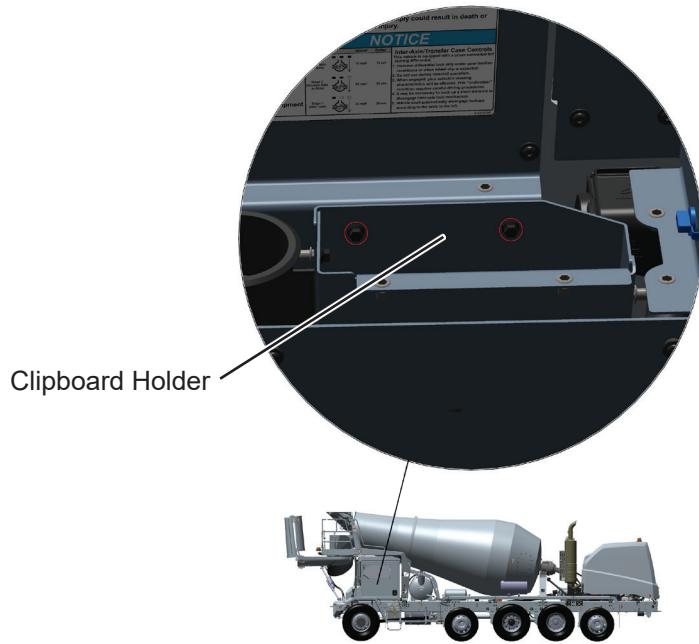
Figure 15

screws to 75 in lbs.

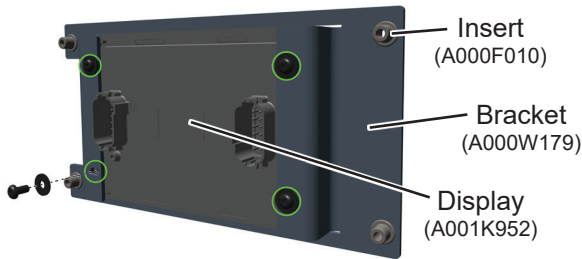
Figure 17

31. Secure Grayhill display (A001K952) to mounting bracket (A000W179) with four screws and washers removed in Step 12. See Figure 17. Final tighten screws to 10 in. lbs.
32. Install inserts (A000F010) in display bracket. See Figure 17.

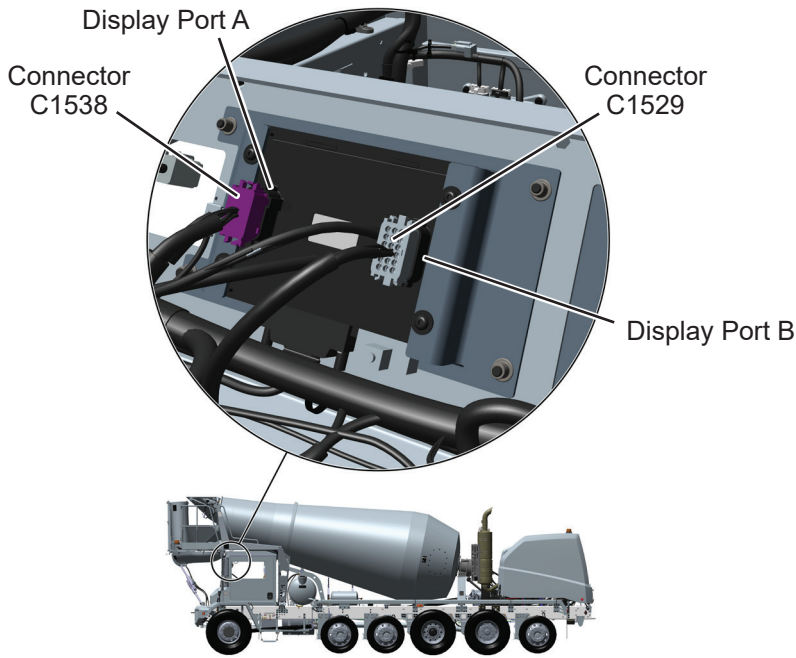
Figure 18

33. Slide display and bracket assembly into overhead console through display opening. See Figure 18.
34. Connect jumper harness connector C1538 to port A on back of display.
35. Connect jumper harness connector C1529 to port B on back of display.
36. Secure display bracket to overhead console with four screws, and flat washers removed in Step 12. See Figure 18.

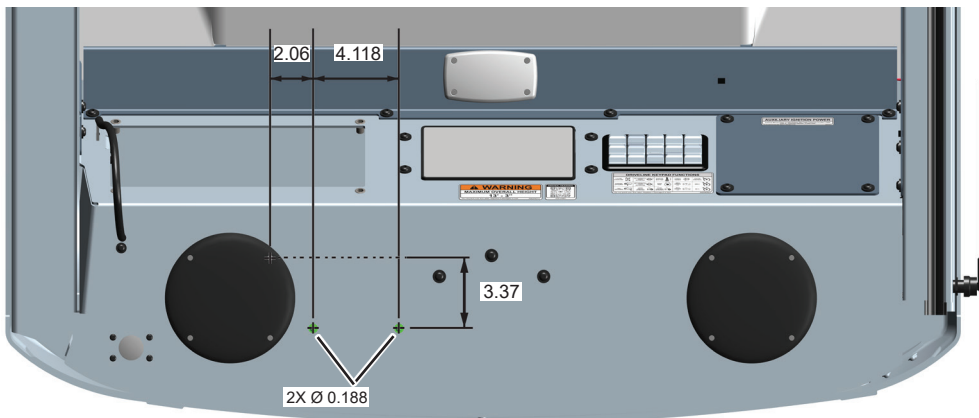
Figure 19

37. Mark and drill two 3/16 inch holes in bottom of overhead console per dimensions in Figure 19.

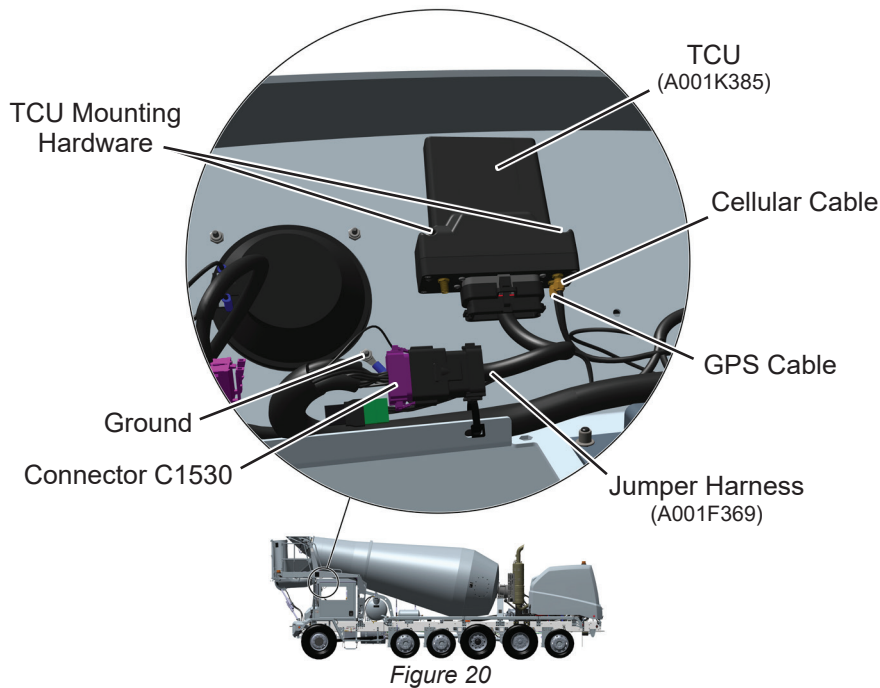
Figure 20

38. Loosen and remove right rear speaker mounting screw and nut. See Figure 20. Save screw and nut for reinstallation.
39. Remove paint from area around where speaker mounting screw and nut was removed in the overhead console. See Figure 20.

40. Place TCU (A001K385) in overhead console through radio panel opening. See Figure 20.
41. Secure TCU module to overhead console through holes drilled in Step 37 with screws (A000W843), washers (A000V858), and acorn nuts (A001C246). See Figure 20. Install screws from top and washers and acorn nuts from the bottom, acorn nuts to be visible from driver's seat. Final tighten hardware to 17 in lbs.

42. Connect jumper harness (A001F369) to connector C1530 and TCU. See Figure 20.
43. Connect cellular and GPS cables disconnected from Micronet display to TCU. See Figure 20.

44. Reinstall right rear speaker mounting screw with jumper harness ground terminal on speaker mounting screw, and install nut removed in Step 38. Final tighten to 17 in. lbs.

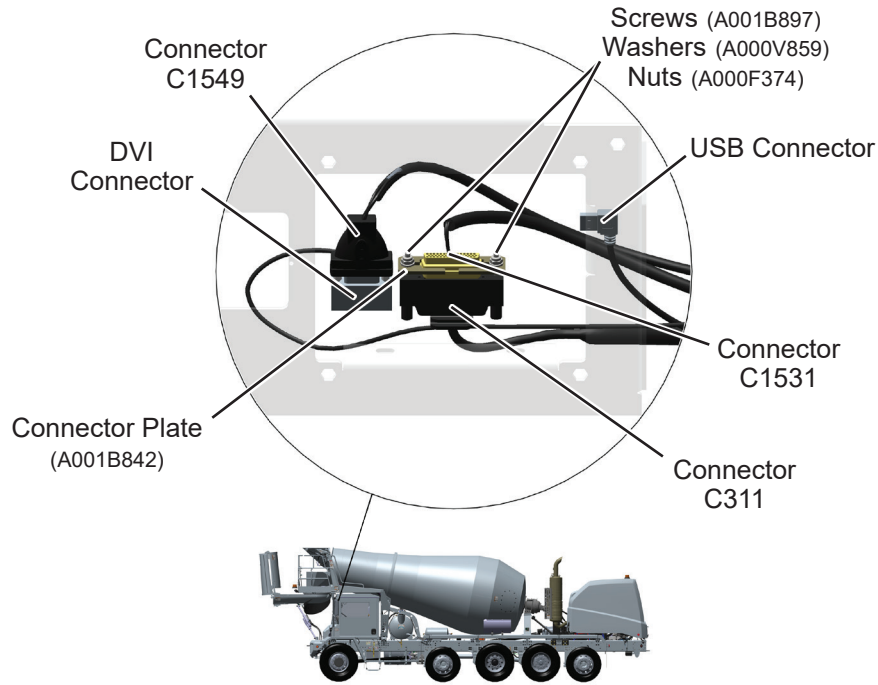
Figure 21

45. Locate connector C311 and DVI connector, that were disconnected from the Micronet display, through the right-hand overhead console access panel, See Figure 21.
46. Connect jumper harness connector C1549 to DVI connector. See Figure 21.
47. Remove the two thumb screws from connector C311. Thumb screws will not be reused.
48. Connect jumper harness connector C1531 to connector C311. See Figure 21.

49. Install connector plate (A001B842), screws (A001B897), washers (A000V859), and nuts (A000F374) to secure connector C311 to C1531. Do not over tighten hardware and bend connector plate. See Figure 21.

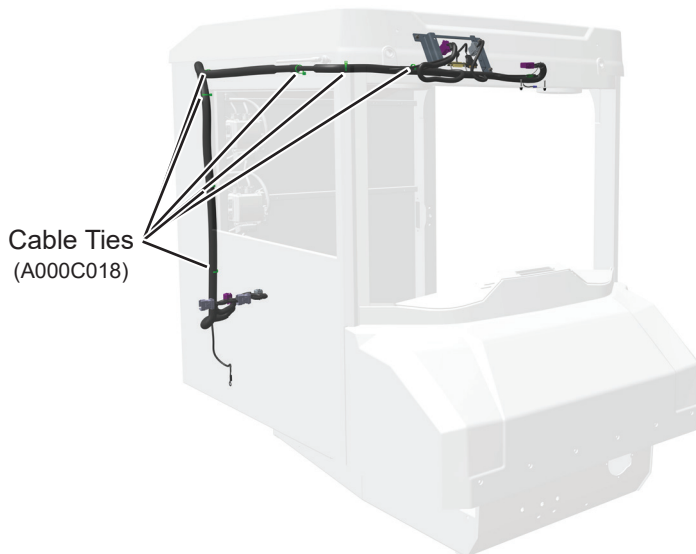
Figure 22

50. Secure all cable routings and excess cable lengths with cable ties (A000C018). See Figure 22.

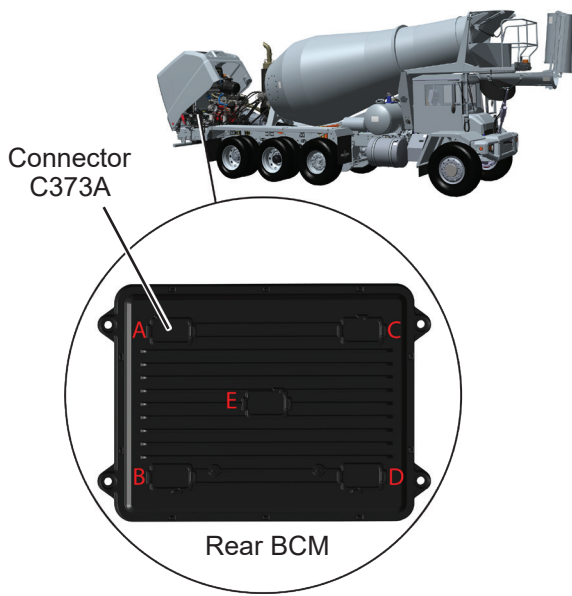
Figure 26

- 57. Update front control module (FCM) to v9.2.51 using the following procedure.
  - a. Disconnect rear control module (RCM) connector C373A to prevent inadvertently updating the wrong control module. See Figure 26.

- 58. Make sure the vehicle's rear work lights function as intended after FCM software update is complete. If rear work lights do not function as intended repeat Step 57.
- 59. Disconnect PCAN device from connector C12 and reinstall terminating resistor.
- 60. Reconnect rear PDM connector C373A disconnected in Step 57a.

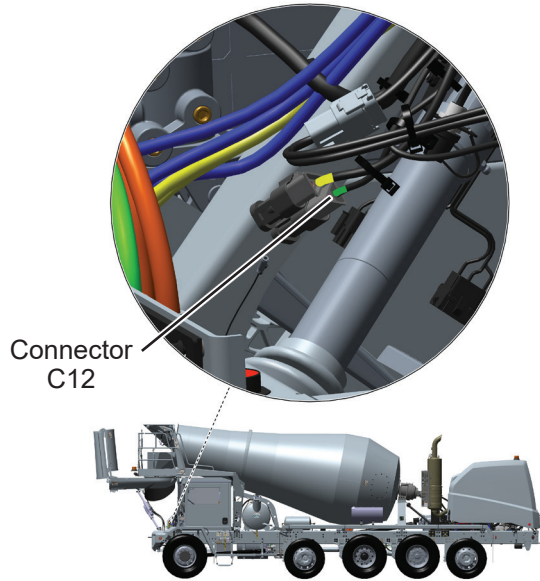
Figure 27

- b. Plug in PCAN adapter cable to laptop. Remove terminating resistor receptacle and connect PCAN adapter to green connector C12 near driver's left foot area in cab. See Figure 27.

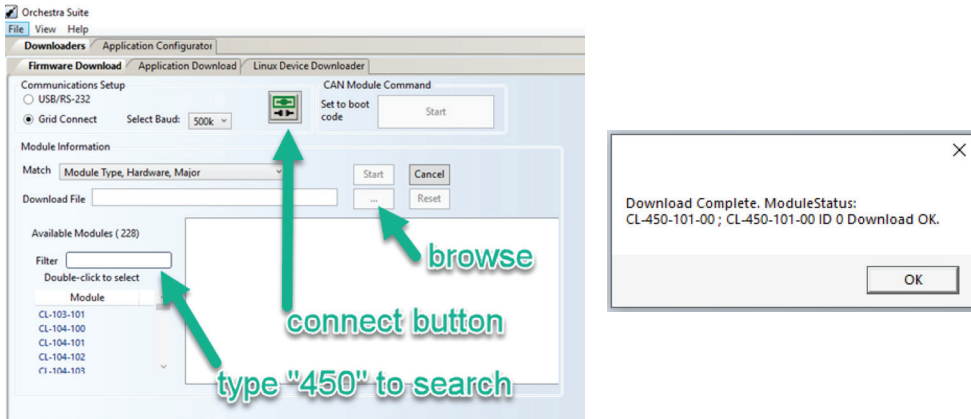
Figure 29

- k. In Orchestra click *Stop*.
- l. Select the *Connect* button. See Figure 29. When connected the keypads blink and the dome lights turn off. If keypads are not blinking and dome lights are not off, select *Connect* button again.
- m. Enter *450* in *Filter* field to search for *CL-450-101-00*. See Figure 29.
- n. Double click on *CL-450-101-00* from module list to select. See Figure 29.
- o. Browse to the computer drive or flash drive location where the controller update programming files are located and select the file to you want to load by clicking on it. See Figure 29.
- p. Click *Start* button. See Figure 29. Status will say downloading to approximately 5 minutes.
- q. Click *OK* when finished

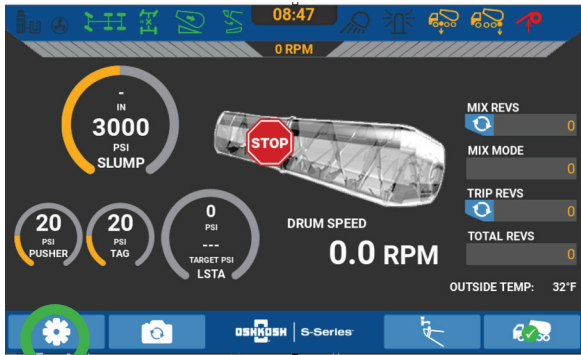
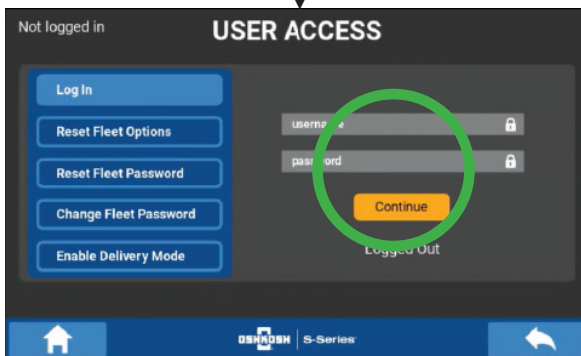
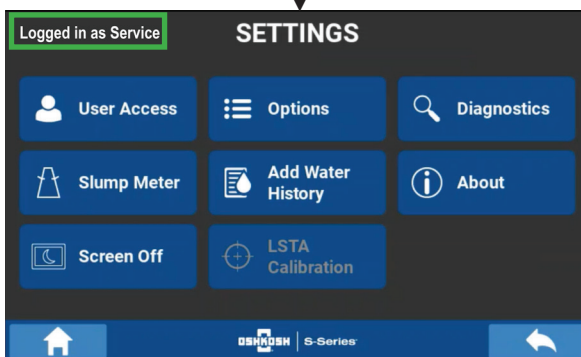
- a. Power on display and log in as service manager.

*Settings -> User Access -> User Name & Password -> Continue -> Return to Settings Screen*

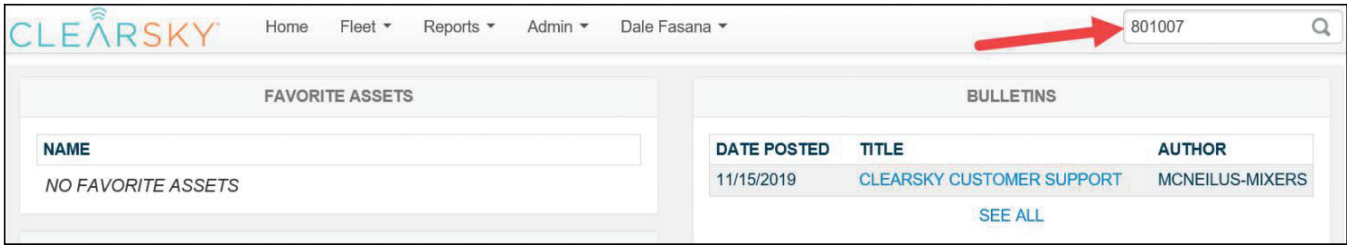
Figure 31

- 65. Search for truck serial number (last six digits of truck VIN) in ClearSky search window. See Figure 31.

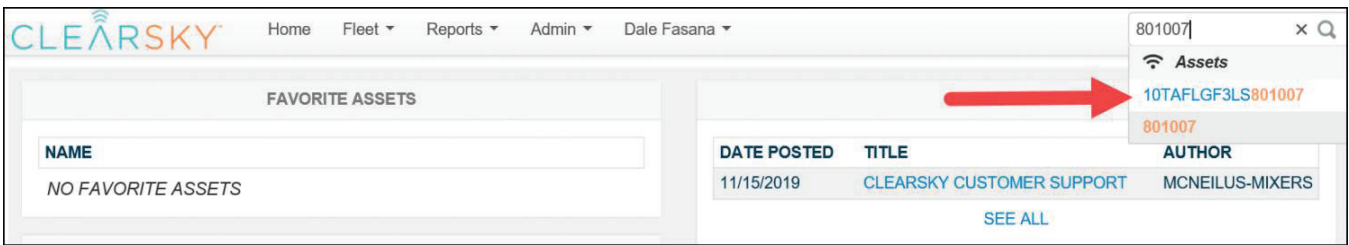
Figure 32

- 66. Make sure the truck's serial number appears in the search results Assets window and select the truck from the search results. See Figure 32.

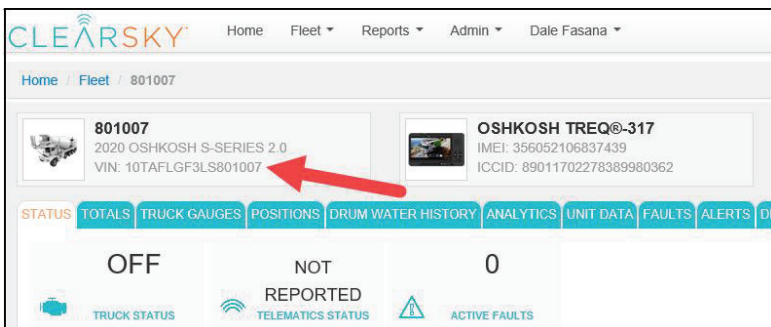
Figure 33

- 67. Make sure the truck VIN displayed in the information box in the upper left corner of page is correct. See Figure 33.

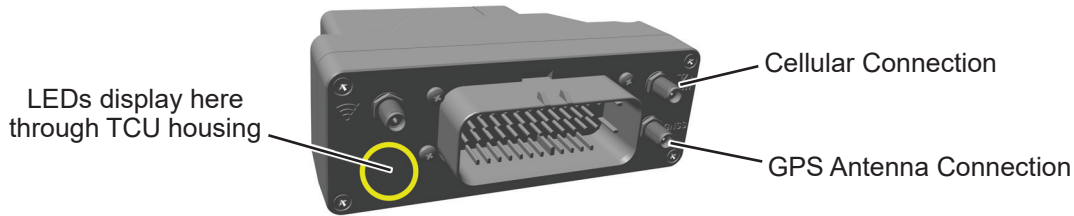
Figure 38

1. Make sure TCU version number populates in overhead display ABOUT screen. If TCU version is not populated the TCU is not communicating.
  - a. Check for a solid red LED and flashing green LED on front of TCU. See Figure 38. No lit LEDs on front of TCU indicates no power to TCU.
  - b. Make sure TCU connectors are fully seated and there are no bent or damaged pins.
2. Make sure GPS antenna and cellular cables are connected correctly.

3. Turn vehicle's battery disconnect switch OFF and wait until LEDs on front of TCU turn off, the TCU has an internal battery which can take up to 3 hours to fully drain before LEDs go out.
4. Turn vehicle's battery disconnect switch ON.
5. Turn vehicle ignition switch ON and recheck if TCU is operating and populates the version number in overhead display ABOUT screen.
6. Contact S-Series service if these troubleshooting steps do not correct TCU operation.
