HYUNDAI

Technical Service Bulletin

GROUP CAMPAIGN	NUMBER 25-01-032H
DATE MAY 2025	MODEL(S) TUCSON (NX4M)

SUBJECT: FPM SOFTWARE UPDATE – DTC B18CC00
(SERVICE CAMPAIGN TCZA)

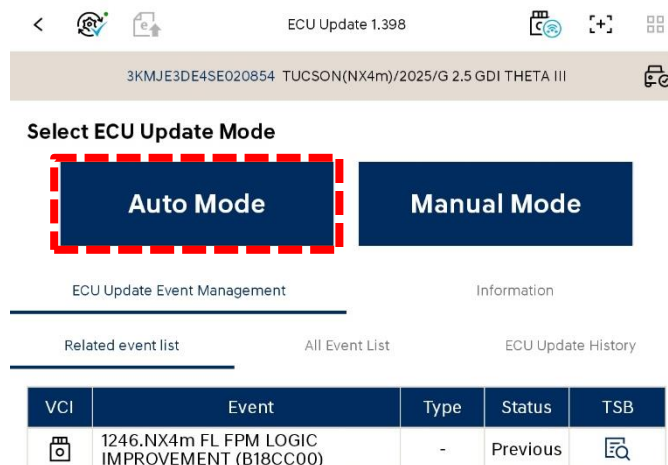
2. Select the **FPM** system to scan the vehicle's current ROM ID.

Check the current ROM ID version and compare it to the ROM ID Information table before attempting to perform the software update.

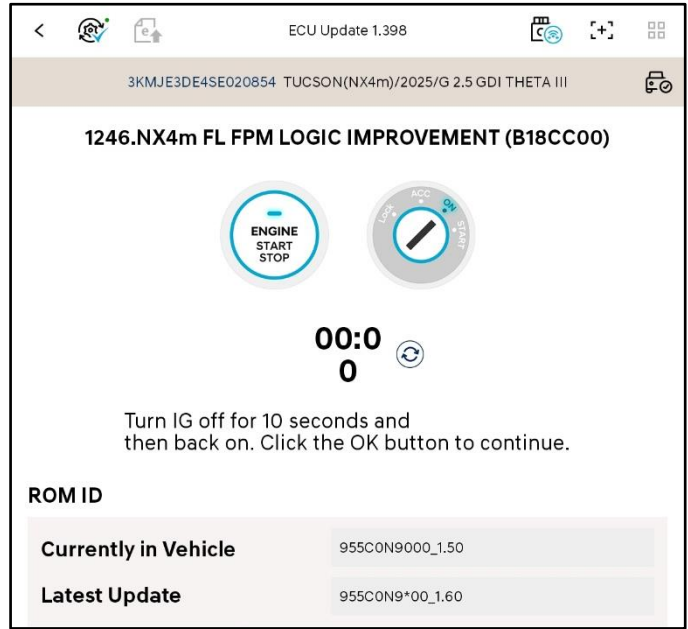
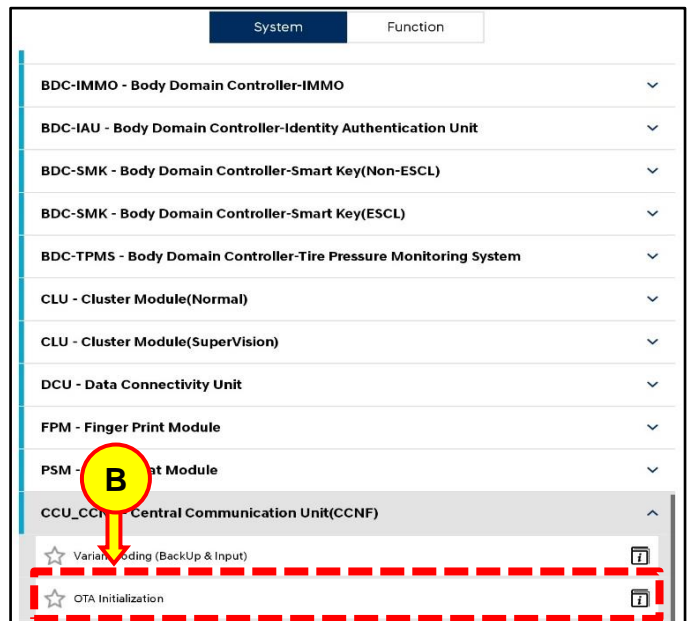
- After the ECU update process shows 100% complete, follow the prompts on the screen to cycle the ignition **OFF** for at least **10 seconds** to reset the control unit (certain models may take up to **30 seconds**).

- OTA initialization (A) should perform automatically:
 - If OTA initialization performs automatically, then proceed with the service procedure.
 - If the OTA initialization process fails, complete it manually under: **S/W Management > CCU_CCNF - Central Communication Unit (CCNF) > OTA Initialization (B)**.

Follow the instructions on the screen.

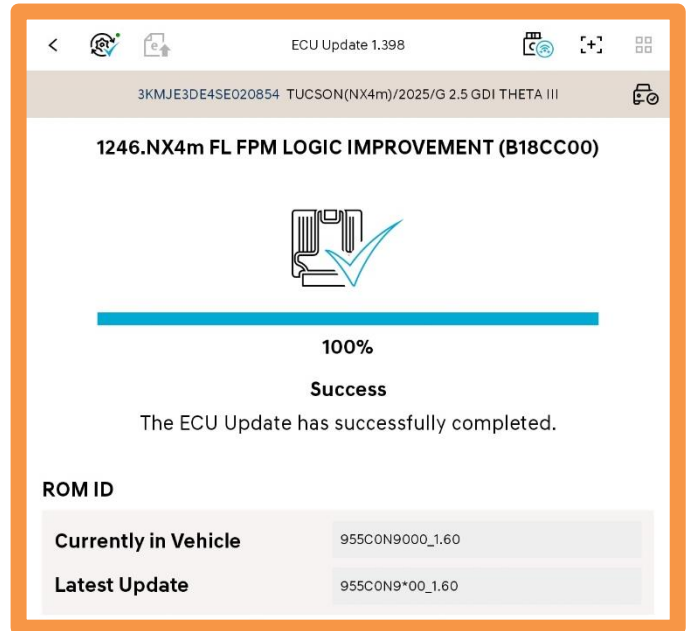
5.

Take a screenshot of the ECU update complete screen using your tablet and upload to STUI.

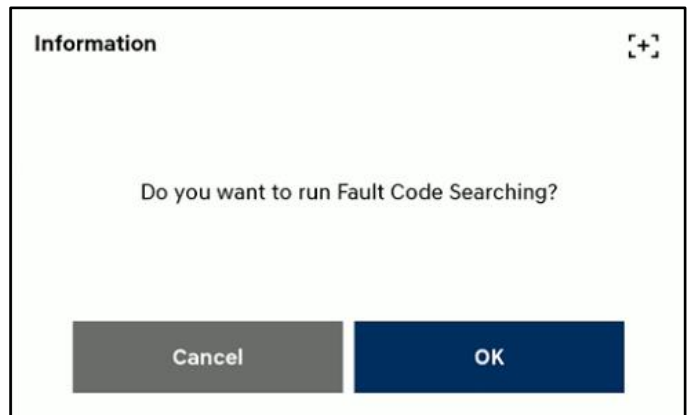
6. Perform an **All Systems Fault Code** search and erase DTC history that had incidentally occurred from the ECU update.
