HYUNDAI Technical Service Bulletin	GROUP AUTOMATIC TRANSMISSION	NUMBER 25-AT-001H
	DATE MAY 2025	MODEL(S) SANTA FE (TMA) SONATA (DN8/DN8A)
SUBJECT: TCU SOFTWARE UPDATE FOR 8DCT HP EOP SENSORLESS LOGIC

Description: Certain Santa Fe (TMA) and Sonata (DN8/DN8A) vehicles equipped with 8-speed dual clutch transmissions (8DCT) may exhibit one of the DTCs listed below, related to the high pressure electric oil pump (HP EOP). Follow the procedures in this TSB to update the Transmission Control Unit (TCU) to the latest sensorless logic on affected vehicles, and then perform air bleeding and transmission learning.

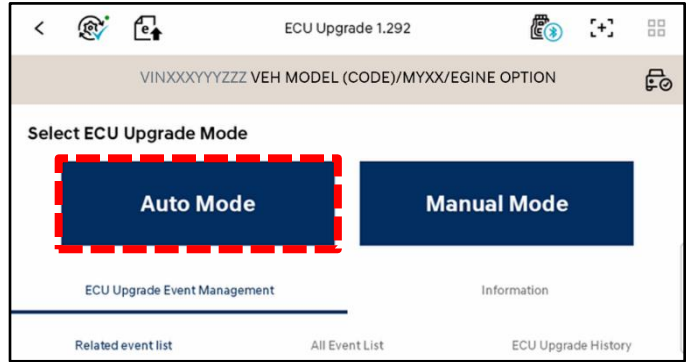
1. Perform the ECU update in **Auto Mode**.

Refer to **TSB # 25-GI-011H**, “**ECU Update Procedure for Tablet-Based GDS-Smart**”, for additional information.

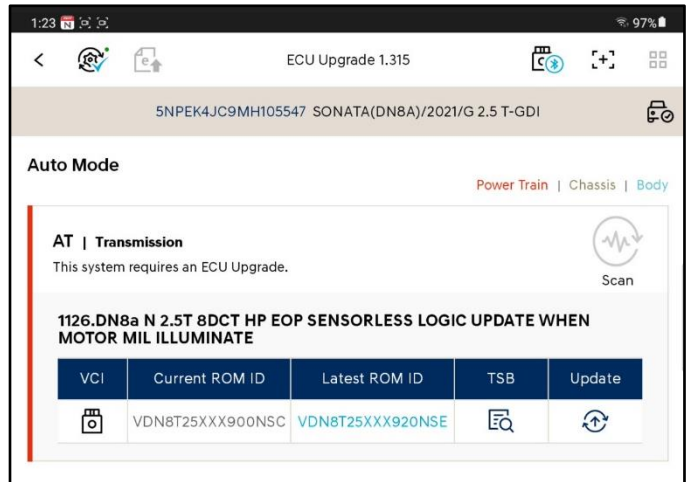
2. Verify the ROM ID by selecting the **AT / Transmission** system to scan the vehicle's current ROM ID.

Check the current ROM ID version and compare it to the ROM ID Information table before attempting to perform the software update.

If the update fails, remove the power connector from the in-cabin fuse box for at least **5 seconds**. Alternatively, disconnect the negative (–) **12V** battery terminal, wait at least **5 seconds**. Reassemble and retry the update.

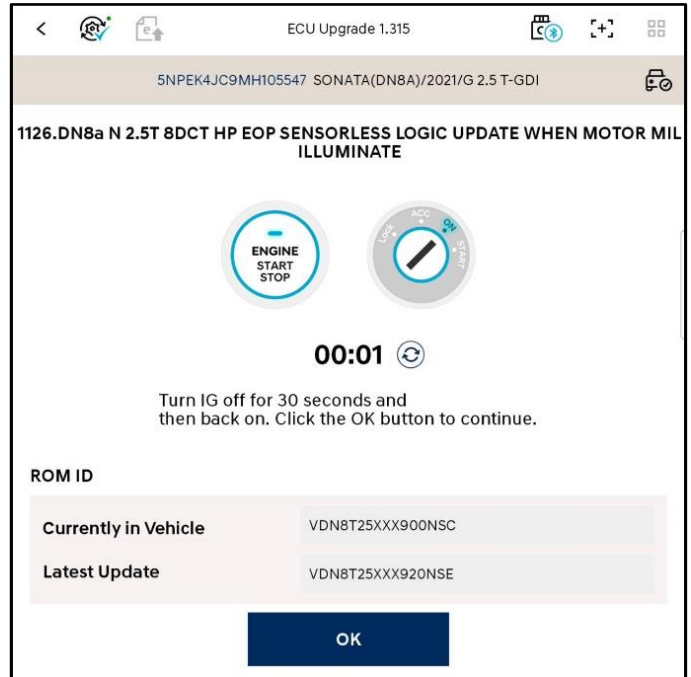
- After the ECU update process shows 100% complete, follow the prompts on the screen to cycle the ignition **OFF** for at least **10 seconds** to reset the control unit (certain models may take up to **30 seconds**).

Use the **Refresh** button to reset the timer.

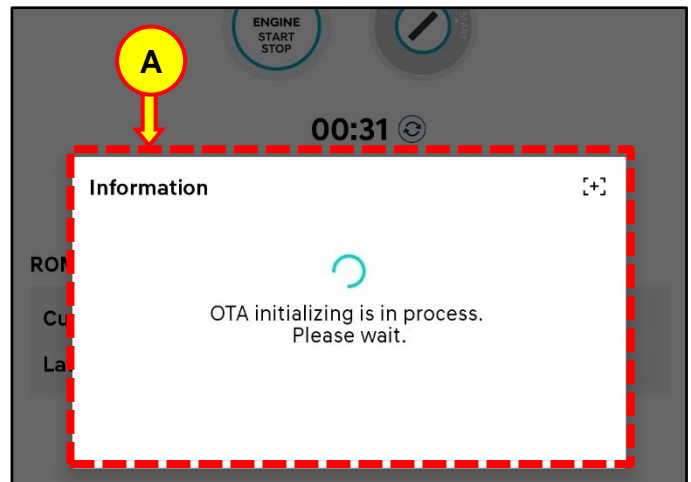
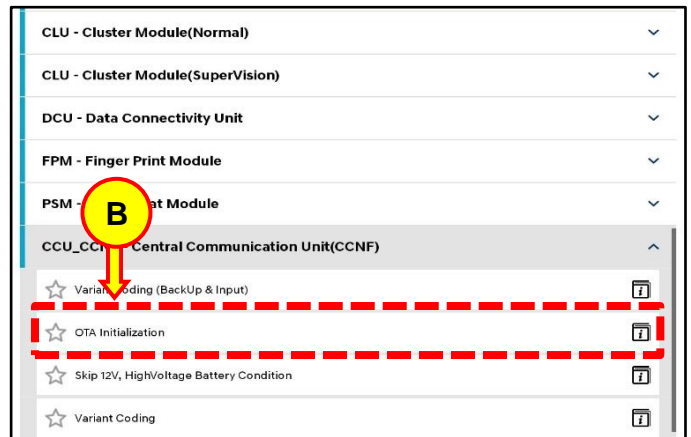
- OTA initialization (A) should perform automatically:
 - If OTA initialization performs automatically, then proceed with the service procedure.
 - If the OTA initialization process fails, complete it manually under: **S/W Management > CCU_CCNF - Central Communication Unit (CCNF) > OTA Initialization (B)**. Follow the instructions on the screen.

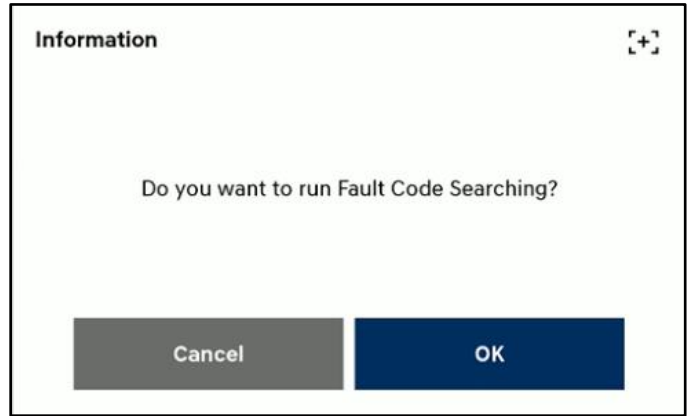
- Perform an **All Systems Fault Code** search and erase DTC history that had incidentally occurred from the ECU update.

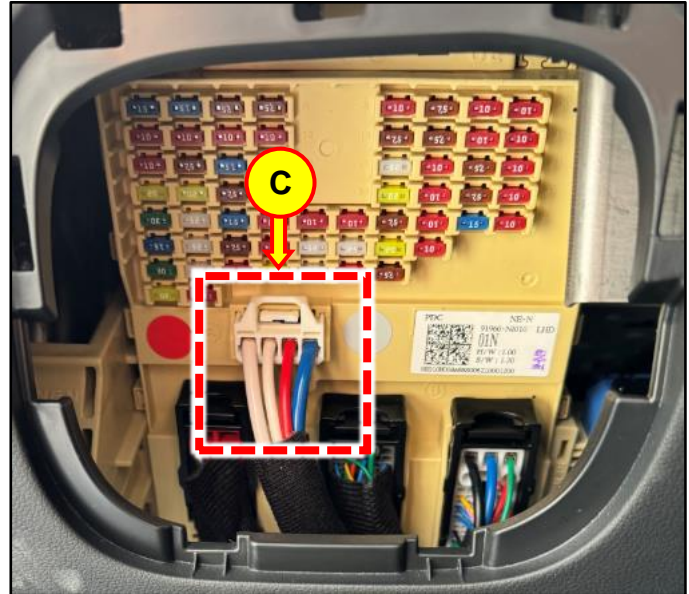
- Remove the power connector (C) from the in-cabin fuse box for at least **5 seconds**, then reconnect it.

Alternatively, disconnect the negative (-) **12V** battery terminal, wait at least **5 seconds**, then reconnect it.

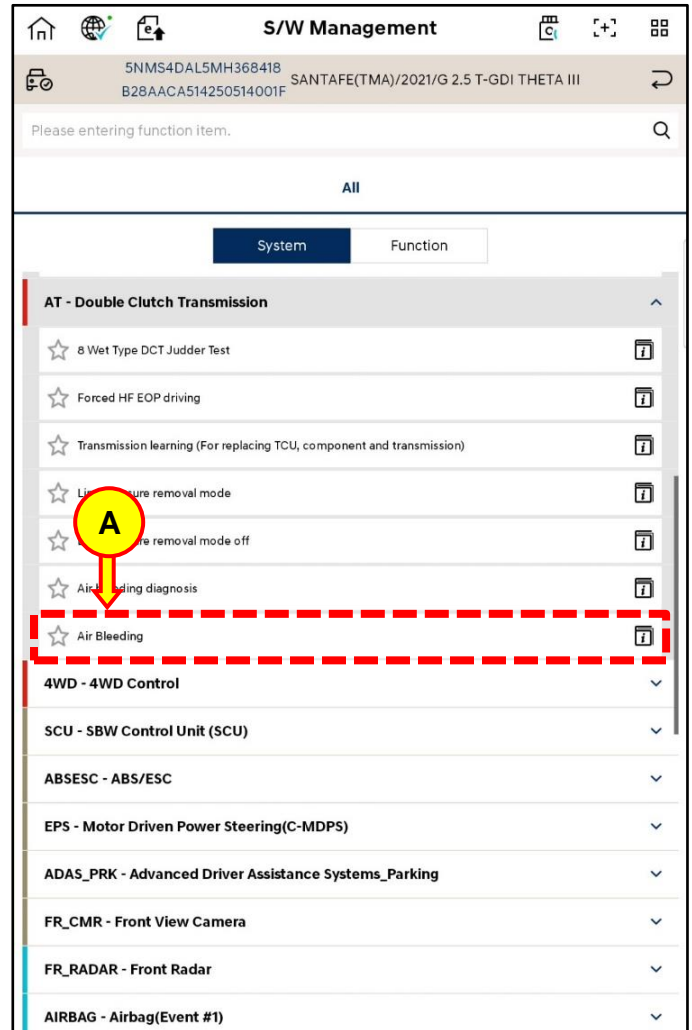
1. Confirm vehicle is set to the following parameters:
 - Vehicle stopped with transmission in Park (P).
 - Ignition switch **ON** (IG ON).
2. Connect GDS to the vehicle.

3. Under **S/W Management > Automatic Transaxle**, select **Air Bleeding (A)**.

Do **NOT** operate any other functions while performing air bleeding.

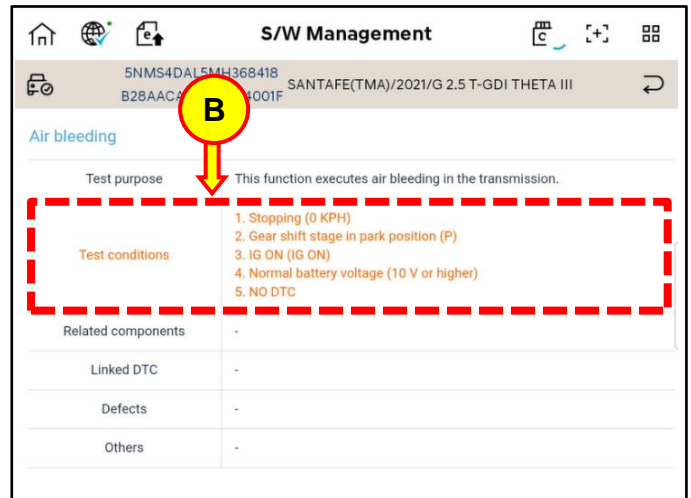
- 4. Confirm the **Test conditions (B)** on the screen, then select **Run (C)**.

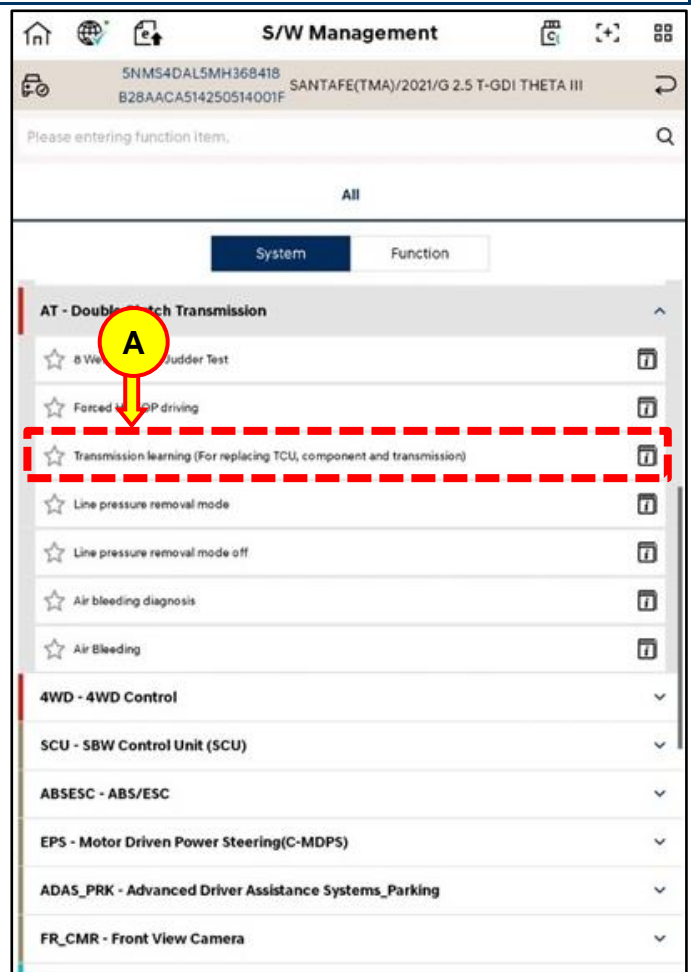
- 1. Under **S/W Management > Automatic Transaxle**, select **Transmission learning (A)**.

Do **NOT** operate any other functions while performing Transmission learning.

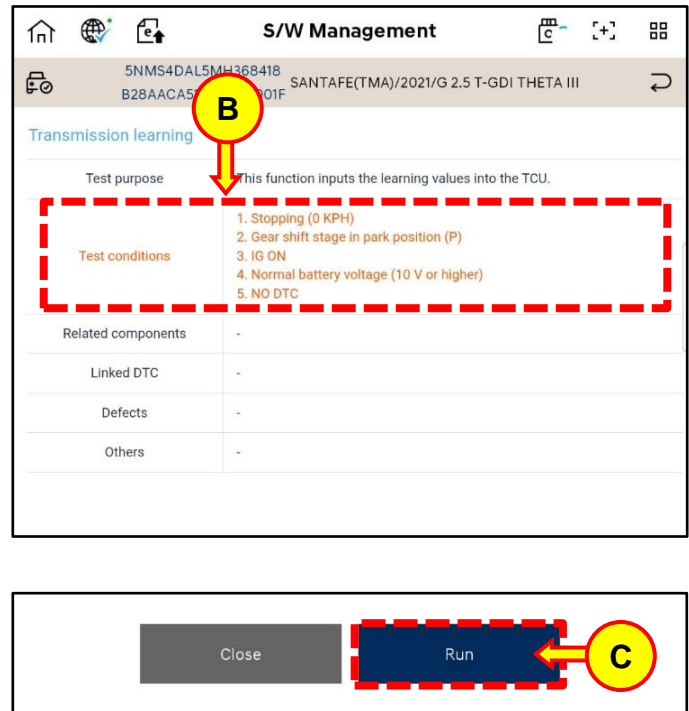
2. Confirm the **Test conditions (B)** on the screen, then select **Run (C)**.
