<b>REFERENCE:</b>	<b>TSB:</b> 08-192-25 <b>GROUP:</b> 08 - Electrical	<b>Date:</b>	June 13, 2025	<b>REVISION:</b>	—
<b>VEHICLES AFFECTED:</b>	<b>2025 (LB) Dodge Charger</b> This bulletin applies to vehicles equipped with a 400V G2300 FR/RR Elec Drive Motors (Sales Code ELJ) with Drive eXperience Recorder (Sales Code JFC) and Drive eXperience Recorder Prep (Sales Code JGB) with Uconnect 5 Nav W 12.3" Display (USA) (Sales Code UBX) or Uconnect 5 Nav W 12.3" Display (CAN) (Sales Code UEX).			<b>MARKET APPLICABILITY:</b> <input checked="" type="checkbox"/> NA <input type="checkbox"/> MEA <input type="checkbox"/> SA <input type="checkbox"/> IAP <input type="checkbox"/> EE <input type="checkbox"/> CH <b>NOTE:</b> This bulletin applies to the North America market.	
<b>CUSTOMER SYMPTOM:</b>	<b>Customers must experience a Malfunction Indicator Lamp (MIL) illumination and the vehicle must exhibit/set one or more of the following Diagnostic Trouble Codes (DTCs):</b> <ul style="list-style-type: none"> <li>• B023C-49 - Dashcam Module 1-Internal Electronic Failure.</li> <li>• U115C-00 - Lost Communication With ETM.</li> </ul> <b>The customer may describe the following:</b> <ul style="list-style-

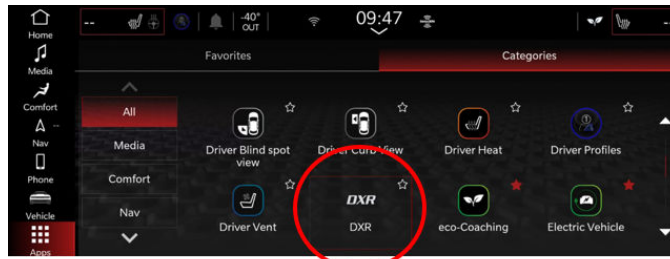
**Fig. 2**  
DXR

- 5. Locate the DXR tile and select it [Fig. 2](#).

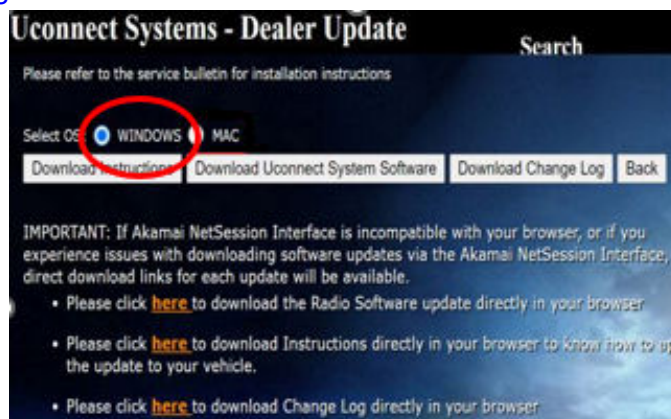
**Fig. 8**

15. Download the software update file to your local PC's desktop. Make sure to select the “WINDOWS” radial button for all downloads [Fig. 8](#).

### WINDOWS Download Steps

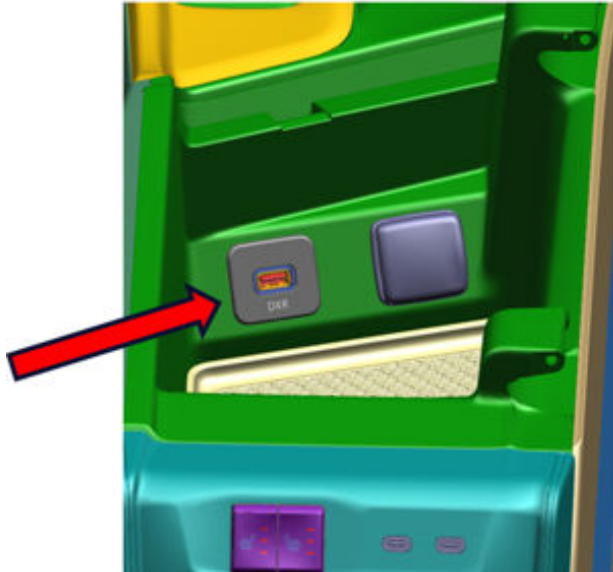
**Fig. 10**  
DXR USB

22. Start the vehicle and insert the USB flash drive into the DXR USB port [Fig. 10](#).

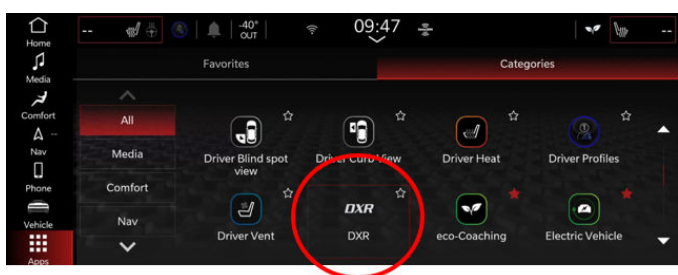
**Fig. 12**  
DXR

25. Locate the DXR tile and select it [Fig. 12](#).

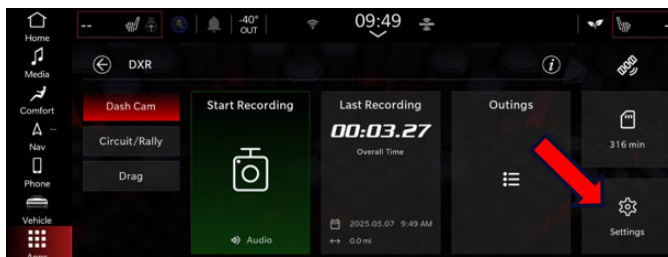
**Fig. 14**  
Settings

27. Click the Settings button to open the settings menu [Fig. 14](#).

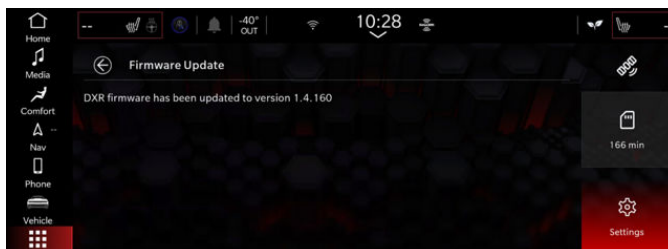
**Fig. 18**

31. This message will be displayed when the update is complete [Fig. 18](#).

Software Updated Screen
