GROUP	MODEL
ELE	2024-2025MY Seltos (SP2) w/ 1.6L T-GDI GAMMA
NUMBER	DATE
359	June 2025

## TECHNICAL SERVICE BULLETIN

### SUBJECT: SERVICE ACTION: OIL CHANGE REMINDER RESET OPERATION LOGIC (SA592)

757.SP2 PE ICU Upgrade for Oil Change Reminder Reset Operation Logic

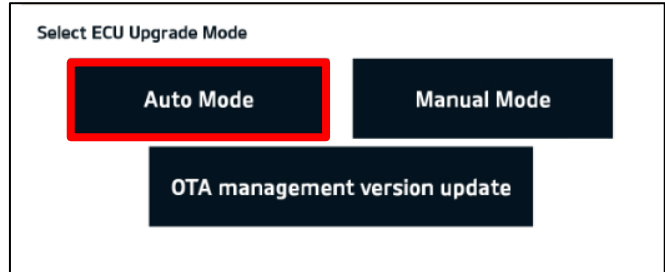
The required software must be installed by selecting the **'Auto Mode'** ECU Upgrade option.

**Note:** In some case, the 'Manual Mode' installation option may be required **ONLY** if the 'Auto Mode' function fails or is otherwise noted above.

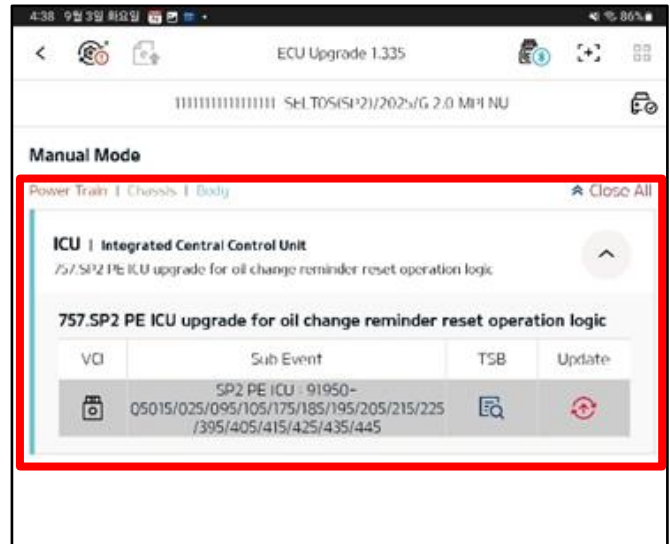
- Select the applicable **'ICU'** system module and the Event Group.
  - 757.SP2 PE ICU Upgrade for Oil Change Reminder Reset Operation Logic"**

Verify the affected vehicle Calibration Identification of the applicable ECU ROM ID and reference the Information Table on page 3 as necessary.

- Confirm that the AVN SW is up to date after completing the ICU upgrade by proceeding to the 'AVN Software Inspection Procedure' on page 5.

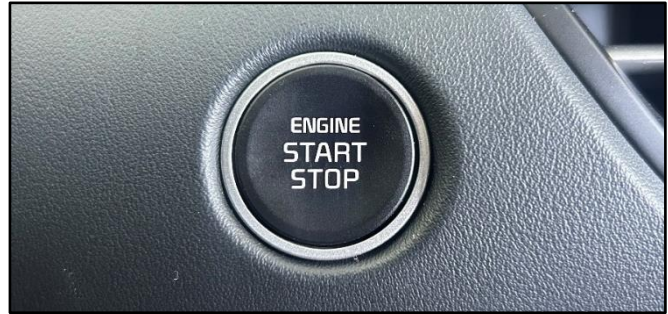
1. Turn the vehicle 'ON'.

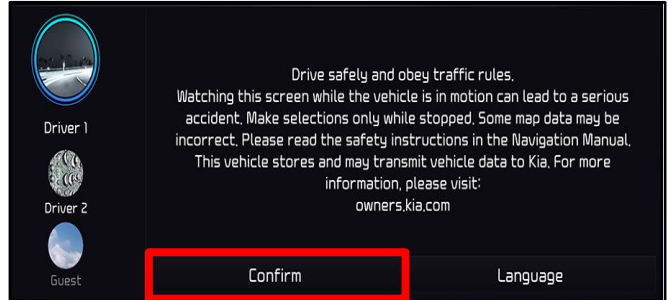
2. Select 'Confirm' on the head unit screen.

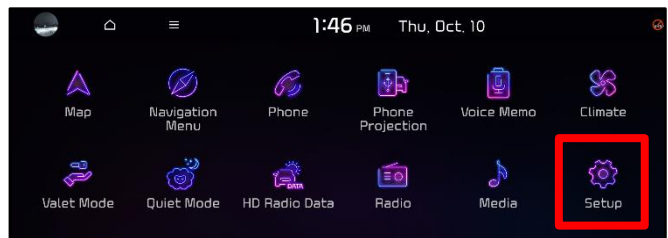
3. Select 'Setup'.

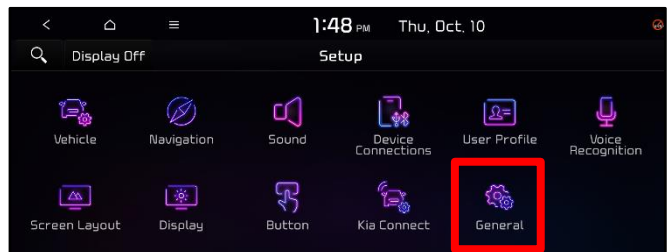
4. Select 'General'.

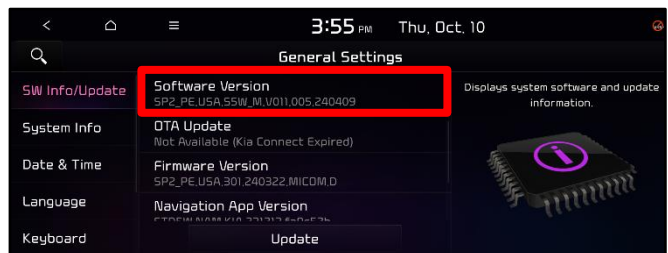
- 5a. Select 'SW Info/Update'.

- 5b. Confirm that the latest AVN S/W is installed.

**SP2\_PE.USA.S5W\_M.V011.005.240409**

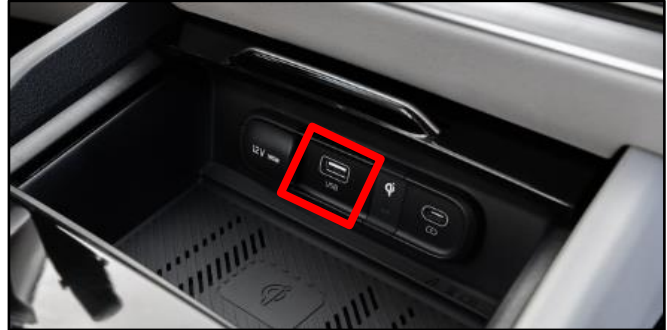
1. Repeat steps 1 - 4 of the 'AVN Software Inspection Procedure' on page 5.
2. Insert the provided USB drive into the USB slot.

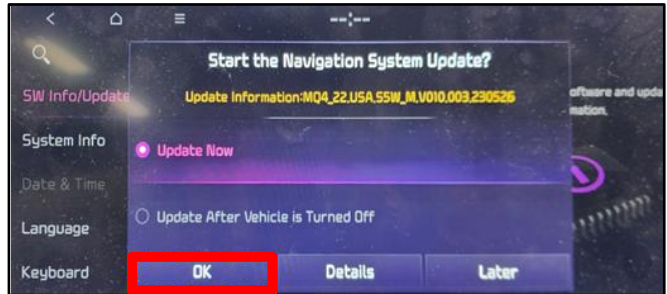
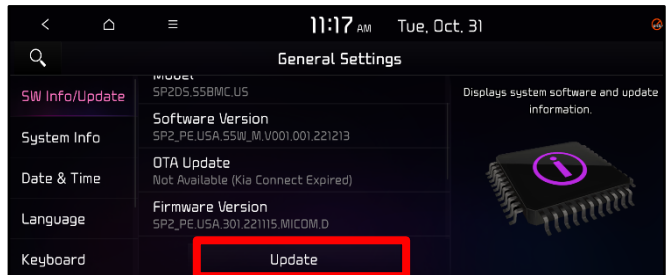
3. Select one of the following:
  - If a pop-up displays, select 'OK'.
  - If a pop-up does not display, select 'Update'.

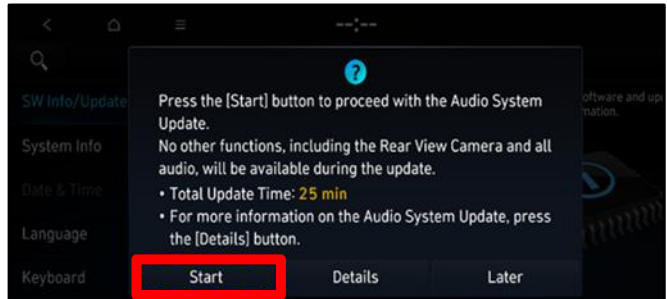
4. Select 'Start' on the pop-up.

**Note:** There may be multiple occurrences where the 'KIA' logo will appear, or the display may be black during the update process. This is normal.

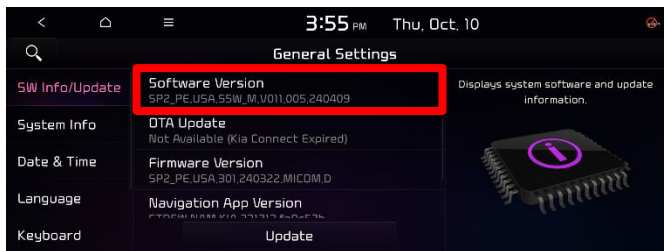
5. After AVN update is complete, verify the software version is the most current on the 'SW Info/Update' screen.

**SP2\_PE.USA.S5W\_M.V011.005.240409**
