TECHNICAL SERVICE BULLETIN

SERVICE ACTION: SUNROOF OPERATION LOGIC IMPROVEMENT (SA620)

This bulletin supersedes TSB SA595 (December 2024) and outlines the procedure to update the Roof Control Module (RCM) software on certain 2025MY K4 (CL4) vehicles produced between September 19, 2024, through May 28, 2025, which may experience inoperative sunroof operation (open/close) due to a software logic error. The updated software includes improved logic to address this issue. To apply the update, verify that the vehicle is within the affected VIN range and follow the steps detailed in this bulletin using the KDS ECU Upgrade function.

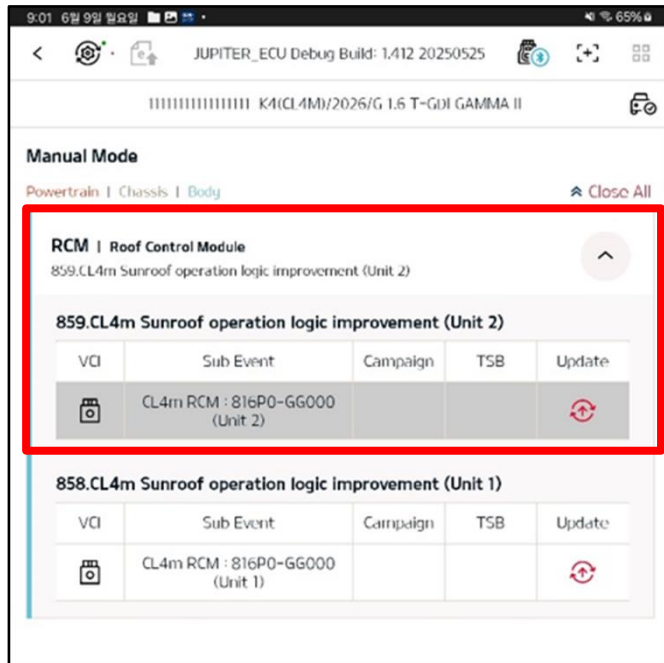
Select the applicable **'RCM'** system module and the Event Group.

- **859.CL4m Sunroof operation logic improvement (Unit 2)**

Verify the affected vehicle Calibration Identification of the applicable ECU ROM ID and reference the Information Table on page 3 as necessary.
