## PRODUCT CAMPAIGN BULLETIN

**APPLICABILITY:** 2020-2022 MY Legacy  
2020-2022 MY Outback

**NUMBER:** WRA-24R

**SUBJECT:** Safety Recall – ODS Sensor Replacement

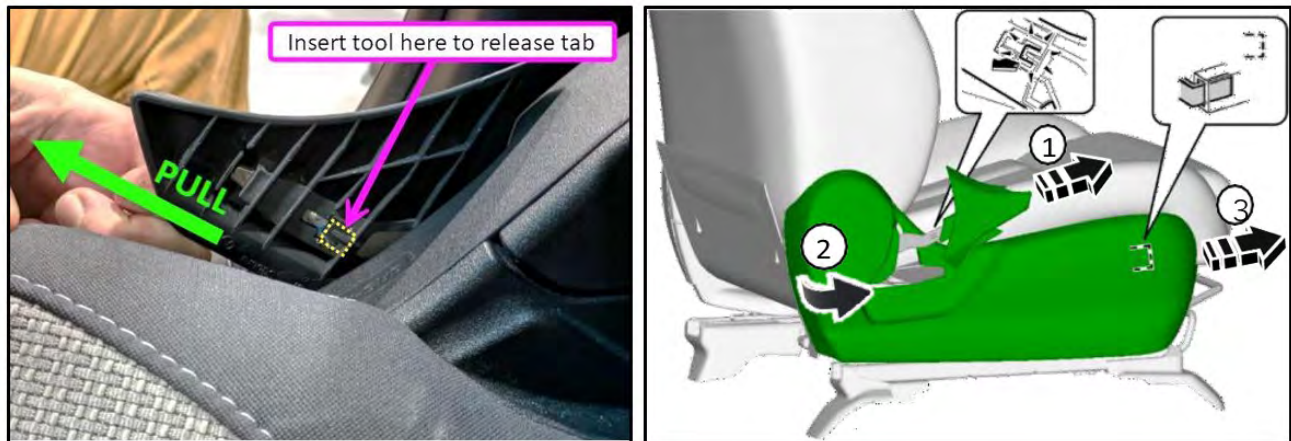
**STEP 8:** Pull up on the backrest adjustment handle and insert a small screwdriver or plastic trim tool into the handle cover locking tab. Once the tab is released pull the handle cover toward the front of the vehicle to remove. Once the handle cover is removed, release the rear section of the seat side cover. With all the holding clips released, the cover can then be removed by pulling towards the front of the vehicle.

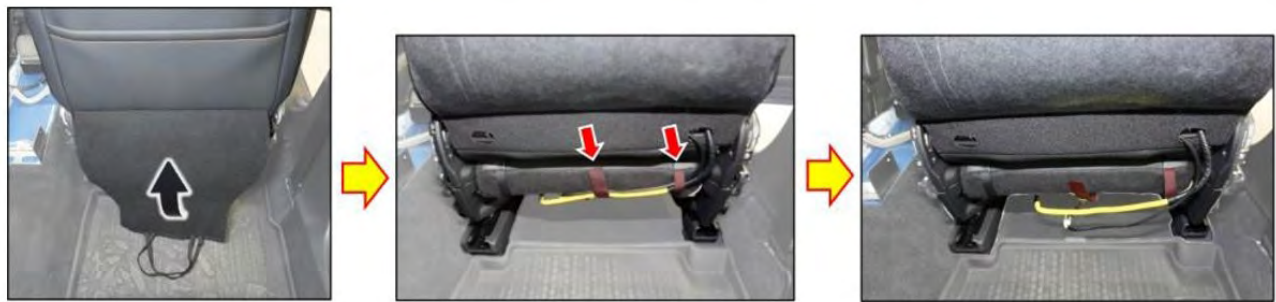
**STEP 12:** Tuck the hanging section of the cover into the rear pocket of the seat. Release the two Velcro straps and free the two harness sections.

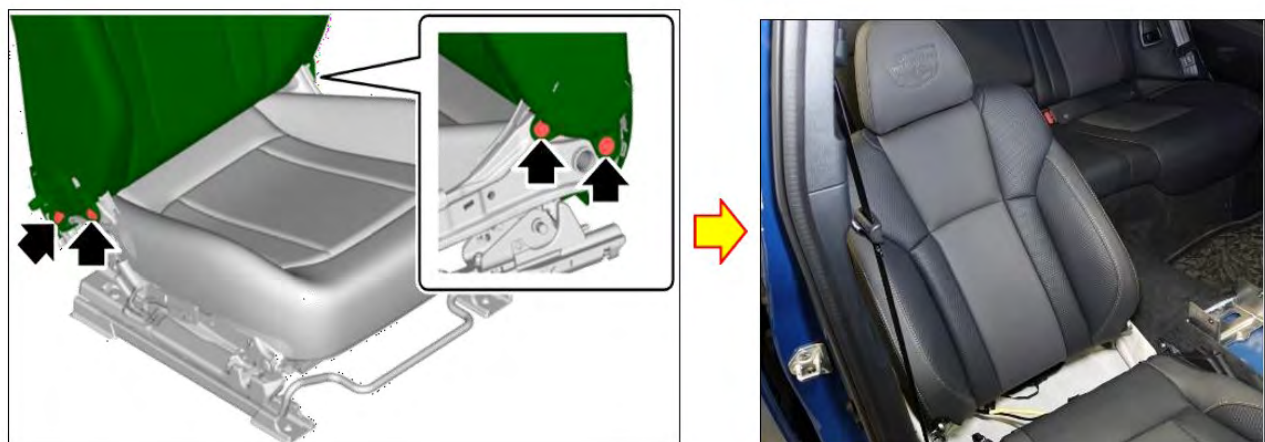
**STEP 13:** Unbolt and discard the four bolts mounting the seat backrest to the bracket. Place the backrest into the rear seat footwell area.

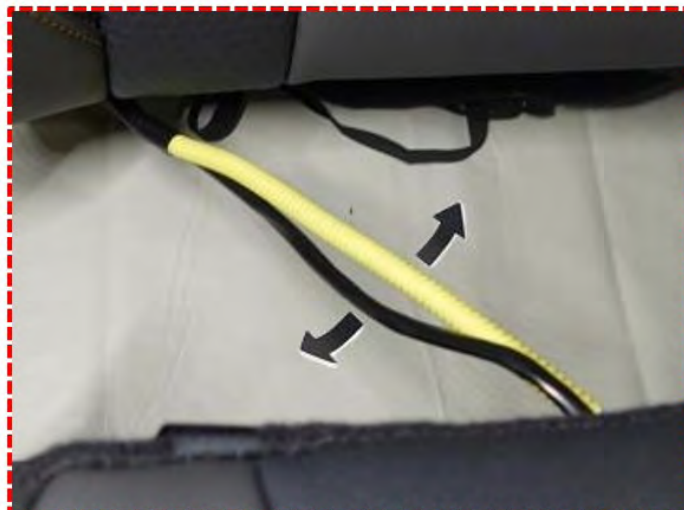
**CAUTION:** Confirm the harness section does not have any excessive tension and is free from pinching of any kind.

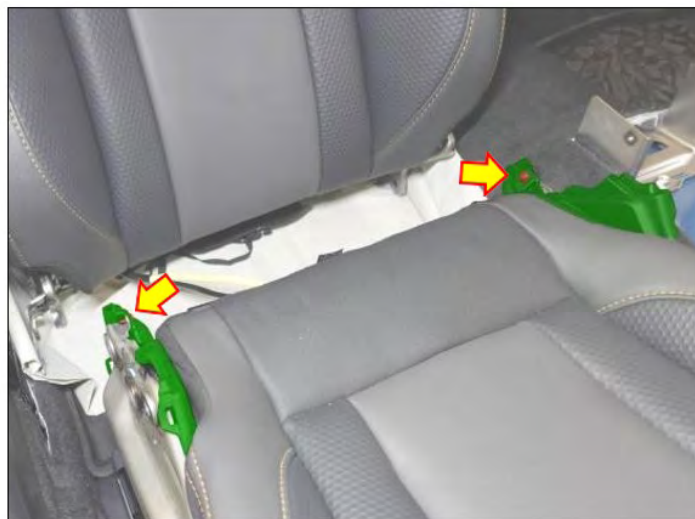
**STEP 14:** Remove both mounting screws for the inner cushion covers.

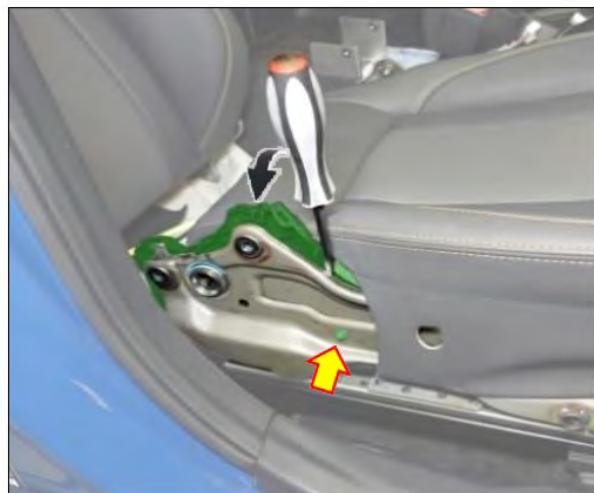
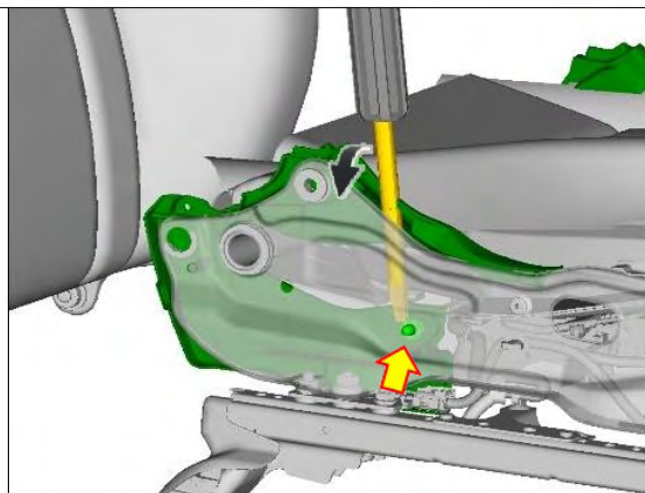
**STEP 15:** Starting with the outside cover, release the mounting clip using a large flat blade screwdriver or suitable plastic trim tool.

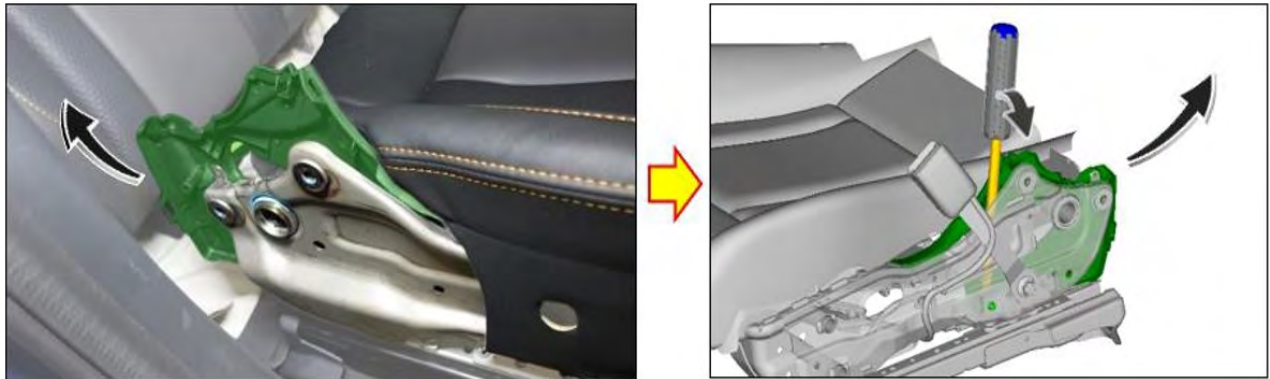
**STEP 16:** Pull the cover back and then CAREFULLY rotate the cover to remove. Using the same method, remove the opposing side inner cover as well.

**CAUTION:** Make sure there is sufficient room between the covers and the seat backrest. DO NOT damage the seat cover. If needed, cover the seat material with a clean protective cloth.

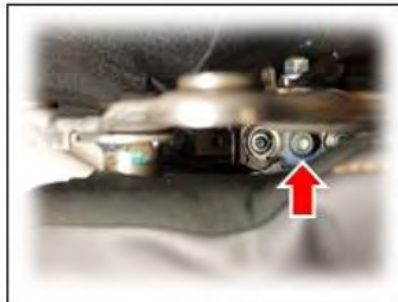
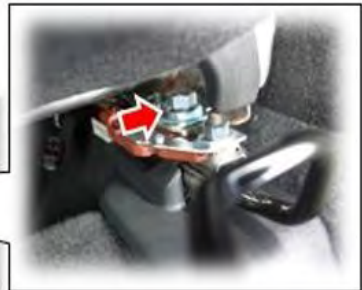
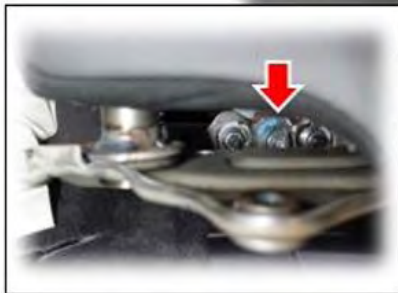
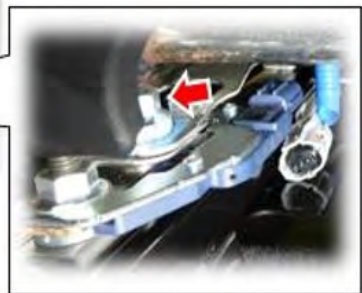
**STEP 18:** Remove the four 14mm (M10) nuts securing the cushion frame. The front nuts can be removed using an offset boxed wrench. The rear nuts can be removed with a 14mm socket, 3/8 in drive ratchet, and 3/8 in drive wobble extension. The nuts can be discarded after removal.

**CAUTION:** Avoid touching the seat adjustment lever with mounting nuts removed. This may cause the left and right rails to become misaligned and difficult to reassemble.

**NOTE:** Snap-on® tool # [FXWK8](#) is an example of a wobble extension suitable for usage.

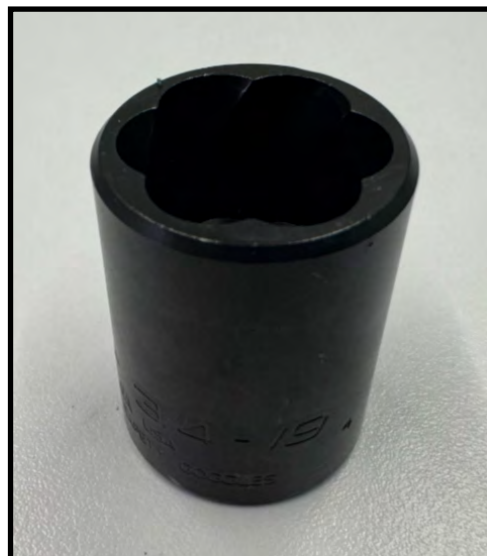
Attach a 19mm twist socket and ratchet to the bottom portion of the stud to prevent it from spinning, then remove the nut securing the ODS sensor to the seat bottom.

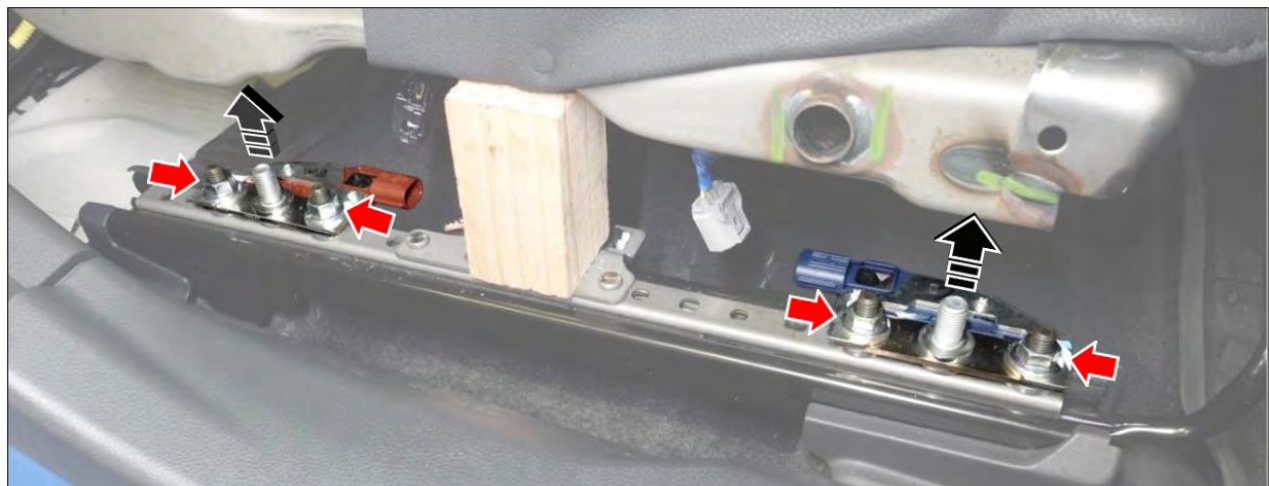
**STEP 20:** Remove and discard the four 12mm (M8) sensor mounting nuts. The two sensors can then be removed and discarded.

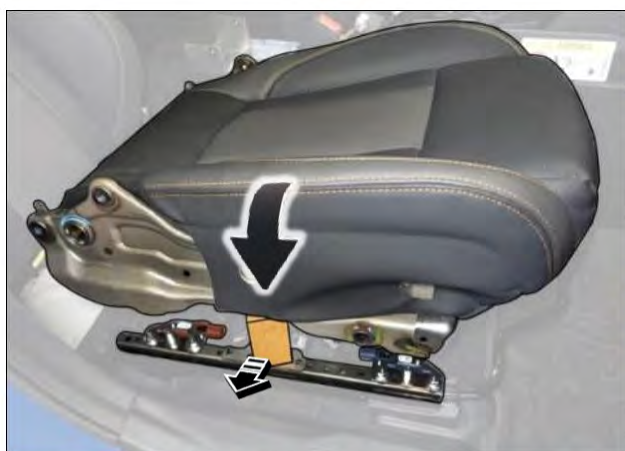
**STEP 22:** Remove the block and CAREFULLY lower the cushion frame.

- Slowly lower the cushion while monitoring the bolt of the sensor and the insertion hole of the cushion frame.
- Do not secure the seat until the inner sensor has been replaced.

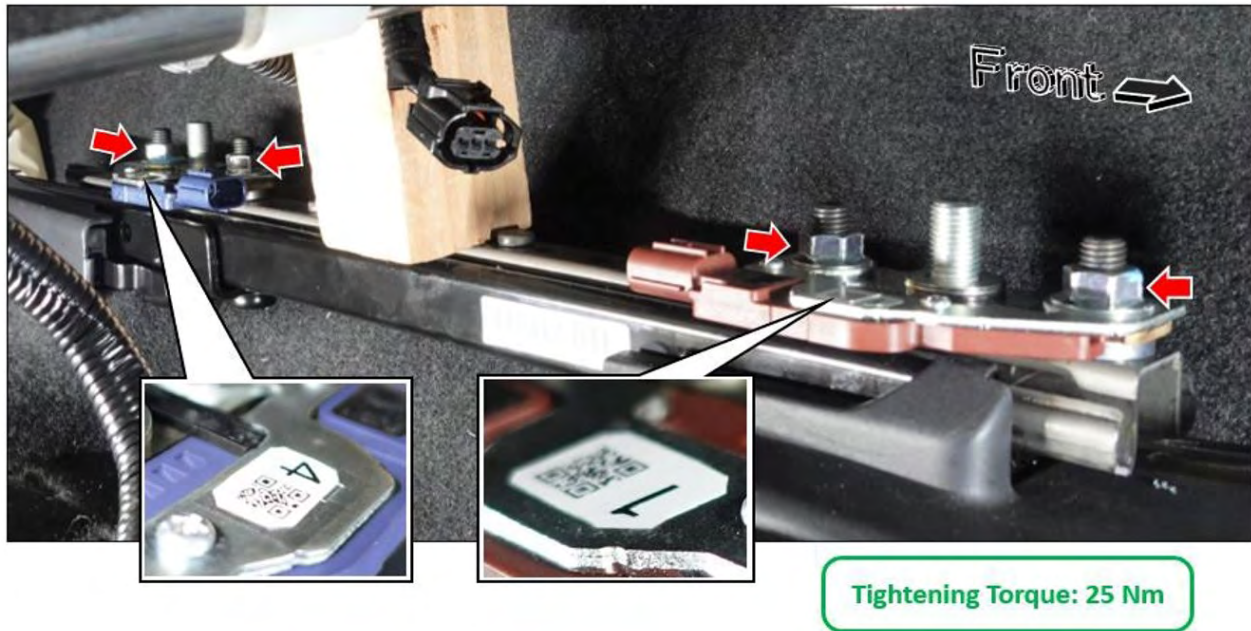
**STEP 25:** Confirm the identification numbers of the NEW Occupant Detection Sensors are #1 and #4. Mount the #1 (**Brown**) sensor to the inner front position and the #4 (**Blue**) sensor to the inner rear position. Torque the NEW sensor mounting nuts (p.n. 64157AN03A) to 25Nm (18.5ft-lbs).

**NOTE:** Take special care in handling the new sensors.

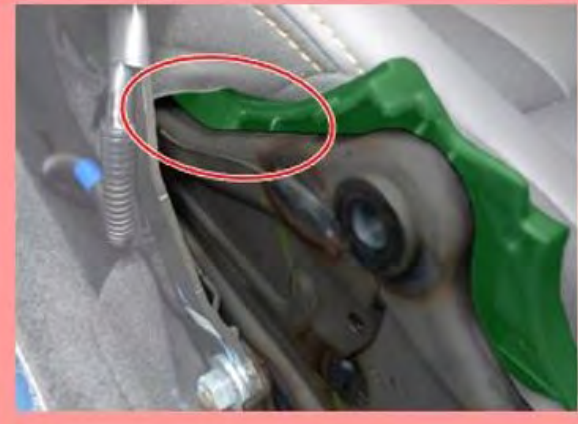
<p>A close-up photograph showing the green plastic cover incorrectly mounted. A red oval highlights the green clip, which is not properly seated and is protruding from the metal surface.</p>

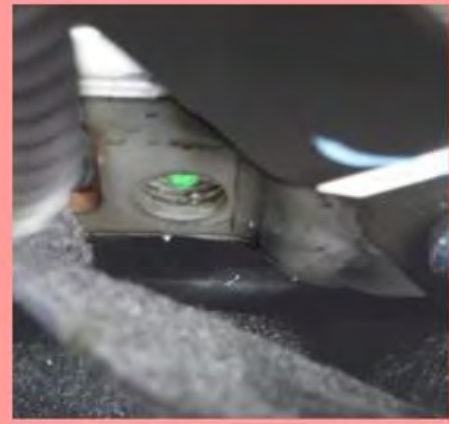
<p>A close-up photograph of the green clip, showing it is incorrectly positioned and not fully engaged with the metal component.</p>

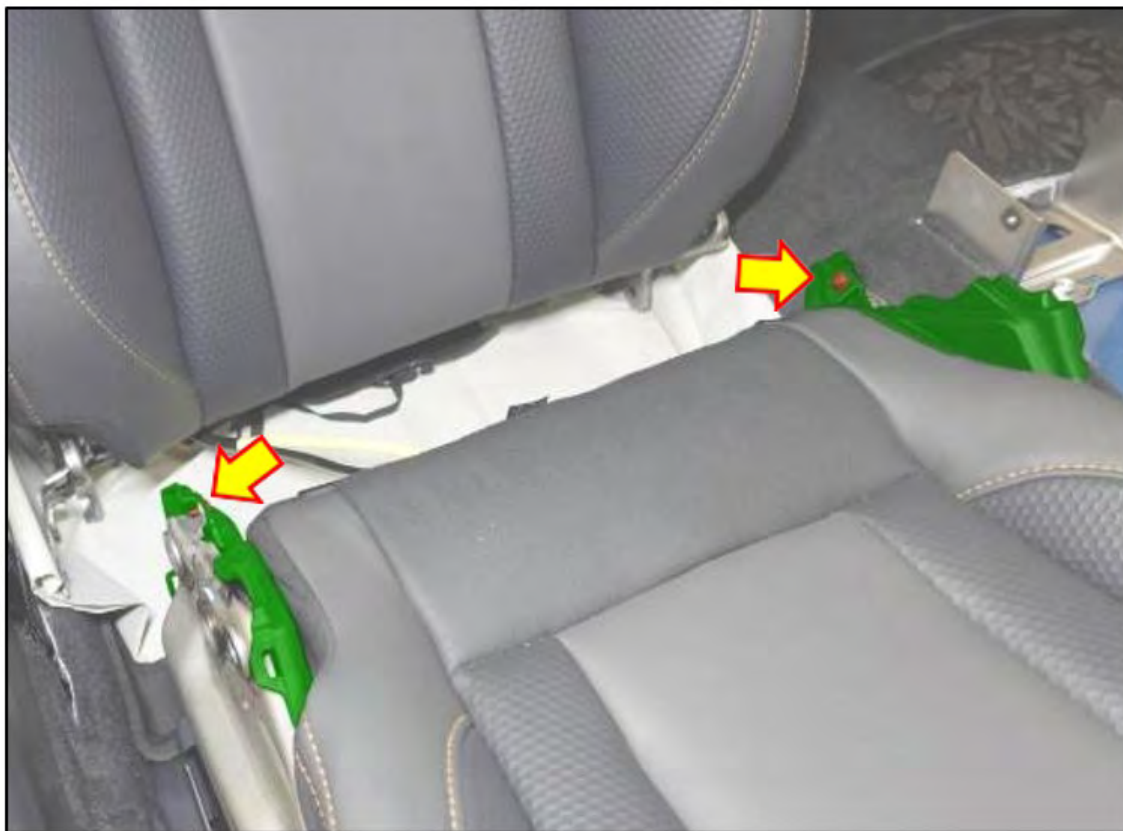
**STEP 31:** Reinstall the two mounting screws for the inner cushion covers.

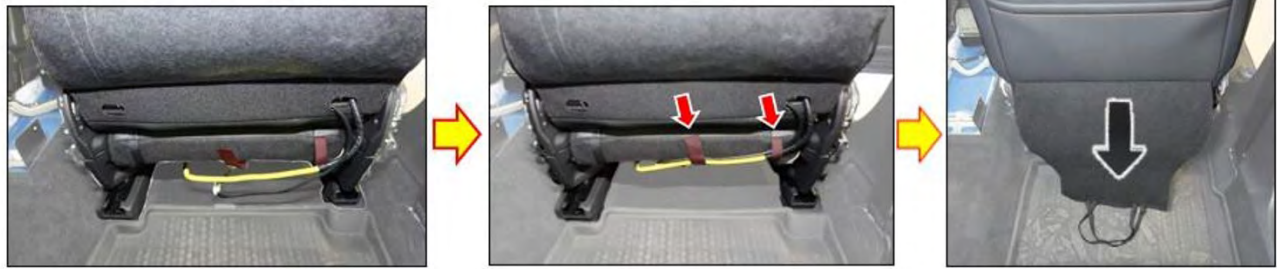
**STEP 33:** Secure the two Velcro straps and harness sections. Untuck the hanging section of the cover from the rear pocket of the seat.

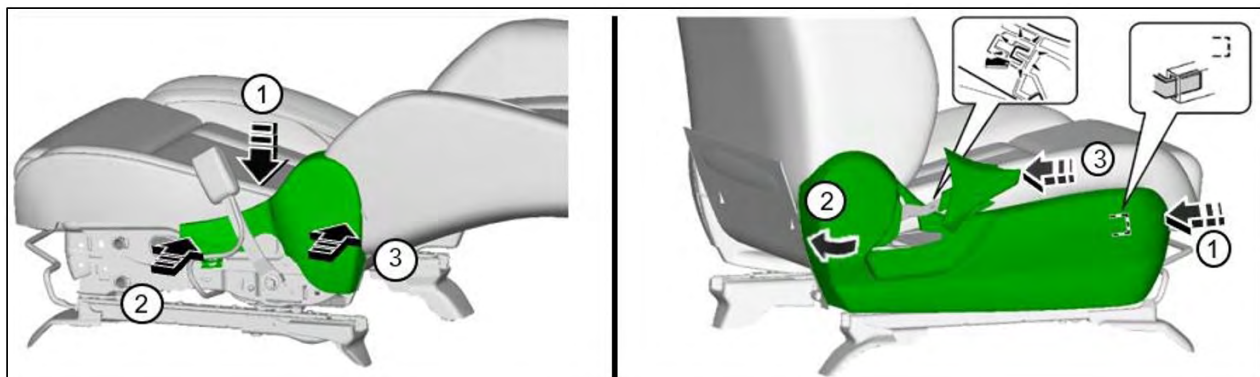
**STEP 35:** Reinstall the inner and outer hinge covers and handle.

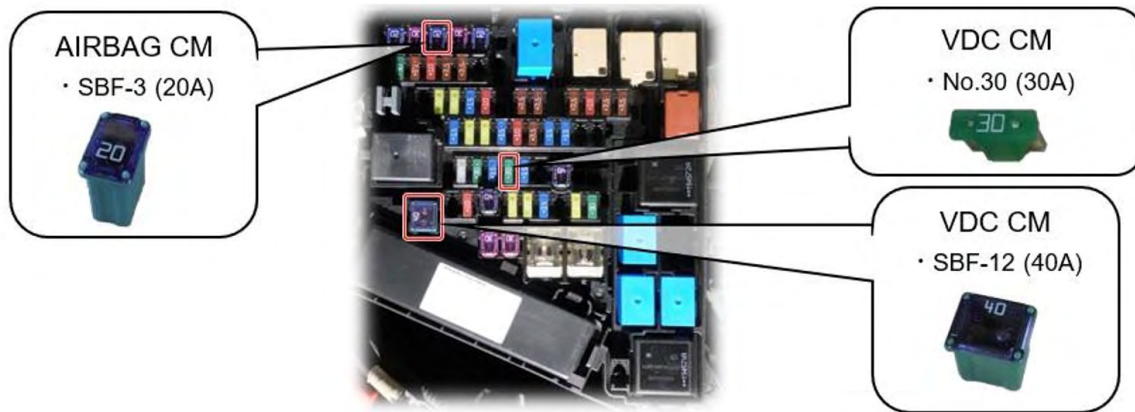
**STEP 36:** Reinstall the center console and gear selector cover.

**STEP 37:** Reinstall the fuses.

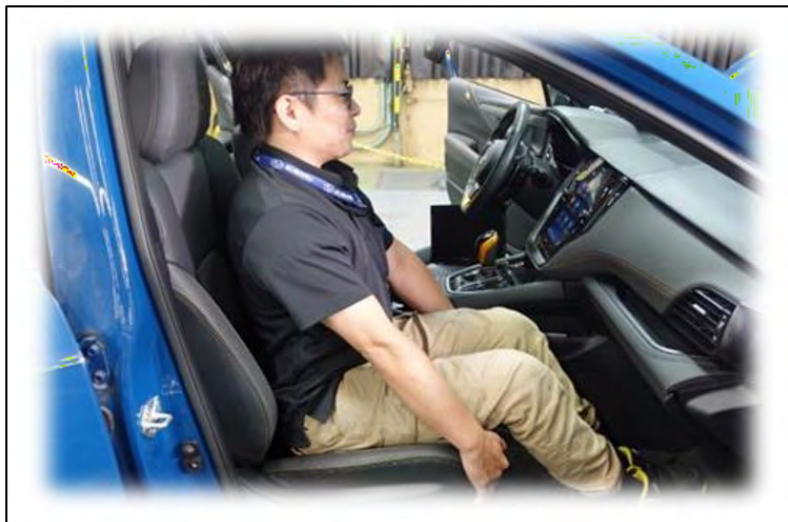
**STEP 38:** Sit on the front passenger seat and slightly move around while adjusting the positions.

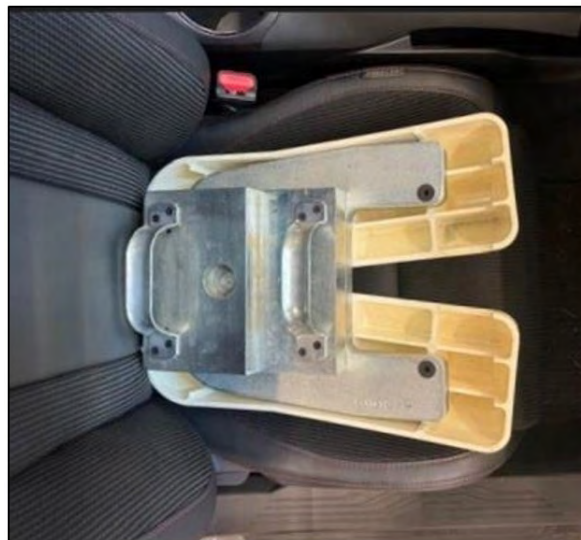
**STEP 41:** Confirm the seat and backrest are adjusted fully forward. Install both components of special tool #J-47673.

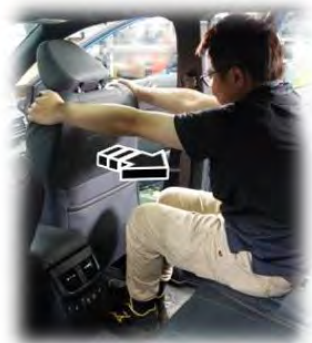
**STEP 44:** While sitting in the passenger rear seat, pull the backrest toward the rear of the vehicle and monitor the values. The front sensors should have a negative (-) value and the rear sensors should have a positive (+) value.

Item	Value	Unit	Maximum	Minimum	Average
<input checked="" type="checkbox"/>	AB Front-Left Sensor Load Value	-37.75	kg	-0.13	-37.75	-4.97
<input checked="" type="checkbox"/>	AB Front-Right Sensor Load Value	-35.90	kg	0.22	-35.90	-4.60
<input checked="" type="checkbox"/>	AB Rear-Left Sensor Load Value	45.33	kg	45.33	0.09	6.39
<input checked="" type="checkbox"/>	AB Rear-Right Sensor Load Value	35.23	kg	35.23	-0.31	4.53

Item	✓	✗		
	Case1	Case2	Case3	Case4
	Value	Value	Value	Value
Front-Left Sensor Load Value	- 37.75	45.33	- 37.75	45.33
Front-Right Sensor Load Value	- 35.90	35.23	45.33	- 37.75
Rear-Left Sensor Load Value	45.33	- 37.75	- 35.90	35.23
Rear - Right Sensor Load Value	35.23	- 35.90	35.23	- 35.90

**IMPORTANT:** In a case when the values do not match the desired specification, it possible the sensor mounting position is incorrect.

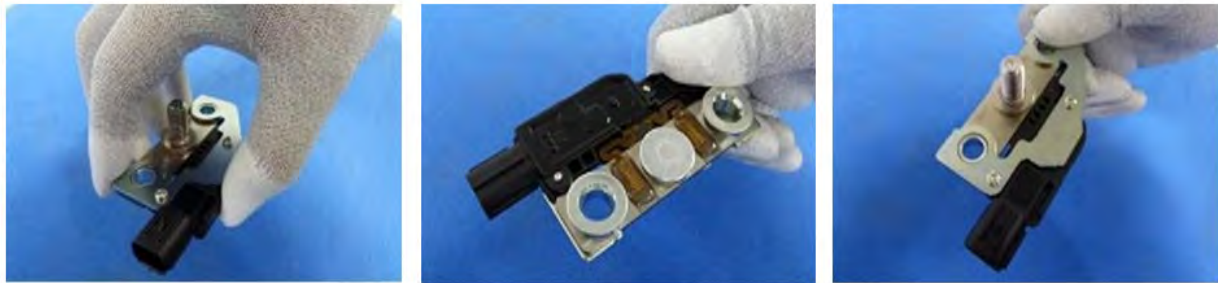
**EXAMPLES OF PROPER SENSOR HANDLING:**

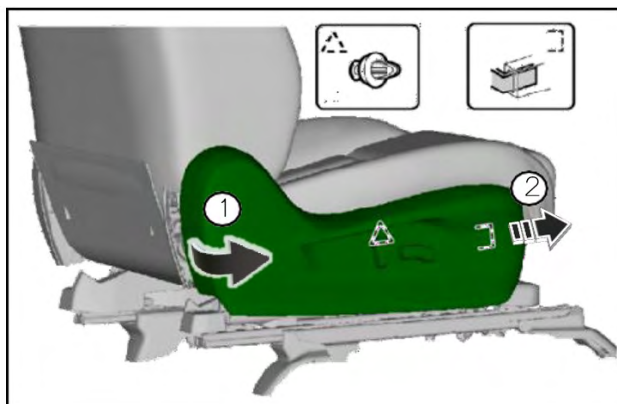
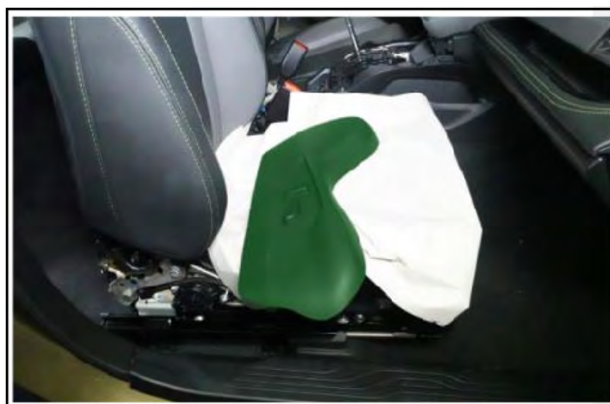
**STEP 10:** Release the rear section of the seat side cover. With all the holding clips released, the cover can then be removed by pulling towards the front of the vehicle. There is no need to disconnect the switch/harness. The cover can be placed on top of the seat. A clean fender cover or cloth can be used for seat protection.

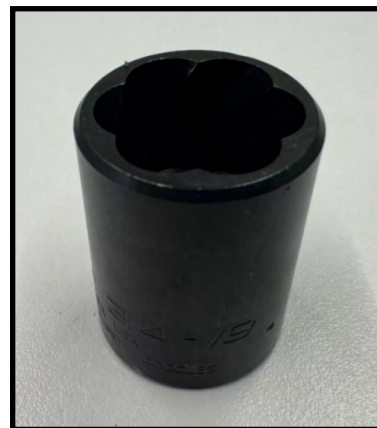
Attach a 19mm twist socket and ratchet to the bottom portion of the stud to prevent it from spinning, then remove the nut securing the ODS sensor to the seat bottom.

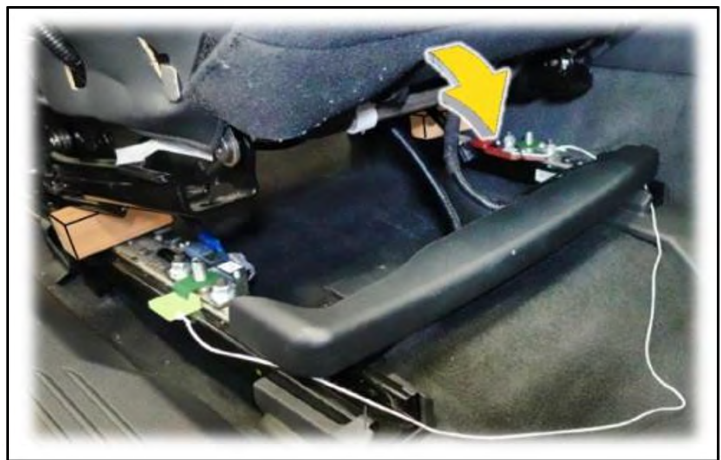
**STEP 19:** Tuck the connector of sensor sensors into the cushion frame. Remove the blocks and CAREFULLY lower the cushion frame.

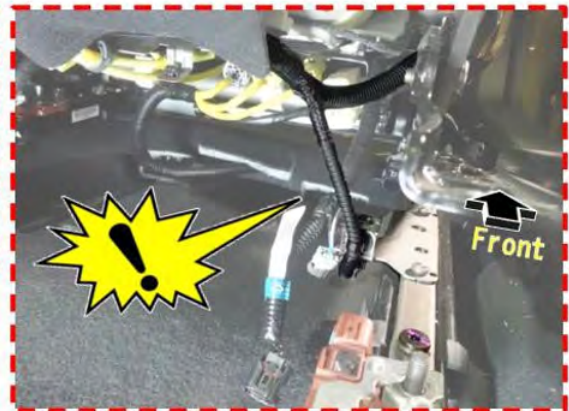
**STEP 21:** CAREFULLY raise the rear of the seat assembly 35-40mm (1.4 to 1.6 inch). Insert both of the pre-prepared blocks between the cushion frame and the seat rail.

- DO NOT damage the slide sensor when inserting the block into the outer rail.
- Pay close attention to the seat harness when lifting the cushion frame. Excessive tension may cause damage to the harness.

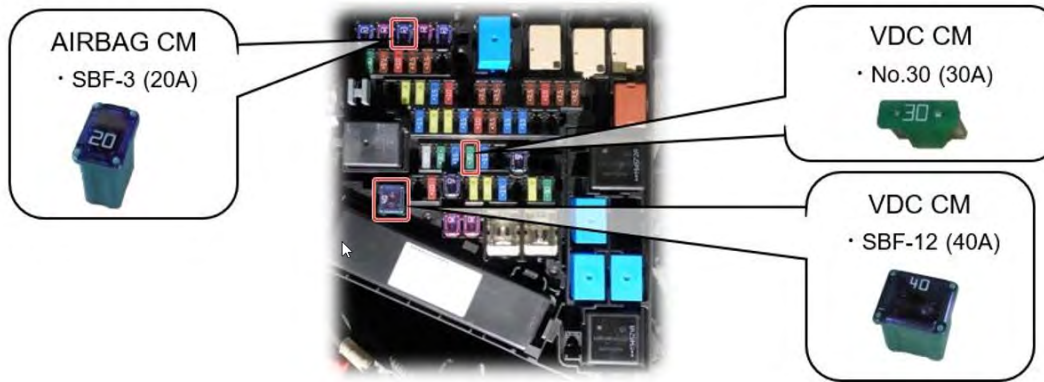
**STEP 34:** Reinstall the fuses.

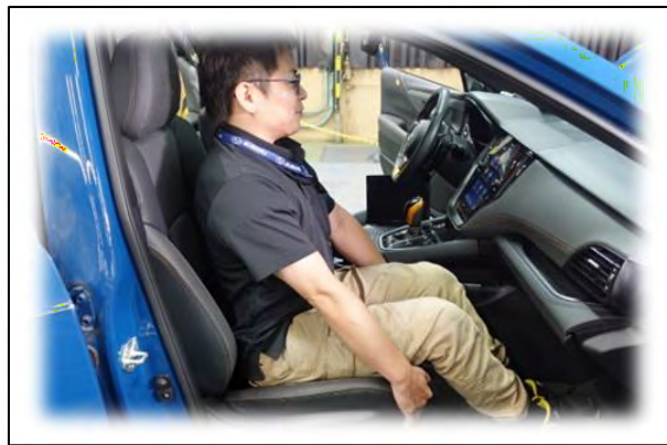
**STEP 35:** Sit on the front passenger seat and slightly move around while adjusting the positions.

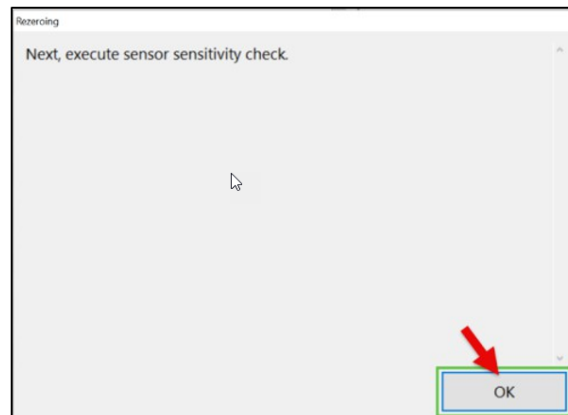
**STEP 37:** Once the “Rezeroing” procedure is successfully completed, you will be prompted to start a “Sensitivity Check”. Click the “OK” button to continue.

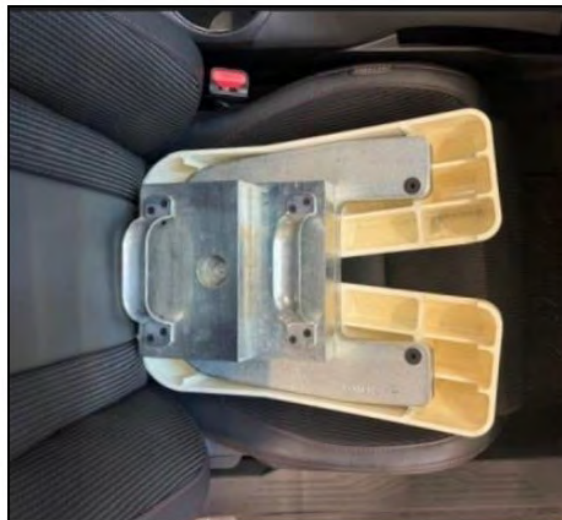
**STEP 38:** Confirm the seat and backrest are adjusted fully forward. Install both components of special tool #J-47673.
