SERVICE INFORMATION BULLETIN

APPLICABILITY: All Models **NUMBER:** 10-105-25R
SUBJECT: **New Procedure and Fail Code for First-Time Undetected A/C Refrigerant Leaks** **DATE:** 05/01/25
REVISED: 06/23/25

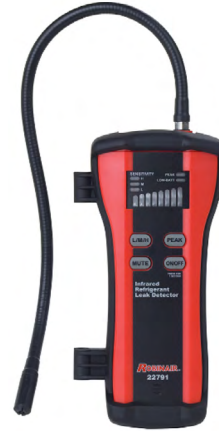
Subaru of America recommends the [Robinair™ LD7 Infrared Leak Detector](#) to be used when diagnosing refrigerant leak concerns.

- **Detection Capability:**
 - R134a is 0.05 ounces per year.
 - R1234y is 0.01 ounces per year.
- **Proper Technique:**
 - Move the probe at 1-2 inches per second in a double-pass method.
 - Keep probe approximately ¼ inch from the component.
 - Focus on low-lying areas. Refrigerant is heavier than air.
