Working on High-Voltage Battery: Additional Photo Documentation Required when Removing the High-Voltage Battery (194/24)

Model Line: **Taycan (Y1A / Y1B / Y1C)**

Concerns: **High-voltage battery**

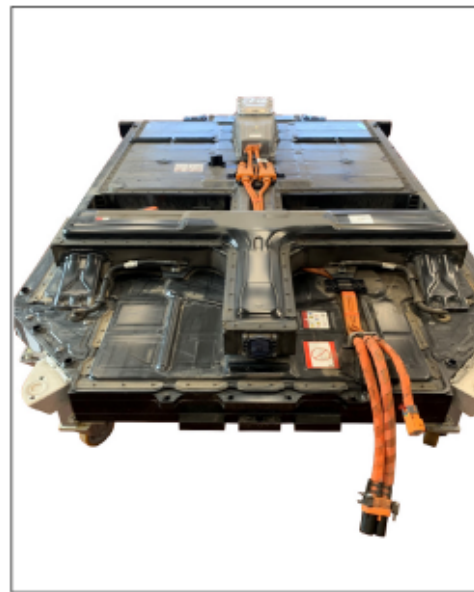
- 2 Photograph the high-voltage battery in the following views.

General overview of rear high-voltage battery

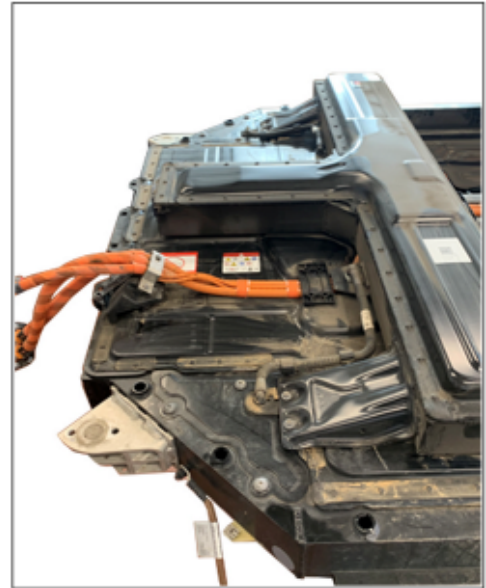
- 3 Photograph the frame at **all four corners** in the following views.

Overview of frame corner (sample representation at rear right frame corner)

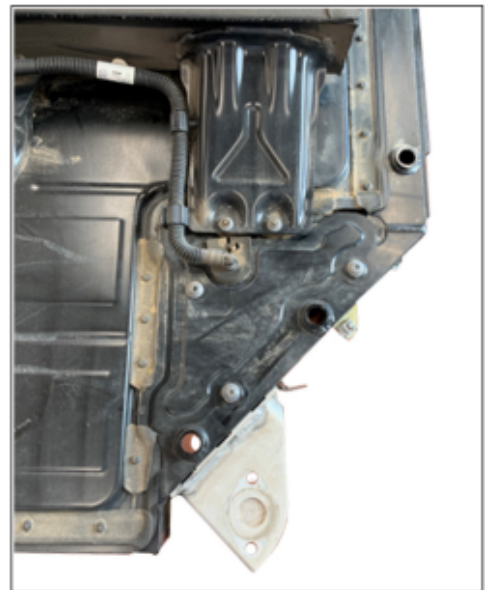
Top view of frame corner (sample representation at rear right frame corner)

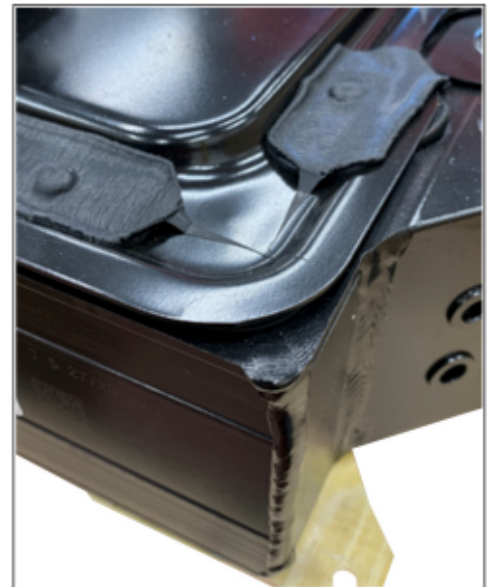
Detailed view of welded seams (sample representation at rear right frame corner)

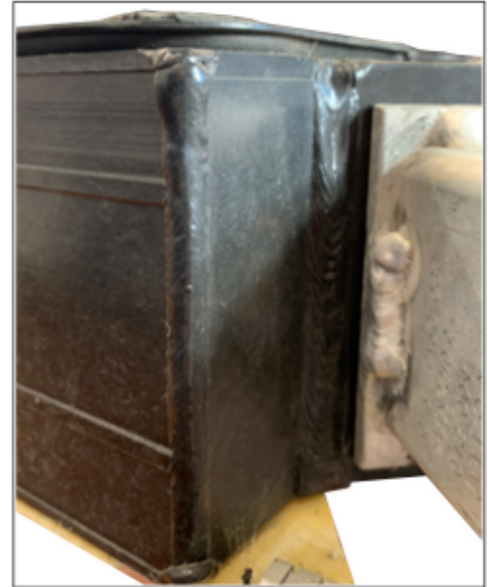
- 5 Clean the high-voltage battery with a cleaning cloth and isopropanol at **all four frame corners** and photograph it in the following views.

Side view of weld seams (sample representation at rear right frame corner)

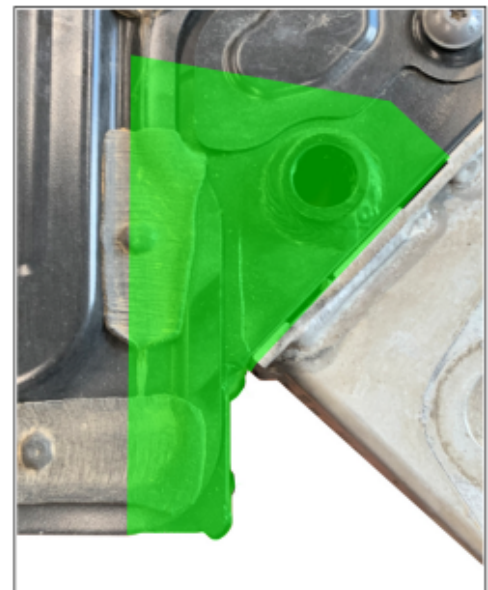
Top view of cleaned weld seams (representation of cleaned surface in green)

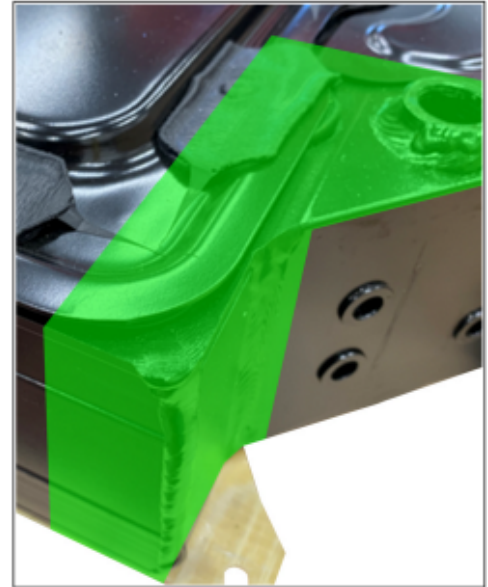
*Detailed view of cleaned weld seams
(representation of cleaned area in green)*

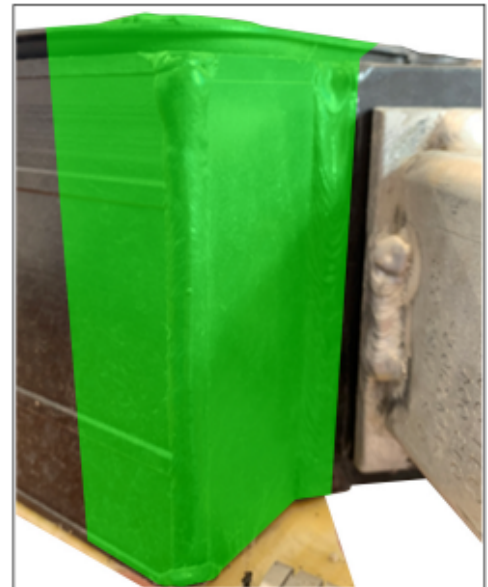
Side view of cleaned weld seams (representation of cleaned surface in green)
