WSF5 – Re-Program DME Control Unit (Workshop Campaign)

Model Line: **Panamera (YAA / YAB)**

Concerns: **DME control unit**

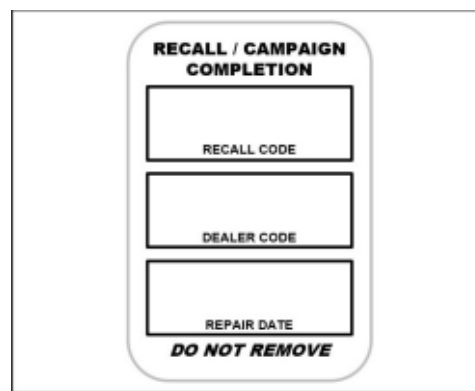
Recall Proof of Completion Label

- 5.1 Fill out the Recall Proof of Completion label
⇒ *Recall Proof of Completion Label* fully and correctly. This includes the recall code "**WSF5**", your Porsche Center code and the repair date.

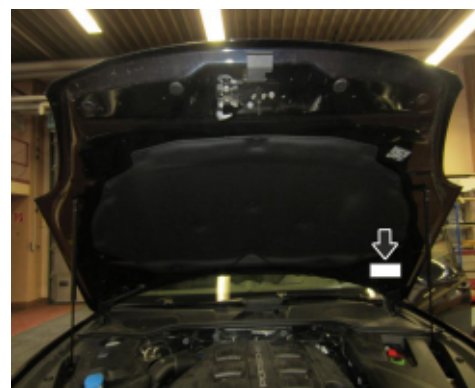
Proof of Completion Label: specified position (Exemplary illustration)

- 5.2 Clean the surface in the lower area on the front lid at the left-hand side in direction of travel at which the Recall Proof of Completion label must be attached ⇒ *Proof of Completion Label: specified position (Exemplary illustration) -arrow-* using a suitable cleaning agent and a clean, grease-free and lint-free cloth.

- 5.3 Affix Recall Proof of Completion label in the lower area of the front lid at the lefthand side in direction of travel ⇒ *Proof of Completion Label: specified position (Exemplary illustration) -arrow-*.
