GENERAL MOTORS
DCS 7269
URGENT - DISTRIBUTE IMMEDIATELY

Subject: N252500160 - Service Update
Failed OTA Update

Models: 2025 Cadillac OPTIQ

N252500160 Failed OTA Update

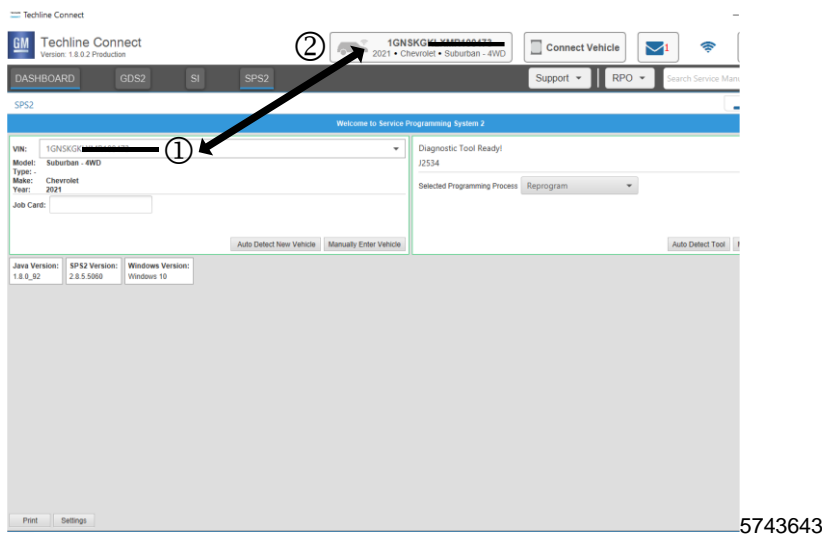
Caution: Be sure the VIN selected in the drop down menu (1) is the same as the vehicle connected (2) before beginning programming.

- For the TLC application, service technicians need to always ensure that the power mode (ignition) is "ON" before reading the VIN from the vehicle's VIN master module and that they do not select a VIN that is already in the TLC application memory from a previous vehicle.
- If the VIN that shows up in the TLC top center window after correctly reading the VIN from the vehicle does not match the VIN plate of the vehicle, manually type in the VIN characters from the vehicle VIN plate into the TLC top center window and use these for programming or reprogramming the subject module with the correct vehicle VIN and software and/or calibrations.

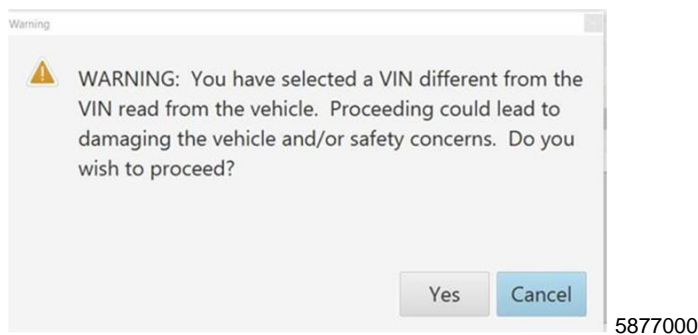
Important: If the vehicle VIN DOES NOT match, the message below will be shown.
