REFERENCE:	TSB: 08-123-25 REV. B GROUP: 08 - Electrical	Date:	July 16, 2025	REVISION:	08-123-25 REV. A
VEHICLES AFFECTED:	2025 (DT) RAM 1500 Pickup This bulletin applies to vehicles built on or after March 15, 2024 (MDH 0315XX) and on or before **October 24, 2024 (MDH 1024XX)** equipped with one of the following radios: <ul style="list-style-type: none"> Uconnect 5 Nav W 12.0" (Sales Code UPQ). Uconnect 5 Nav W 14.4" (Sales Code UPW). 			MARKET APPLICABILITY: <input type="checkbox"/> NA <input checked="" type="checkbox"/> MEA <input type="checkbox"/> SA <input type="checkbox"/> IAP <input type="checkbox"/> EE <input type="checkbox"/> CH NOTE: This bulletin applies to the Middle East and Africa market.	
CUSTOMER SYMPTOM:	Customers may experience the following: <ul style="list-style-type: none"> All lumbar seat controls inoperable. 				
CAUSE:	Radio software

This bulletin involves updating the radio software level from 31.42 to U35.26.

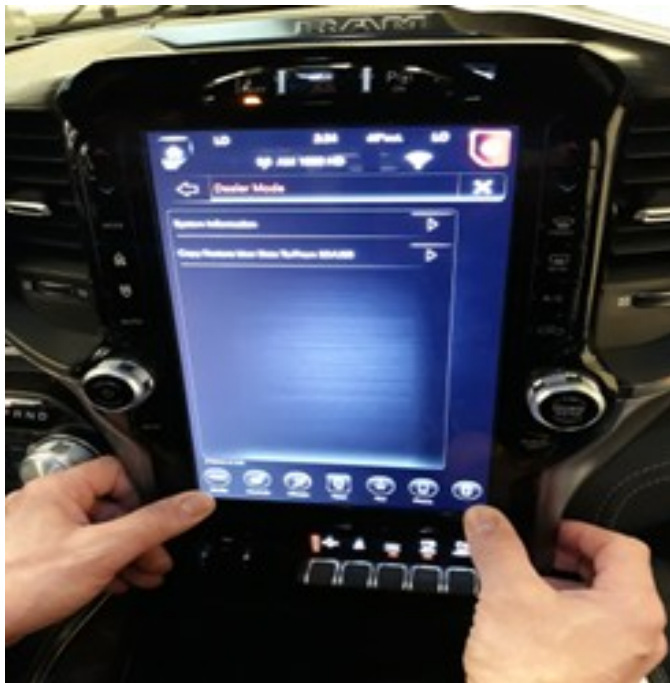
2. Verify if the radio has the latest software already installed by using the radio touch screen and simultaneously place both thumbs on the corners of the touch screen and hold for approximately six seconds or until the “Dealer Mode” screen is displayed [Fig. 1](#).

Fig. 1
Finger Position On Touch Screen

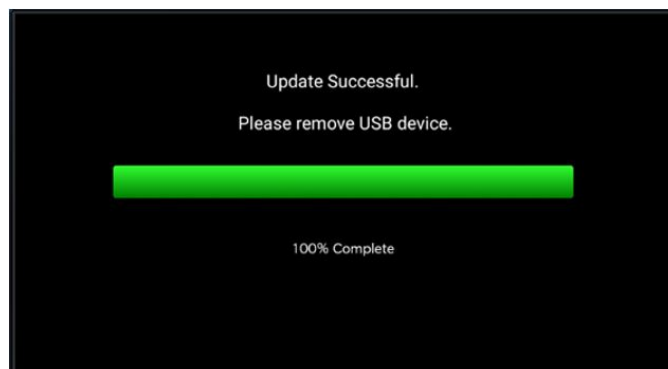
19. The radio will reboot and the software update will begin. The software update should only take 30 minutes Fig. 6.

Fig. 6
Update Successful
