GENERAL MOTORS
DCS 7273
URGENT - DISTRIBUTE IMMEDIATELY

Subject: REVISION: N252500160-01 - Service Update
Future OTA Updates Disabled
Revised Subject Line & Condition and Correction Statements

Models: 2025 Cadillac OPTIQ

N252500160 Future OTA Updates Disabled

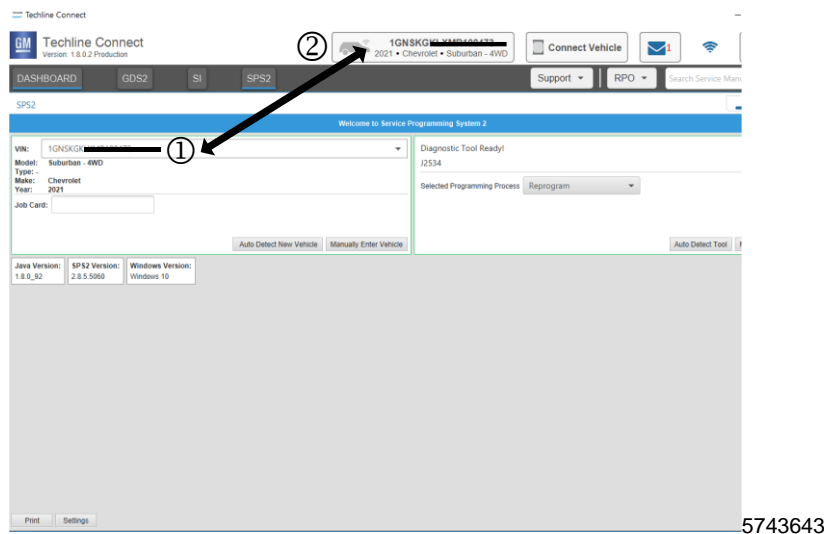
Caution: Be sure the VIN selected in the drop down menu (1) is the same as the vehicle connected (2) before beginning programming.

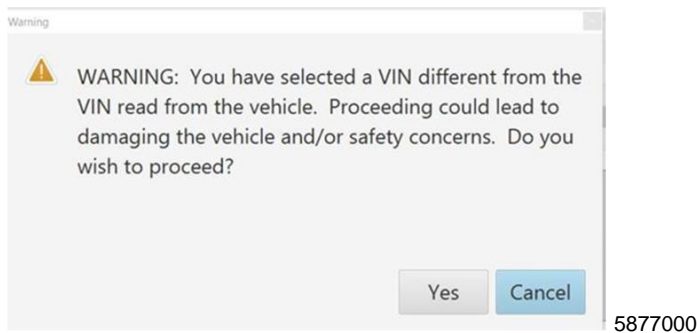
Important: If the vehicle VIN DOES NOT match, the message below will be shown.
