GROUP	MODEL
<b>Voluntary Service Campaign</b>	<b>2024MY Telluride (ON)</b>
NUMBER	DATE
<b>SC344</b>	<b>July 2025</b>

### SMART CRUISE CONTROL SOFTWARE LOGIC IMPROVEMENT (SC344)

This bulletin provides information to upgrade the Smart Cruise Control (SCC) system software on 2024MY Telluride (ON) vehicles produced from May 16, 2023 through September 10, 2024. Due to radar signal interference in certain roadway conditions, the subject vehicles may unnecessarily and momentarily reduce speed when SCC is engaged, accompanied by the illumination of a "Collision Warning" message in the instrument cluster, a warning sound, as well as the activation of the vehicle's brake lights. After the warnings cease, the vehicle will accelerate normally to the SCC set speed. Dealers will upgrade the software logic of the front radar (FR\_RADAR) system to prevent unnecessary reduction in vehicle speed. Refer to [SST081](#) for software upgrade instructions using Kia Diagnostic System (KDS) tablet and VCI-II and confirm the Upgrade Event Number/Name, ROM ID Information, and Manual Mode passwords (if applicable) on the applicable vehicle. Before conducting the procedure, verify that the vehicle is include

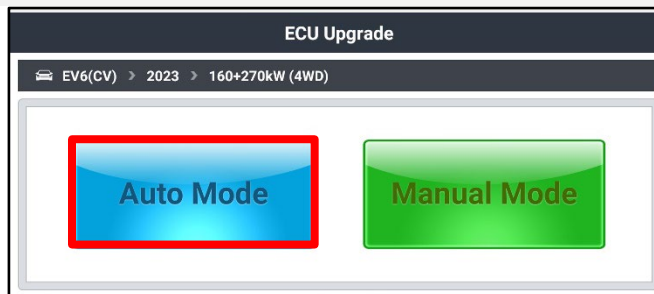
The required software must be installed by selecting the **'Auto Mode'** ECU Upgrade option.

**Note:** In some case, the 'Manual Mode' installation option may be required ONLY if the 'Auto Mode' function fails or is otherwise noted above.

If the automatic upgrade fails, turn the ignition 'OFF' for about 10 seconds then place it back in the 'ON' position to reset the control unit BEFORE performing the manual upgrade.

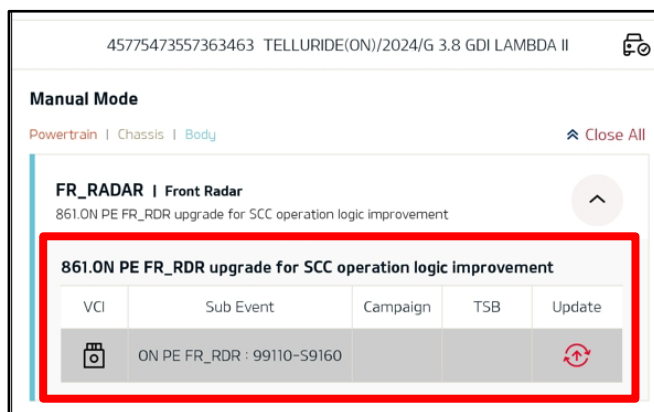
Select the applicable **'FR\_RADAR'** system module and the Event Group.

- 861.ON PE FR\_RDR Upgrade for SCC Operation Logic Improvement

Verify the affected vehicle Calibration Identification of the applicable ECU ROM ID and reference the Information Table on page 3 as necessary.
