Title: Radio Clock is Freezing

Applies To: Next Gen CE Bus

The radio may not change/update the displayed time. The time will stay frozen until a button or dial on the radio is used, and then it will update to the current time. This iKNOW will provide the steps to update the radio software to correct this condition. This applies to Radio part numbers 4275485C91 and 4275486C91.

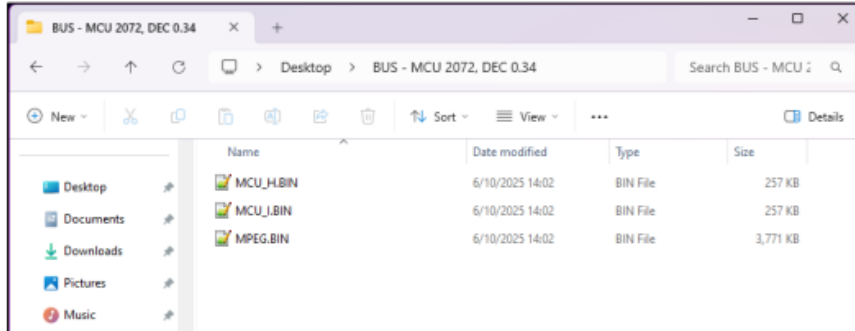
1. Radio software ZIP file ([Click Here](#))
2. Open the .zip folder
3. Extract the folder to your computer desktop. To do this, right-click on the zip file and select "Extract All...". Keep the default settings and select "Extract."
4. Select Desktop and click OK.
5. Once the file is saved. Confirm there are three files in the folder that was created and opened. The three files should be "MCU_H.BIN", "MCU_I.BIN", and "MPEG.BIN". See example below.

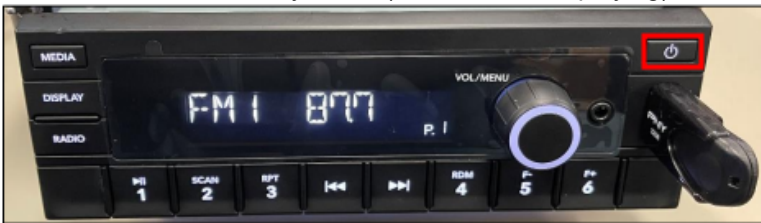
1. Turn the key to Accessory = ON. If the radio is not yet powered on, press the radio power button. Make sure the radio is fully powered on, not in standby mode (ensure audio is playing).

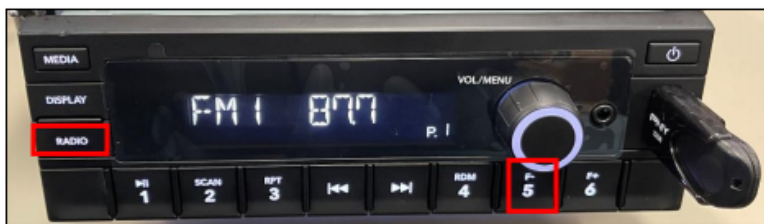
3. Press and hold the "RADIO" and "5" buttons at the same time to access the hidden software menu

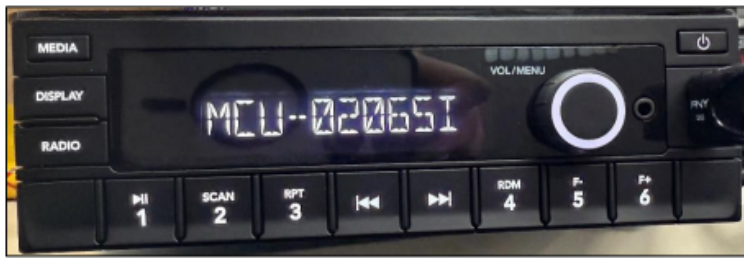
4. The radio will display its current software version on the screen.

Note that you will likely see "MCU—2065H" or "MCU—2065I" on your display.

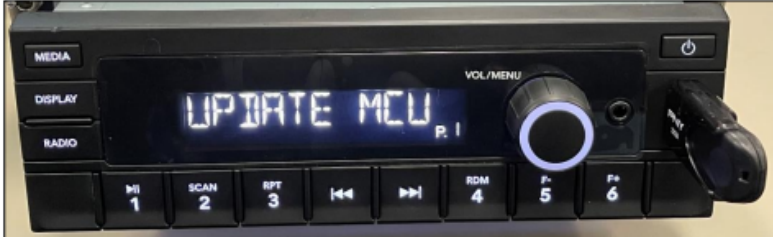
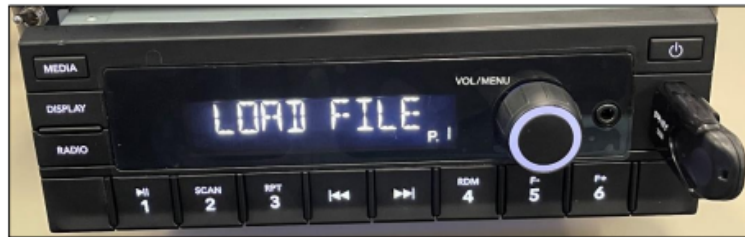
5. Turn the knob until "UPDATE MCU" is displayed. Press down on the knob, and the screen will now say "LOAD FILE". After a few seconds, the radio will automatically start updating.

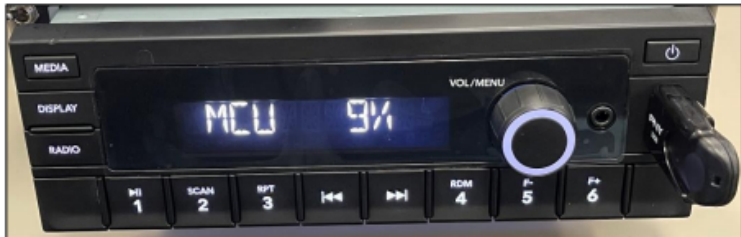
6. The radio is now updating. Wait for the update to finish. Do not power off the radio or remove the USB Flash Drive. When the MCU update is complete, the radio will automatically restart. (Image below is showing at 9% complete)

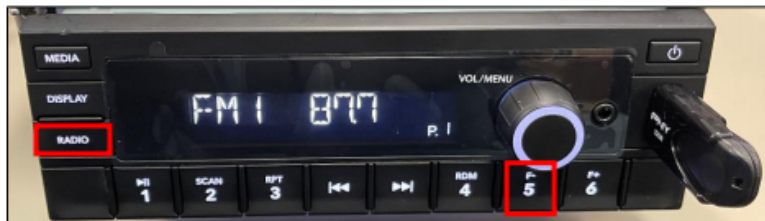
7. After the restart, press and hold the "RADIO" and "5" buttons at the same time to access the hidden software menu again.

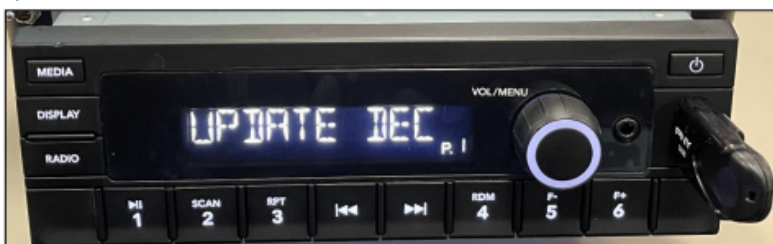
8. Turn the knob to scroll through the options. This time, select "UPDATE DEC". Press down on the knob to begin the DEC update.

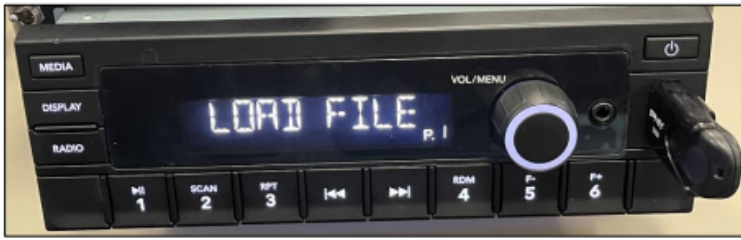
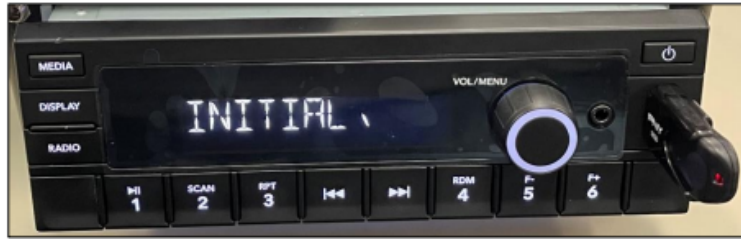
9. The radio will display "LOAD FILE" → "INITIAL" and then begin updating. The time between "LOAD FILE" and "INITIAL" may vary.

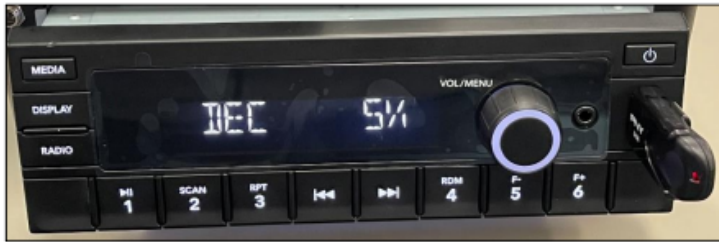
10. The DEC is now updating. Do not power off the radio or remove the USB Flash Drive. When the DEC update is finished, the radio will automatically restart.
(Image below is showing 5% complete)

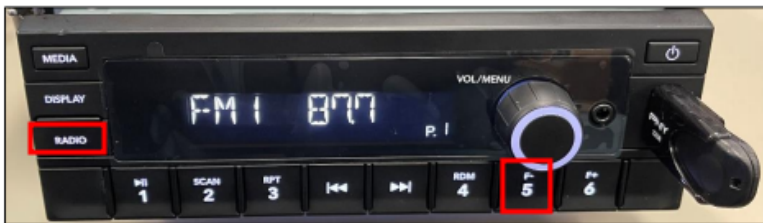
11. After the restart, confirm the radio has successfully updated the MCU and the DEC to the correct versions. Press and hold the "RADIO" and "5" buttons at the same time to access the hidden software menu one more time.

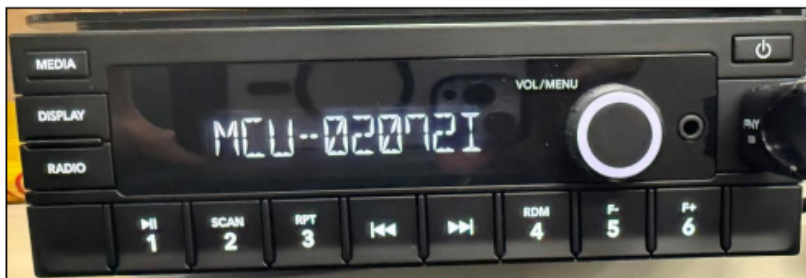
12. Once in the hidden software menu, confirm the screen displays "MCU-02072H" or "MCU02072I".

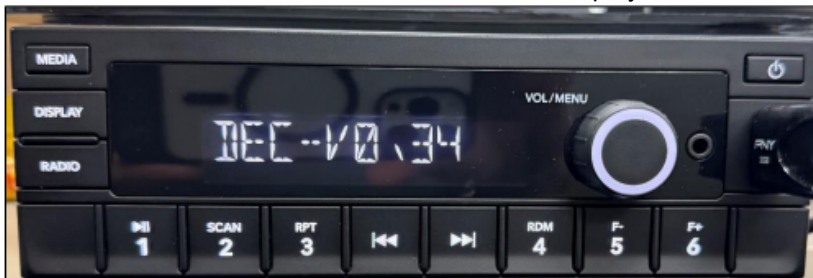
13. Turn the knob once and confirm the screen displays "DEC-V0.34".
