## K73 Telematics Control Module Software Updates #1

Year	Model	Trim Level	VIN Range
2024	ZDX	ALL	ALL

### SYMPTOMS RESOLVED BY FIXES AND ENHANCEMENTS

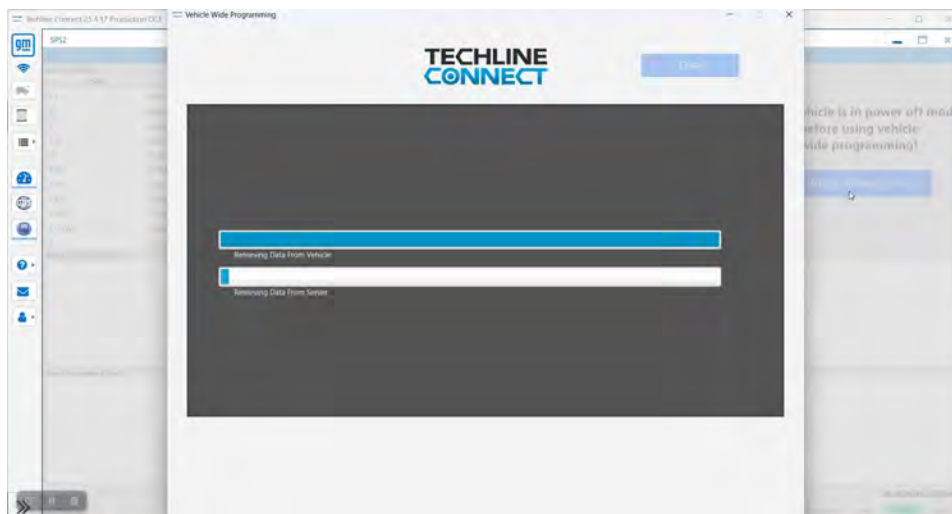
**NOTE:** TLC will automatically compare the software installed on the vehicle against what is available on the server.

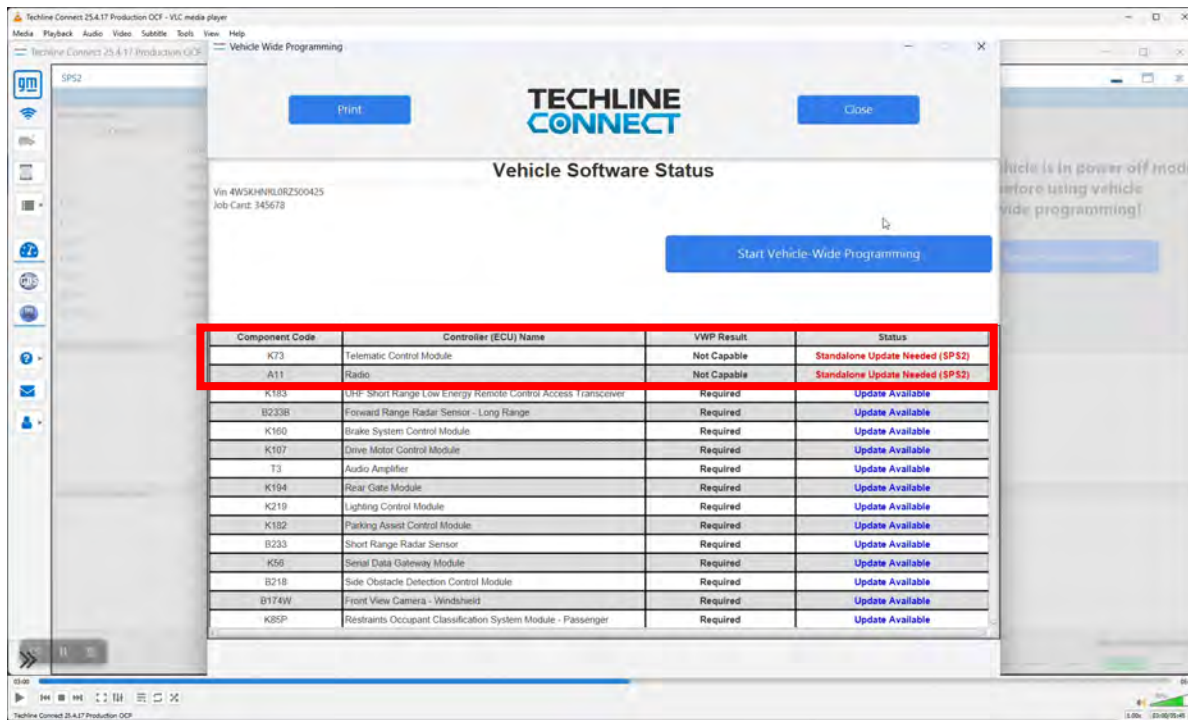
8. Check the vehicle software status. Locate Component Code **K73** with the Controller (ECU) Name **Telematic Control Module**.
  - If the Status column shows “Standalone Update Needed (SPS2)”, click **Close** to exit the Vehicle Software Status and proceed to **Programming Procedure** below.
  - If the Status column shows “Up-to-date”, an update is **NOT** needed. Submit warranty claim for inspection and continue with normal troubleshooting.

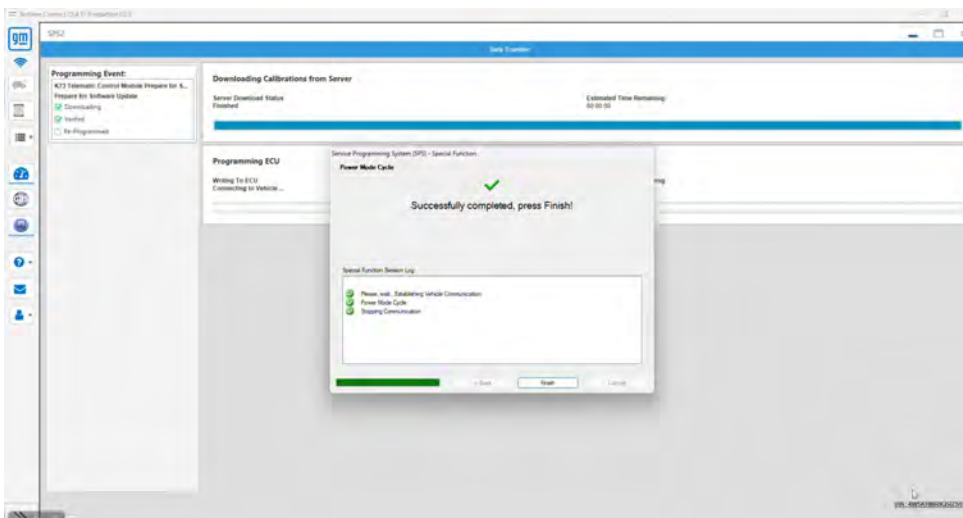
9. Under Select Function Sequence ensure **PREPARE FOR SOFTWARE UPDATE** is selected and click next. This will prepare the Telematic Control Module for the update process. This process can take approximately 2 minutes.
