## Rear Camera Displays Black and White Image

Year	Model	Trim Level	VIN Range
2023–25	CR-V	LX, EX, Sport	ALL

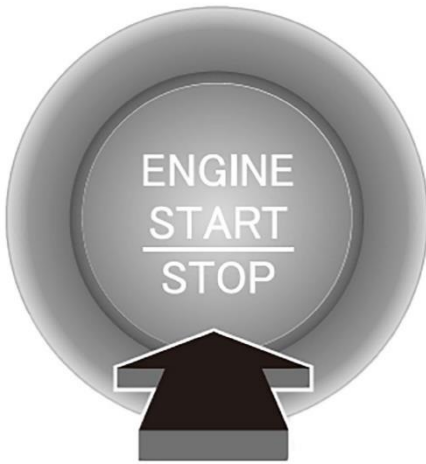
4. Without pressing the brake pedal, push the **ENGINE START/STOP** button to **ON**.

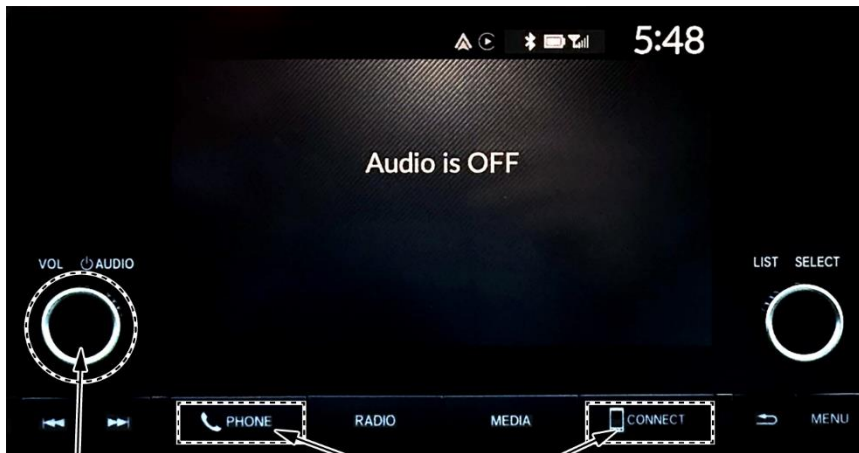
5. With the audio unit turned **OFF**, press the **PHONE** and **CONNECT** buttons at the same time, continue to hold the buttons, then press the **VOL/ AUDIO** knob **5 times** to enter the diagnostic menu.

**VOL/AUDIO KNOB**  
Press 5 times.

**PHONE and CONNECT BUTTONS**  
Press and hold simultaneously.

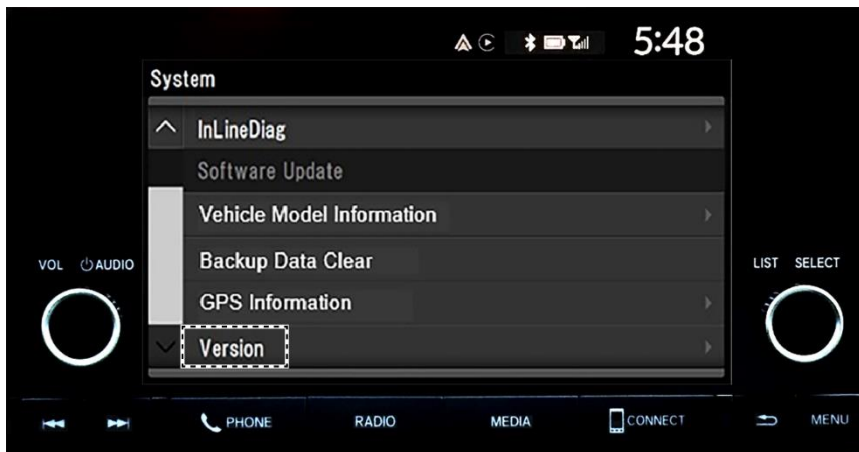
6. Select **System**, then scroll down and select **Version**.

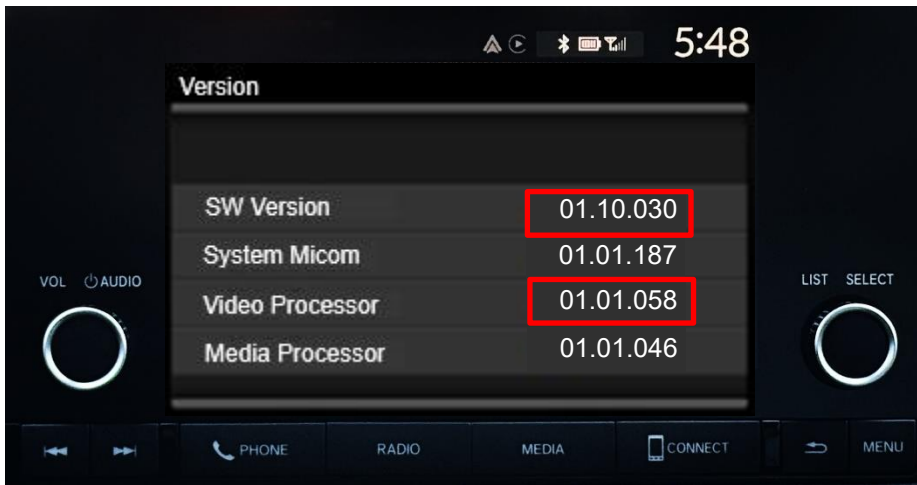
7. Check the audio unit **SW Version** and the **Video Processor** version.

Is the **SW Version** and the **Video Processor** equal to or greater than 01.10.030 and 01.01.058?

- **Yes** - The update has been applied; continue normal troubleshooting.
- **No** - Update the SW Version and Video Processor to the following:
  - Software Version 01.10.**030**
  - Video Processor 01.01.**058**

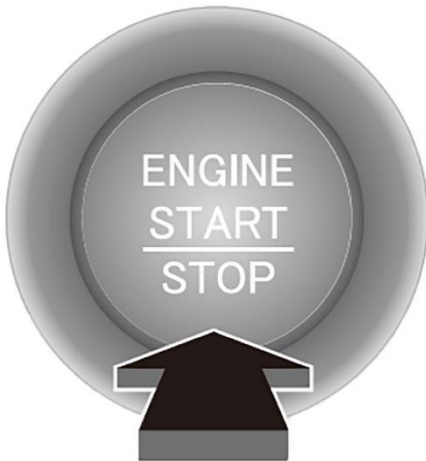
8. Push the **ENGINE START/STOP** button to **OFF**.

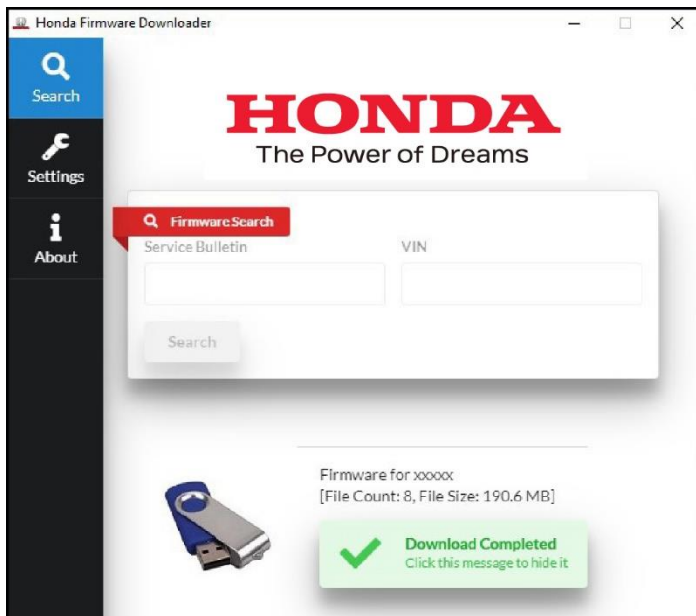
4. Once the download is complete, remove the USB flash drive and return to the vehicle to complete the update.

NOTE: If at any time during the download process a **"TIMEOUT err"** or **"UNDEF err"** message appears on the screen, check the USB flash drive for damage, use a new or different USB flash drive.

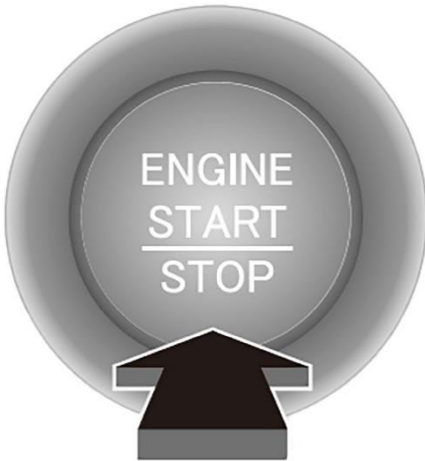
1. Apply the parking brake to keep the headlights off during the update procedure.
2. Without pressing the brake pedal, push the **ENGINE START/STOP** button to **ON**.

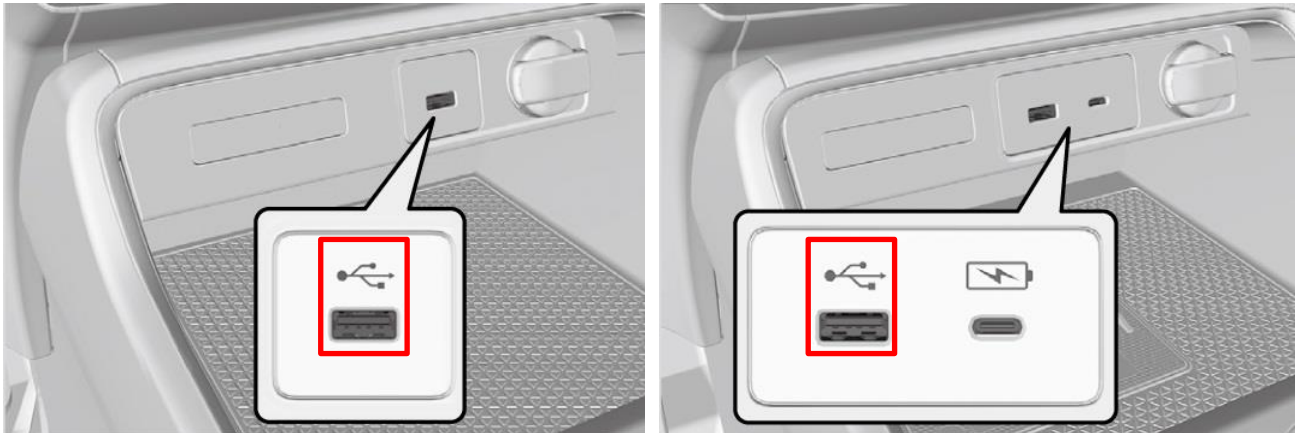
### USB-A Data Port

3. Insert the USB flash drive into the USB data port.

- Make sure there are no devices connected to the front and rear (if equipped) USB ports. (USB flash drive, Smartphone, etc.)
- Connect the power supply to the vehicle, leave it connected during the entire update procedure to maintain constant voltage.

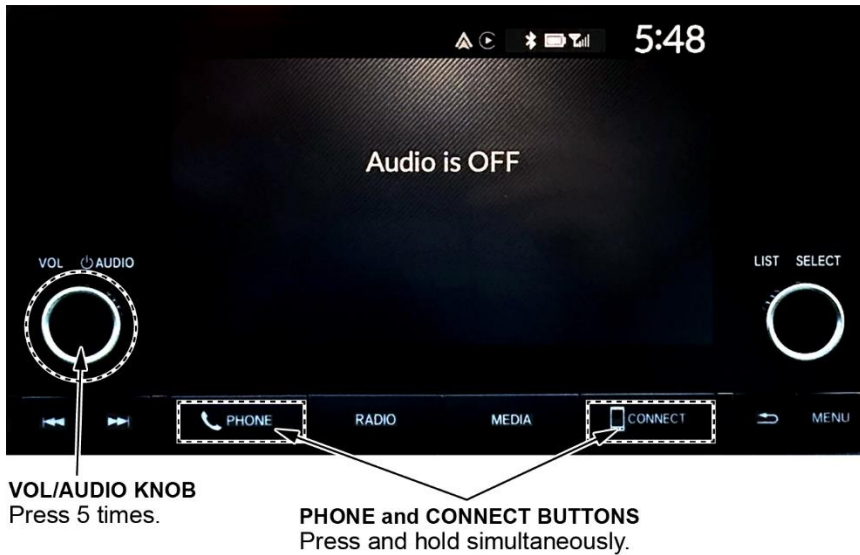
4. With the audio unit turned **OFF**, press the **PHONE** and **CONNECT** buttons at the same time, continue to hold the buttons, then press the **VOL/ AUDIO** knob **5 times** to enter the diagnostic menu.

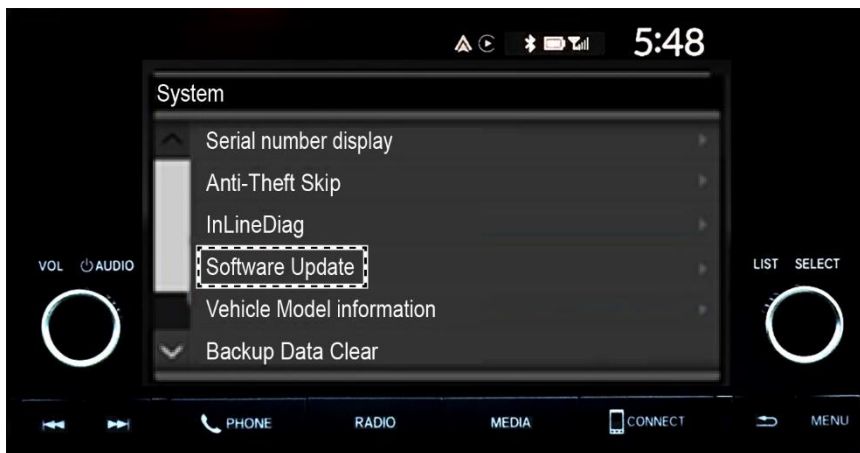
5. Select **System**, then scroll down and select **Software Update**.

NOTE: If the **Software Update** selection is grayed out, make sure the USB flash drive is fully inserted and in the USB data port, **not** the USB charging port.

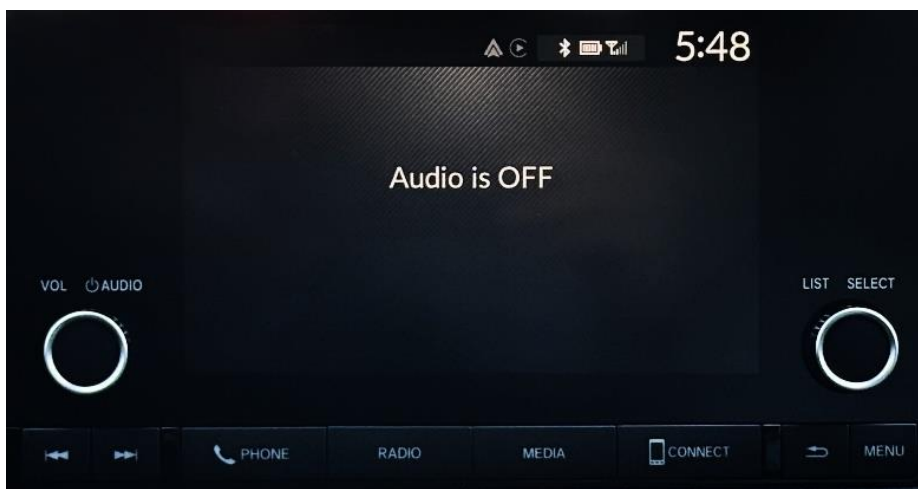
2. After the update is complete the unit will automatically reboot to **Audio is OFF** mode.

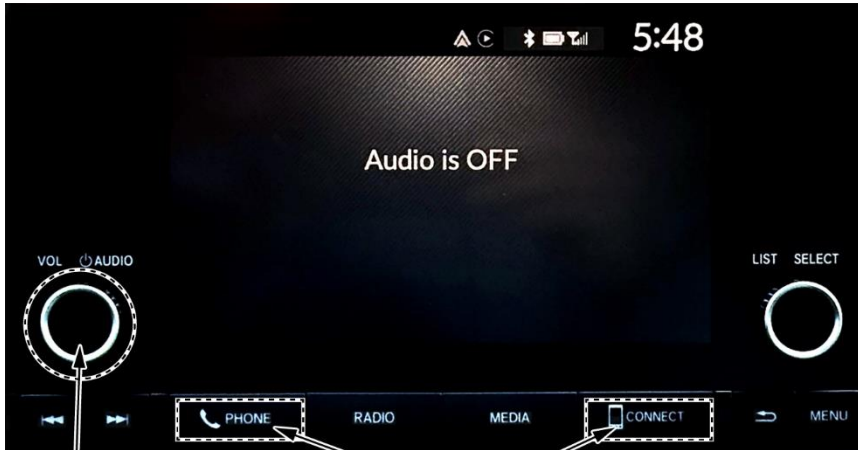
1. With the audio unit turned **OFF**, press the **PHONE** and **CONNECT** buttons at the same time, continue to hold the buttons, then press the **VOL/ AUDIO** knob **5 times** to enter the diagnostic menu.

**VOL/AUDIO KNOB**  
Press 5 times.

**PHONE and CONNECT BUTTONS**  
Press and hold simultaneously.

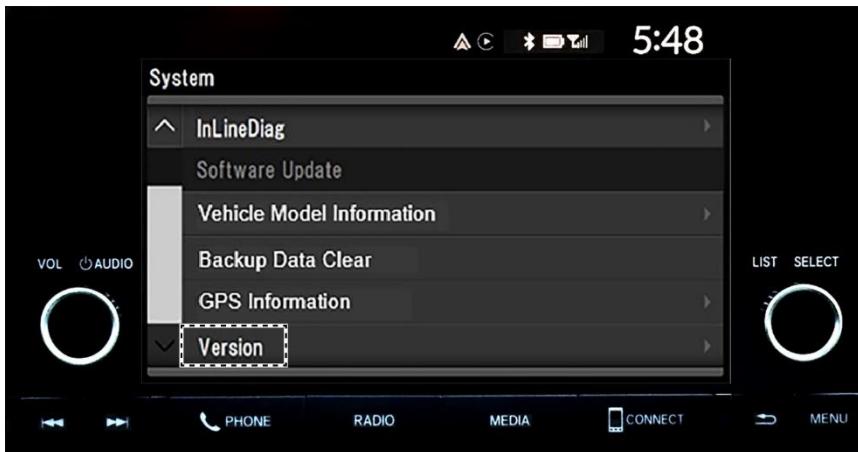
2. Select **System**, then scroll down and select **Version**.

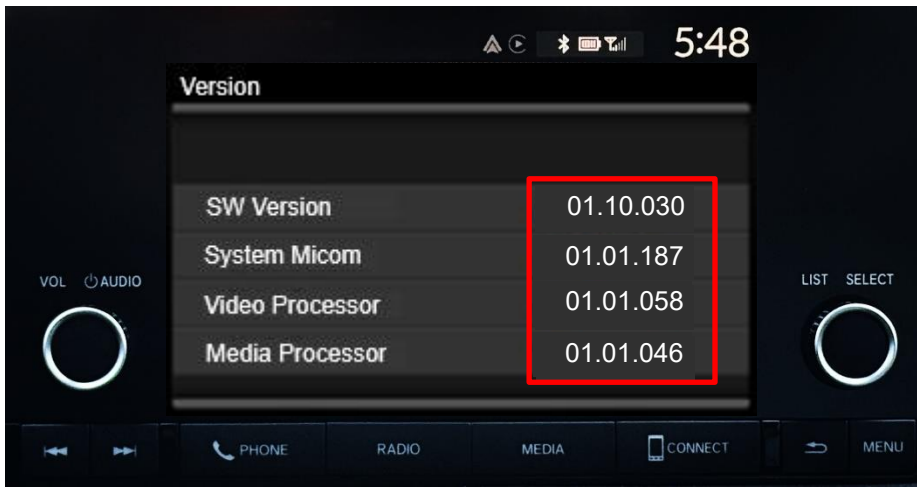
3. Confirm the software versions match the table below.
