Rear Camera Displays Black and White Image

Year	Model	Trim Level	VIN Range
2023–25	HR-V	LX, Sport	ALL

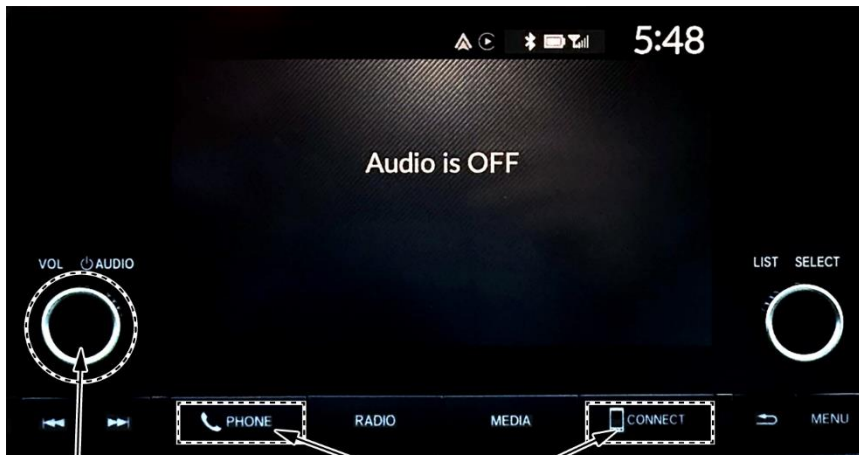
5. With the audio unit turned **OFF**, press the **PHONE** and **CONNECT** buttons at the same time, continue to hold the buttons, then press the **VOL/ AUDIO** knob **5 times** to enter the diagnostic menu.

VOL/AUDIO KNOB
Press 5 times.

PHONE and CONNECT BUTTONS
Press and hold simultaneously.

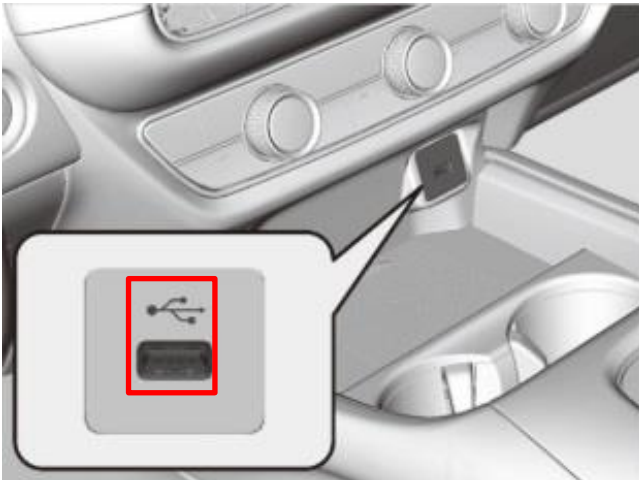
USB-A Data Port

3. Insert the USB flash drive into the USB data port.

- Make sure there are no devices connected to the front and rear (if equipped) USB ports. (USB flash drive, Smartphone, etc.)
- Connect the power supply to the vehicle, leave it connected during the entire update procedure to maintain constant voltage.

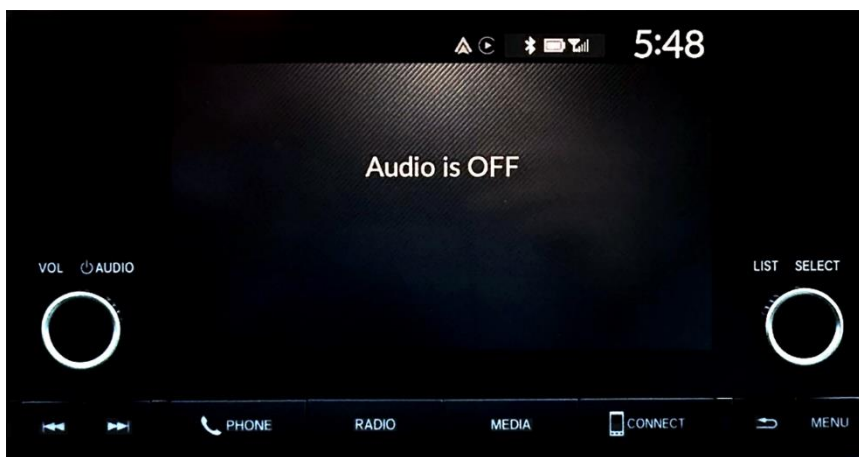
2. After the update is complete the unit will automatically reboot to **Audio is OFF** mode.
