August 13, 2025

Rear Camera Displays Black and White Image

Year	Model	Trim Level	VIN Range
2023–25	Pilot	LX, Sport	ALL

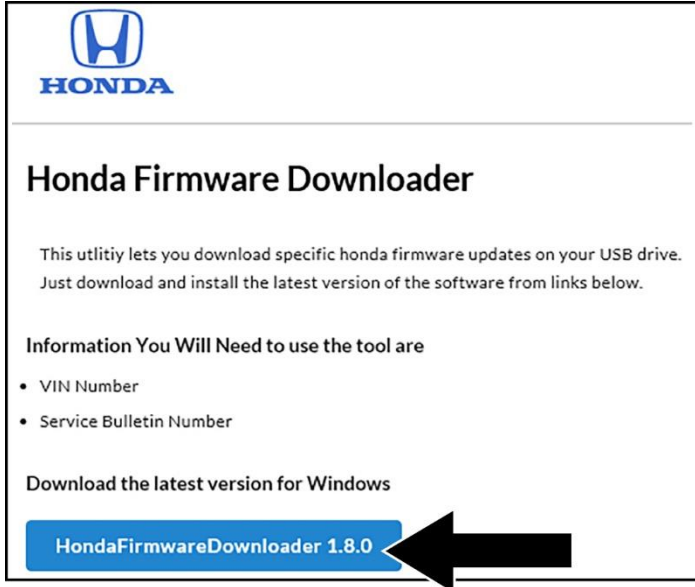
1. From your computer, select and open the *Honda Firmware Downloader*. Make sure to use a blank/empty USB flash drive that is formatted to **FAT32**. Refer to the Job Aid: [Honda Firmware Downloader](#) for additional information.

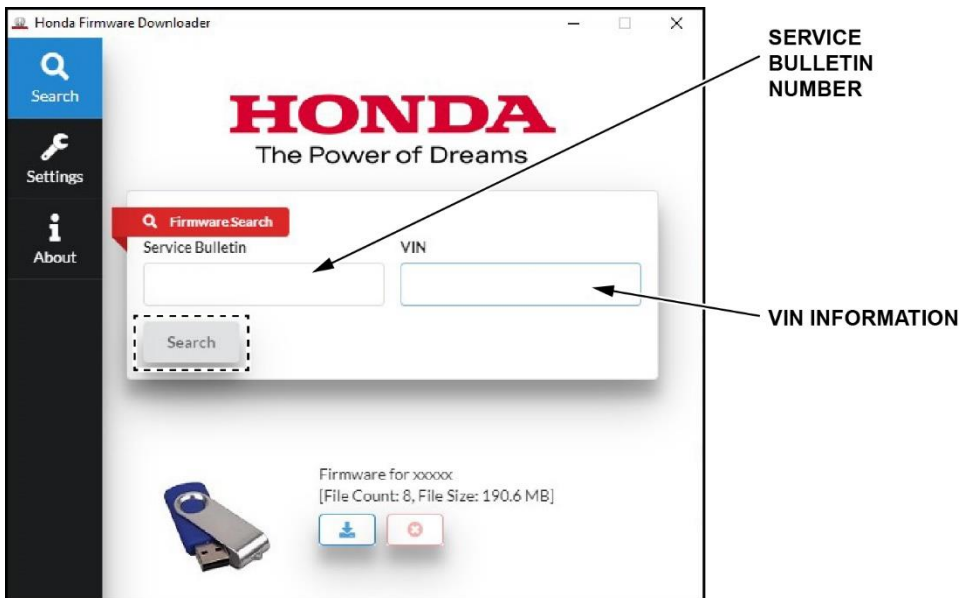
2. Refer to the corresponding service bulletin that directs you to use the Honda Firmware Downloader. Enter the service bulletin number and the VIN, then press **Search**. The system will provide the available software update version.

NOTE: The VIN field letters must be entered in CAPS.

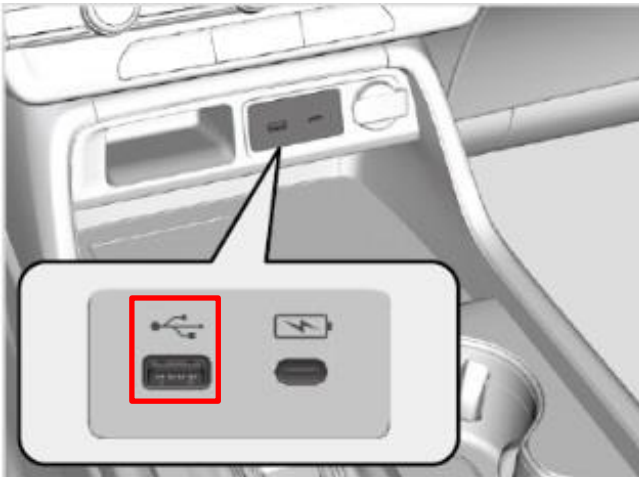
USB-A Data Port

3. Insert the USB flash drive into the USB data port.

- Make sure there are no devices connected to the front and rear (if equipped) USB ports. (USB flash drive, Smartphone, etc.)
- Connect the power supply to the vehicle, leave it connected during the entire update procedure to maintain constant voltage.

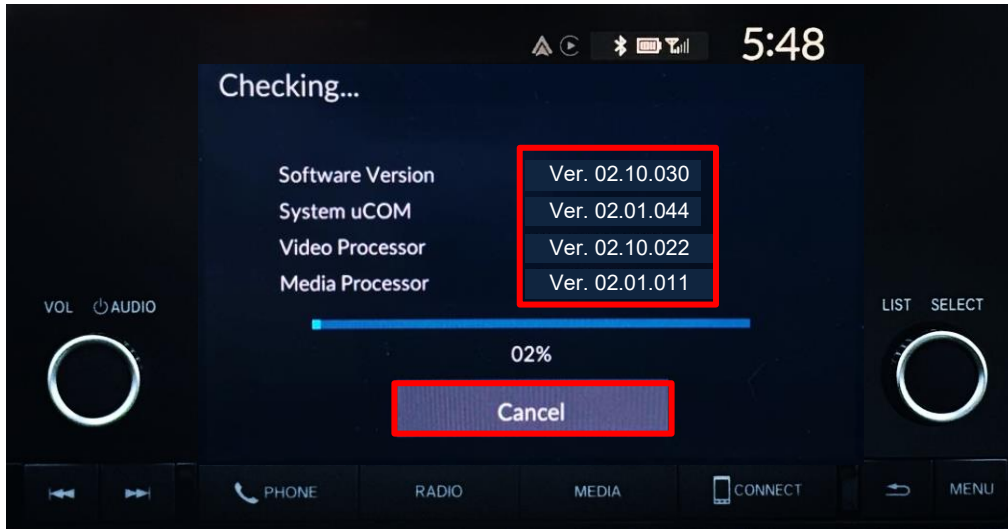
EXAMPLE: Incorrect Software

1. During the software “Checking” stage, it is important to confirm the software information on the screen matches the software table.
2. If the information does not match the table below, immediately press **CANCEL**. The update file on the USB flash drive **does not** apply to this vehicle. Confirm that you have downloaded the correct file for the vehicle model/trim you are working on.
