Technical Service Bulletin (TSB)
R1H Radio T27.38 USB Software Update

REFERENCE:	TSB: 08-271-25 GROUP: 08 - Electrical	Date:	August 20, 2025	REVISION:	–
VEHICLES AFFECTED:	2023 (WL) Jeep Grand Cherokee / Grand Cherokee L This bulletin applies to vehicles built on or after October 09, 2020 (MDH 1009XX) and on or before September 30, 2024 (MDH 0930XX) equipped with Uconnect 5 Nav w 10.1" Display (CHN) (Sales Code UQN).			MARKET APPLICABILITY: <input type="checkbox"/> NA <input type="checkbox"/> MEA <input type="checkbox"/> SA <input type="checkbox"/> IAP <input type="checkbox"/> EE <input checked="" type="checkbox"/> CH NOTE: This bulletin applies to the China market.	
CUSTOMER SYMPTOM:	The following software enhancements are available: <ul style="list-style-type: none"> • Virtual wall radio setting is back. • Fix for difficulty playing music through QQ Music. • Corrected installation error reported in the past for Macintosh App. • Improvement in navigation.

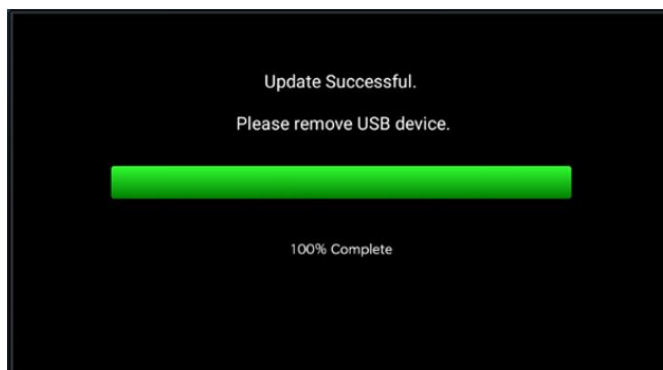
15. The radio will reboot and the software update will begin. The software update should only take 30 minutes [Fig 5](#).

Fig. 5
Update Successful
