HYUNDAI

Technical Service Bulletin

GROUP CAMPAIGN	NUMBER 25-01-057H
DATE AUGUST 2025	MODEL(S) SEE BELOW

SUBJECT: DCU SOFTWARE UPDATE
(SERVICE CAMPAIGN TDF)

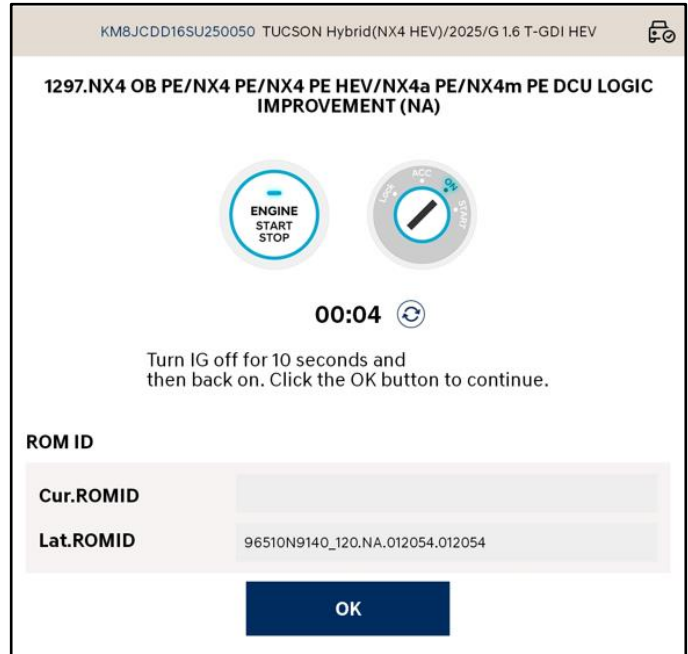
- After the ECU update process shows 100% complete, follow the prompts on the screen to cycle the ignition **OFF** for at least **10 seconds** to reset the control unit (certain models may take up to **30 seconds**).

Use the **Refresh** button to reset the timer.

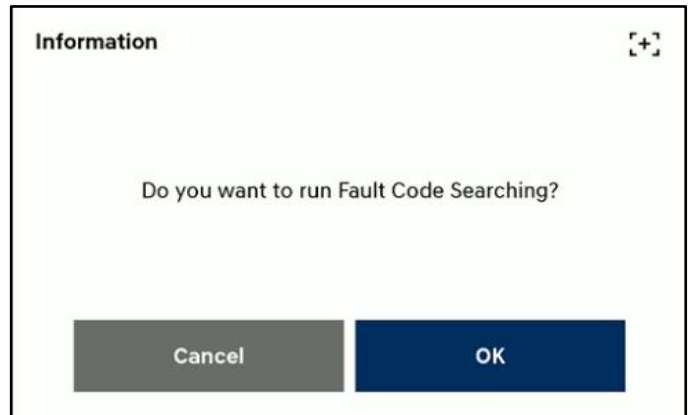
6. Perform an **All Systems Fault Code** search and erase DTC history that had incidentally occurred from the ECU update.
