Technical Service Bulletin

GROUP	NUMBER
CAMPAIGN	25-01-057G
DATE	MODEL(S)
AUGUST 2025	G80 (RG3)

SUBJECT: DCU SOFTWARE UPDATE
(SERVICE CAMPAIGN T73G)

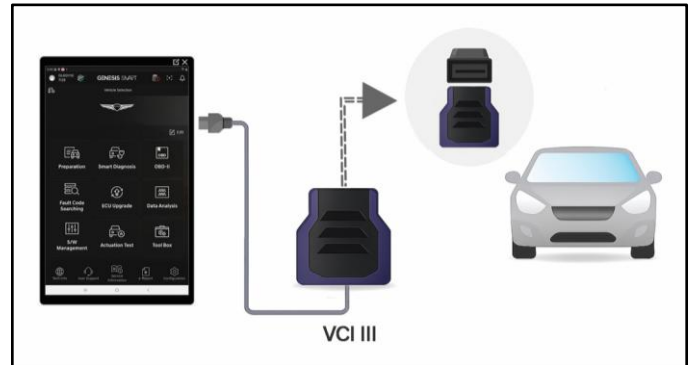
1. Connect the Ethernet Communication Interface (ECI) DLC cable to the OBD connector of the vehicle.
2. Connect the VCI DLC cable to the ECI.
3. Select the appropriate tablet cable (type C, 5-pin) to the ECI.
4. Connect the cable to the tablet PC.

Refer to **TSB 23-GI-005G** for detailed information on configuring Ethernet communication for setup.

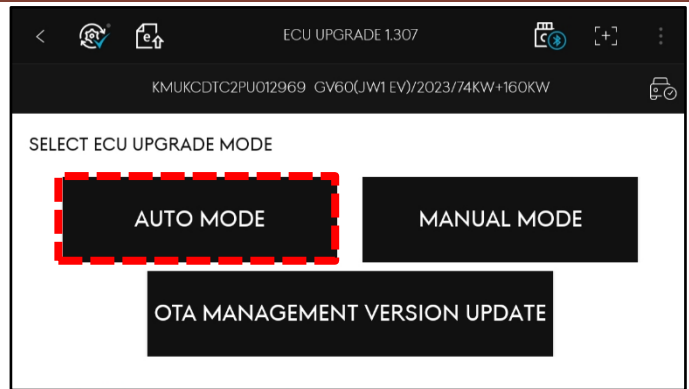
1. Perform the ECU update in **Auto Mode**.

Refer to **TSB # 24-GI-016G**, “**ECU Update Procedure for Tablet-Based Genesis Smart**”, for additional information.

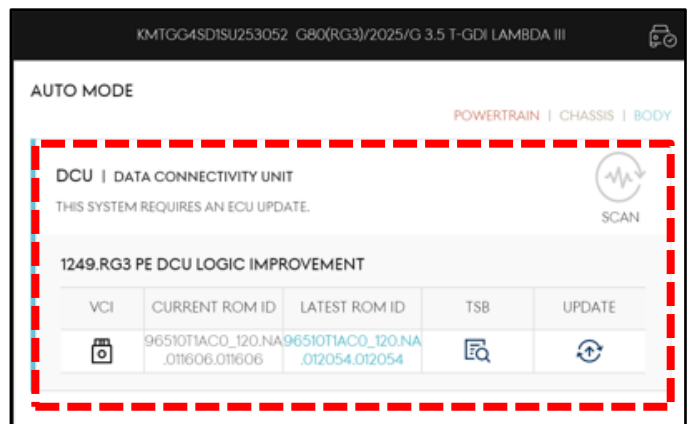
2. Verify the ROM ID by selecting the **DCU** system to scan the vehicle’s current ROM ID.

Check the current ROM ID version and compare it to the ROM ID Information table before attempting to perform the software update.

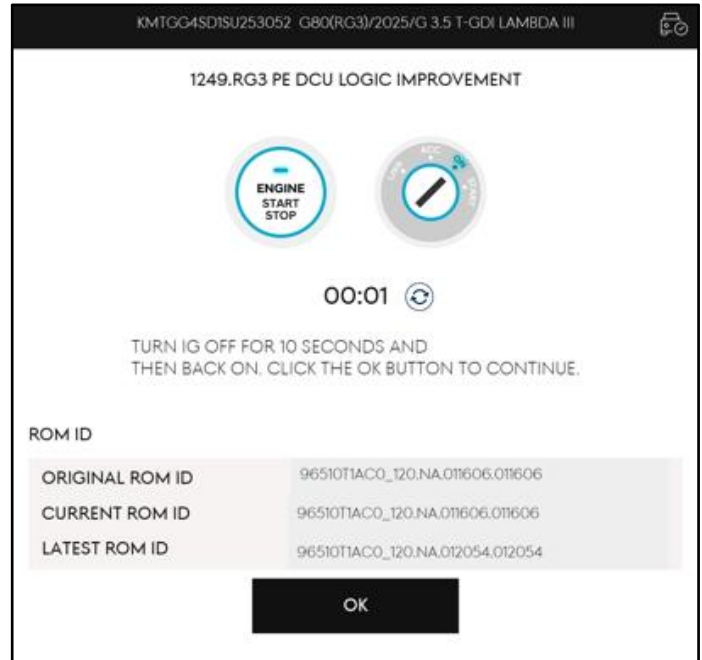
- After the ECU update process shows 100% complete, follow the prompts on the screen to cycle the ignition **OFF** for at least **10 seconds** to reset the control unit (certain models may take up to **30 seconds**).

Use the **Refresh** button to reset the timer.

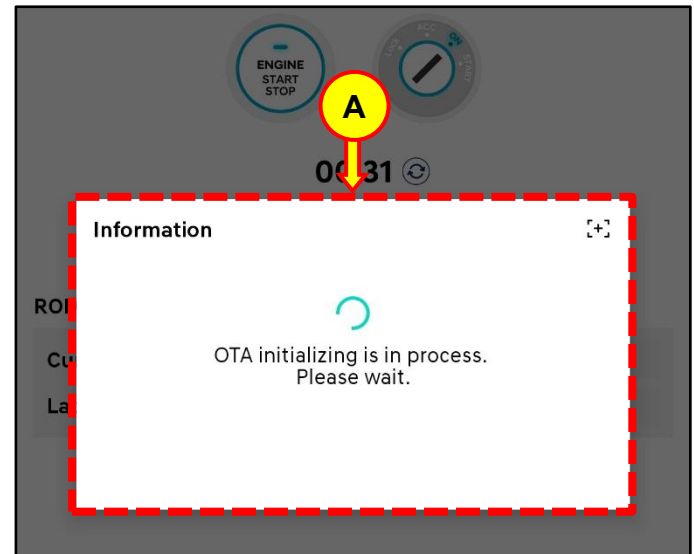
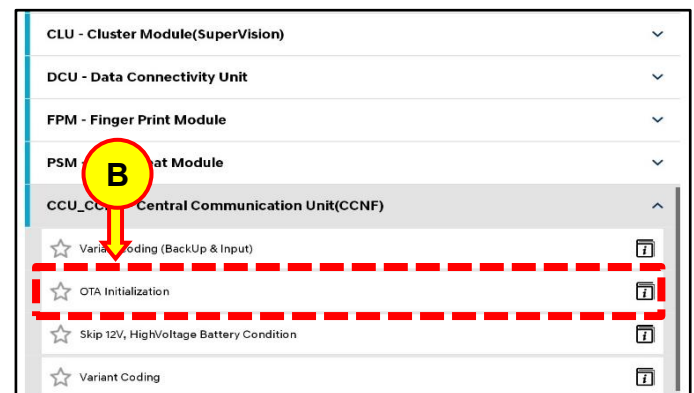
- OTA initialization (A) should perform automatically:
 - If OTA initialization performs automatically, then proceed with the service procedure.
 - If the OTA initialization process fails, complete it manually under: **S/W Management > CCU_CCNF - Central Communication Unit (CCNF) > OTA Initialization (B)**.

Follow the instructions on the screen.

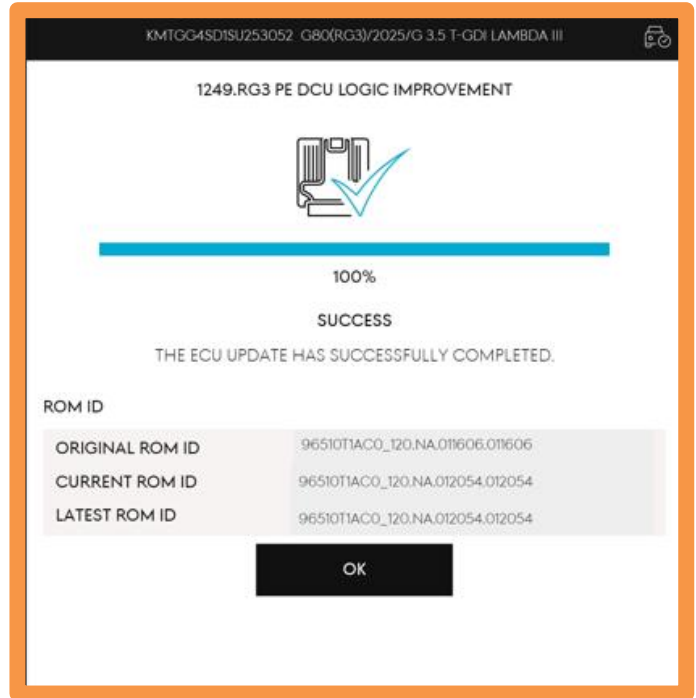
Take a screenshot of the ECU update Success screen using your tablet and upload to STUI.

NOTE 3: This TSB includes repair validation photos. Op times include VIN, mileage, and photo capture of the ECU Update "Success" screen as outlined in the Digital Documentation Policy.

This TSB includes repair validation photos. Refer to the latest Warranty Digital Documentation Policy for requirements.

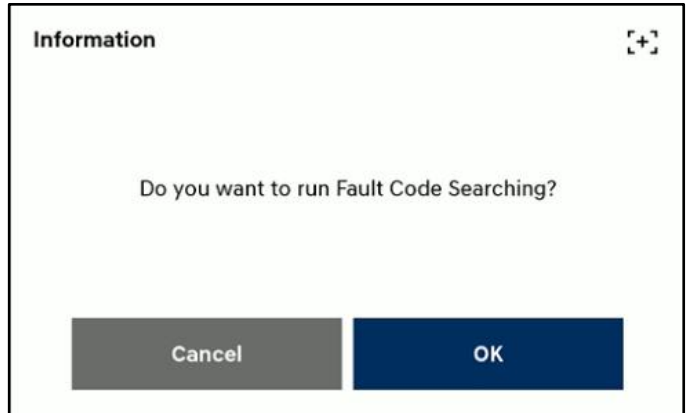
6. Perform an **All Systems Fault Code** search and erase DTC history that had incidentally occurred from the ECU update.
