REFERENCE:	TSB: 08-191-25 REV. A GROUP: 08 - Electrical	Date:	August 27, 2025	REVISION:	08-191-25
VEHICLES AFFECTED:	2024 (LB) Dodge Charger **This bulletin applies to vehicles equipped with a: <ul style="list-style-type: none"> • Drive eXperience Recorder (Sales Code JFC). • Drive eXperience Recorder Prep (Sales Code JGB). • Uconnect 5 Nav W 12.3" Display (USA) (Sales Code UBX). • Uconnect 5 Nav W 12.3" Display (CAN) (Sales Code UEX).** 			MARKET APPLICABILITY: <input checked="" type="checkbox"/> NA <input type="checkbox"/> MEA <input type="checkbox"/> SA <input type="checkbox"/> IAP <input type="checkbox"/> EE <input type="checkbox"/> CH NOTE: This bulletin applies to the North America market.	
CUSTOMER SYMPTOM:	Customers must experience a Malfunction Indicator Lamp (MIL) illumination and the vehicle must exhibit/set one or more of the following Diagnostic Trouble Codes (DTCs): <ul style="list-style-type: none"> • B023C-49 - Dashcam Module 1-Internal Electronic Failure. • U115C-00 - Lost Communication With ETM. The customer may describe the following: <ul style="list-style-type: none"> • Blinking odometer (remains accurate).

CAUSE:	Radio software

This bulletin involves inspecti

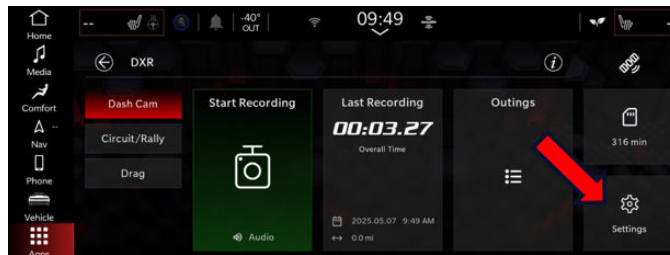
Fig. 4
Settings

- 7. Click the Settings button to open the settings menu [Fig. 4](#).

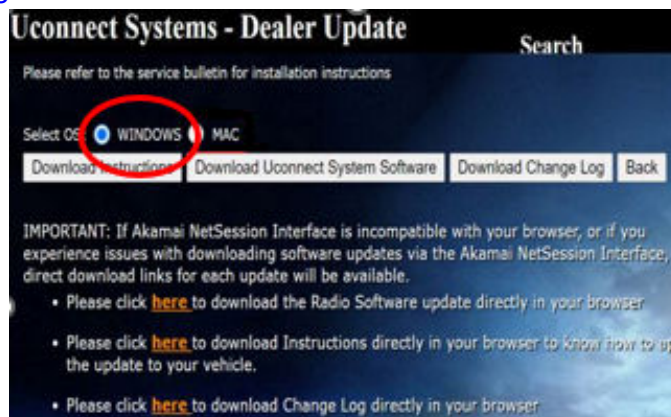
Fig. 8

15. Download the software update file to your local PC's desktop. Make sure to select the “WINDOWS” radial button for all downloads [Fig. 8](#).

WINDOWS Download Steps
