Technical Service Bulletin (TSB)
DXR USB Update to v1.4.160 For MIM Radio

REFERENCE:	TSB: 08-192-25 REV. A GROUP: 08 - Electrical	Date:	August 28, 2025	REVISION:	08-192-25
VEHICLES AFFECTED:	2025 (LB) Dodge Charger **This bulletin applies to vehicles equipped with a: <ul style="list-style-type: none"> • Drive eXperience Recorder (Sales Code JFC). • Drive eXperience Recorder Prep (Sales Code JGB). • Uconnect 5 Nav W 12.3" Display (USA) (Sales Code UBX). • Uconnect 5 Nav W 12.3" Display (CAN) (Sales Code UEX).** 			MARKET APPLICABILITY: <input checked="" type="checkbox"/> NA <input type="checkbox"/> MEA <input type="checkbox"/> SA <input type="checkbox"/> IAP <input type="checkbox"/> EE <input type="checkbox"/> CH NOTE: This bulletin applies to the North America market.	
CUSTOMER SYMPTOM:	Customers must experience a Malfunction Indicator Lamp (MIL) illumination and the vehicle must exhibit/set one or more of the following Diagnostic Trouble Codes (DTCs): <ul style="list-style-type: none"> • B023C-49 - Dashcam Module 1-Internal Electronic Failure. • U115C-00 - Lost Communication With ETM. The customer may describe the following: <ul style="list-style-type: none"> • Blinking odometer

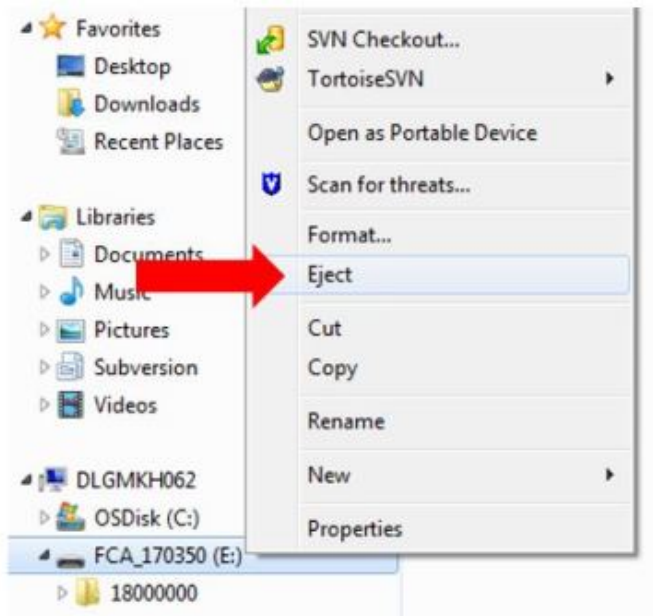
Fig. 9

- 19. Perform the following steps to properly eject the USB flash drive [Fig. 9](#):
 - a. Right click on the location of the USB flash drive.
 - b. Click “Eject” to avoid data corruption.
 - c. Remove the USB flash drive from the PC.

Ejecting The USB Flash Drive
