Service Alert

Subject: MYMAZDA APP CONNECTED VEHICLE ERROR CODE DESCRIPTION AND RECOVERY INFORMATION	Service Alert No.: SA-009/25
	Last Issued : 08/22/2025

Some customers may experience a Connected Vehicle failure. The MyMazda App may display an Error Code. This document provides Error Code description and recovery information to assist with repairs.

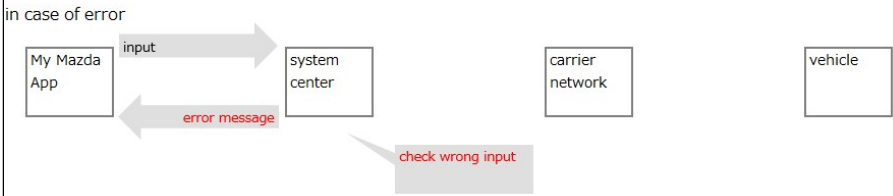
<p>in case of error</p>

Dealer	Go to Vehicle Confirmation Instructions .
400C05	Description	Occurs when there is no data matching the conditions during processing (ex. inbox update process)	
	MyMazda App Message	Please check the input and try again. [400C05]	
	Process Flow	<p>normal flow</p>

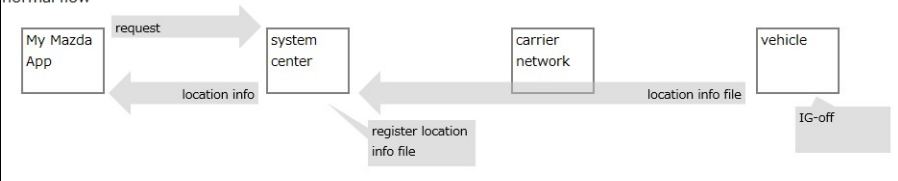
Process Flow	<p>normal flow</p>

• If the information file cannot be sent to the system center when IG-off, the vehicle status may not be updated.
		Dealer	Follow the Vehicle Confirmation Instructions .
400S06	Description	This occurs when location information cannot be obtained when logging in, performing a service that obtains location information, such as displaying a map or Vehicle Finder. Main factorsThe signal condition at the parking place is poor.	
	MyMazda App Message	The location data is not available. [400S06]	
	Cause	The signal condition at the parking place is poor. Occurs in the case of specific conditions of in-vehicle data.

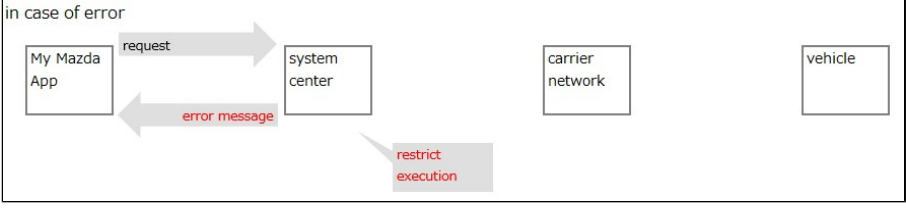
<p>in case of error</p>

Dealer	Follow the Vehicle Confirmation Instructions .	
400S07	Description	It occurs if code generation for authentication is locked temporarily.	
	MyMazda App Message	N/A	
	Cause	Passcode generation is temporarily locked.	
	Process Flow	<p>normal flow</p>

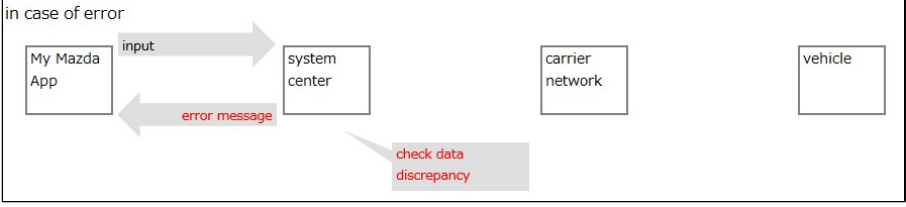
<p>in case of error</p>

Confirmation/Recovery	Customer	Wait at least 60 minutes and try again.	
	Dealer	If the error continues to occur, there may be a problem with the system center -> Go to " Troubleshooting Instructions ".	
400S08	Description	This occurs when the OTP expiration time (10 minutes) has expired. *OTP = one time passcode	
	MyMazda App Message	N/A	
	Process Flow	<p>normal flow</p>

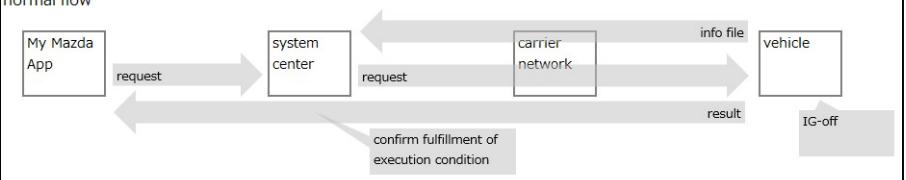
<p>If Remote Engine Start is used, the engine will stop running automatically after 15 minutes for safety, security and emissions. Remote Engine Start can only be used 2 consecutive times while the vehicle is not driven. After the vehicle has been driven, the use count is reset.</p>
	Cause	Exceeded the number of times the remote engine start.
	Process Flow	<p>normal flow</p>

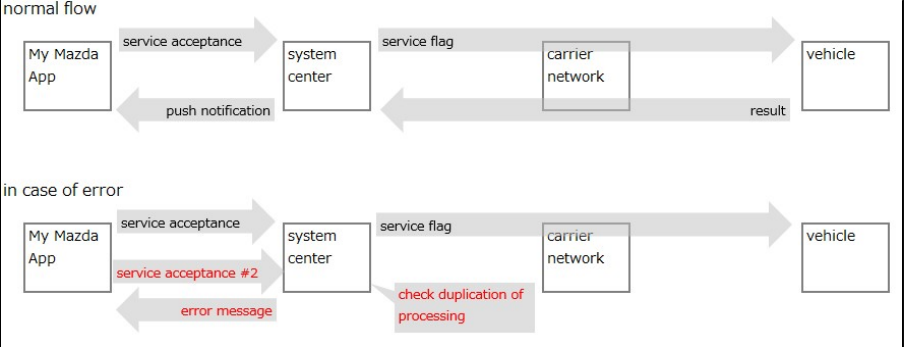
<p>If the information file cannot be sent to the center when IG-off, the vehicle status may not be updated.</p>
<p>400S12</p>	<p>Description</p>	<p>This occurs when a request is accepted again during the contract/ cancellation process for a connected service.</p>	
	<p>MyMazda App Message</p>	<p>"The enrollment process may take a few minutes. Once it is completed, you will be notified in the MyMazda app. Thank you for your patience. [400S12]"</p>	
	<p>Cause</p>	<p>Enrollment request is being processed.</p>	
	<p>Process Flow</p>

<pre> graph LR subgraph "normal flow" MA[My Mazda App] -- service acceptance --> SC[system center] SC -- service flag --> CN[carrier network] CN -- result --> V[vehicle] V -- push notification --> MA end subgraph "in case of error" MA -- service acceptance --> SC SC -- service acceptance #2 --> SC SC -- error message --> MA SC -- check duplication of processing --> SC SC -- service flag --> CN CN --> V end </pre>

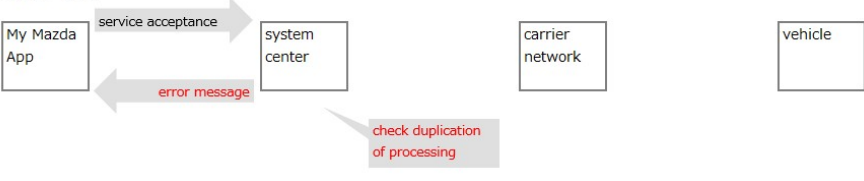
<p>in case of error</p>

Cause	Enrollment processing has already been completed.	
	Process Flow	<p>normal flow</p>

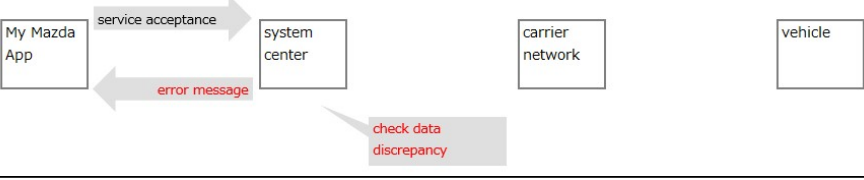
<p>in case of error</p>

Confirmation/Recovery	Customer	If the "ENROLL" button continues to be displayed, sign out and log in again.
		Dealer	If the error continues to occur, there may be a problem with the system center. -> Go to " Troubleshooting Instructions ".
400S14	Description	This occurs when either the date of initial registration or the vehicle registration number cannot be obtained.	
	Cause	Registration of vehicle information is incomplete.	
	Process Flow	<p>normal flow</p>

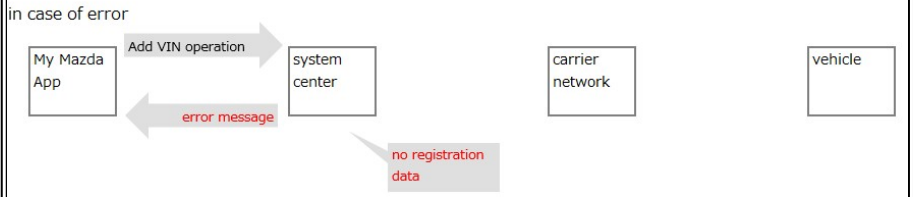
<p>in case of error</p>

Dealer	Follow the Vehicle Confirmation Instructions .
400S17	Description	This issue occurs when performing Add VIN on a vehicle that does not have a connected contract (occurs only for destinations that do not have a function that supports vehicle identification).	
	MyMazda App Message	N/A	
	Cause	Target vehicle is not eligible for CV service	
	Process Flow	<p>normal flow</p>

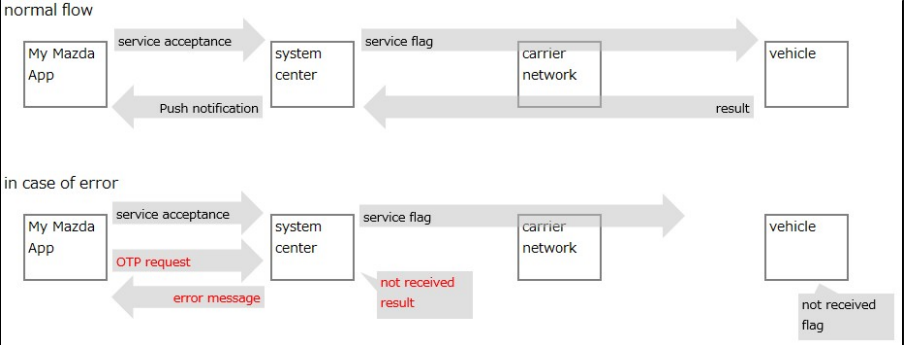
<p>18PF OPENING COMMUNICATION LINE HAS NOT BEEN COMPLETED (OTP request before line opening completed)</p>
	Cause	TCU replacement during OTP process In-Vehicle WiFi Contract interference	
	Process Flow

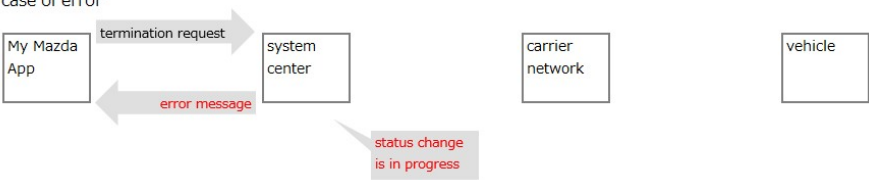
<p>in case of error</p>

<p>Error</p> <p>Please wait for a while and try again. If the error error continues, please contact the call center. (400S21)</p> <p>OK</p>	<p>CV cancelation has failed. Update TCU to the latest software.</p>
	<p>Cause</p>	<p>TCU replaced during TCU cancellation process Active In-Car WiFi contract</p>	
	<p>Process Flow</p>	<p>normal flow</p>

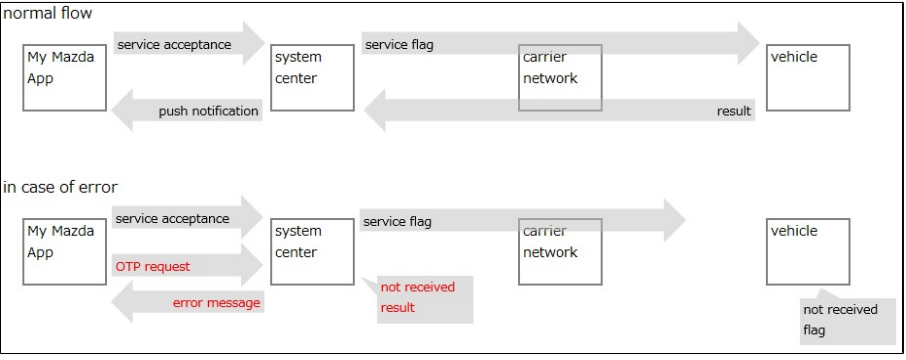
<div style="border: 1px solid black; padding: 5px;"> <p>Error</p> <p>Authorization Code request is processing. This may take up to 12 hours to complete. You will be notified when the process is completed. (400S25)</p> <div style="text-align: center; margin-top: 10px;"> <div style="background-color: black; color: white; padding: 5px 15px; display: inline-block;">OK</div> </div> </div>	<p>User will receive push notification to continue with OTP request.</p>
	<p>Cause</p>	<p>TCU is not in "Open" status</p>	
	<p>Process Flow</p>

<p>The diagram illustrates two scenarios: 'normal flow' and 'in case of error'. In the normal flow, the My Mazda App sends a 'service acceptance' message to the system center, which then sends a 'service flag' to the carrier network, which finally reaches the vehicle. The vehicle returns a 'result' to the carrier network, which sends a 'push notification' back to the system center, which then sends a 'push notification' to the My Mazda App. In the 'in case of error' scenario, the My Mazda App sends a 'service acceptance' message to the system center, which sends a 'service flag' to the carrier network, which reaches the vehicle. However, the vehicle does not return a 'result' (labeled 'not received result'), and the carrier network does not send a 'push notification' to the system center (labeled 'not received flag'). Instead, the system center sends an 'error message' back to the My Mazda App, which then sends an 'OTP request' to the system center.</p>

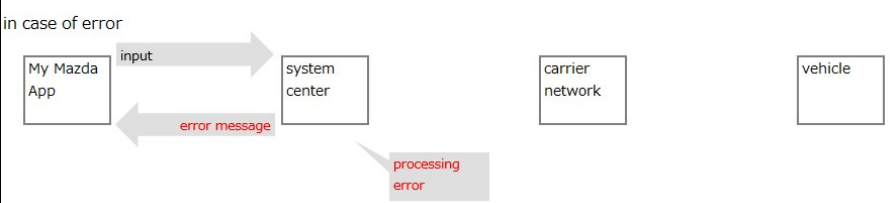
resolved by repeated retries. If the error continues to occur, there may be a problem with the system center -> Go to " Troubleshooting Instructions ".
500C03	Description	Occurs when the system center fails to access the database.	
	MyMazda App Message	An unexpected error has occurred. Please contact the call center. [500C03]	
	Cause	This is a system error and cannot be resolved by retrying.	
	Process Flow	<p>normal flow</p> <pre> graph LR A[My Mazda App] -- input --> B[system center] B -- result --> A C[carrier network] D[vehicle] </pre> <p>in case of error</p> <pre> graph LR A[My Mazda App] -- input --> B[system center] B -- error message --> A C[processing error] D[carrier network] E[vehicle] </pre>	
Confirmation/Recovery	Customer	Wait about 30 minutes and try the operation again.	
	Dealer	If the error continues to occur, there may be a problem with the system center -> Go to " Troubleshooting Instructions ".

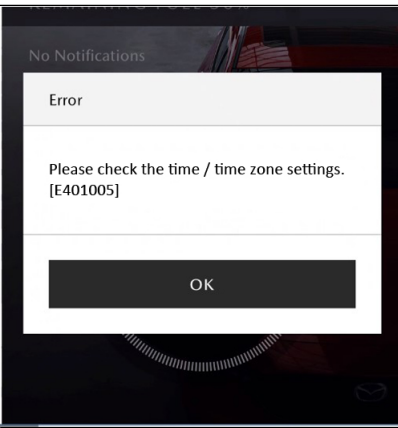
Confirmation/Recovery	Customer	Wait about 30 minutes and try the operation again.
		Dealer	System error and may or may not be resolved by repeated retries. If the error continues to occur, there may be a problem with the system center -> Go to " Troubleshooting Instructions ".
E401005	Description	Due to the app's specifications, if there is a 2+ hour difference or lag with the actual/correct time, an error could occur.	
	MyMazda App Message	Please check the time / time zone settings. (E401005)

Customer	Customer to check and verify their Date & Time settings on their phone (note: most phones will have the correct time automated based on their time zone). iPhone Example

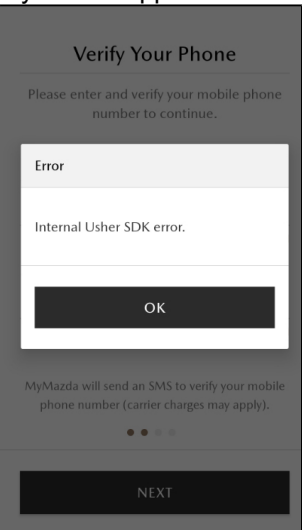
<p>Internal Usher SDK error.</p>	<p>MyMazda App Message</p>	<p>MyMazda App - Internal Usher SDK error.</p>

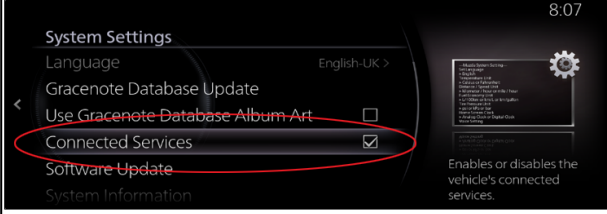
2	Check whether the vehicle requirements for remote operation are met (example : key left in vehicle during remote start function). Does the customer's smartphone MyMazda App have a failure message at the time of occurrence?	Yes	proceed to the next step
		No	Check the remote operation condition again and confirm if it works properly (example : key left in vehicle during remote start function).
3	Check MAZDA CONNECT settings. Confirm Connected Services in System Settings is Enabled.

Yes	proceed to the next step
		No	Select Enable and retry.
4	Using M-MDS, are there any DTC's stored? DTC INSPECTION	Yes	Go to normal MGSS DTC troubleshooting
		No	proceed to the next step
5	Is the TCU and CMU at the latest software version? <ul style="list-style-type: none">• CMU Software Update• TCU Software Update	Yes	proceed to the next step
		No	Update software to the latest version, then recheck concern.
6	Does the CV reception strength icon show good or weak reception? Does the CV reception strength icon show no contract?	Good Reception

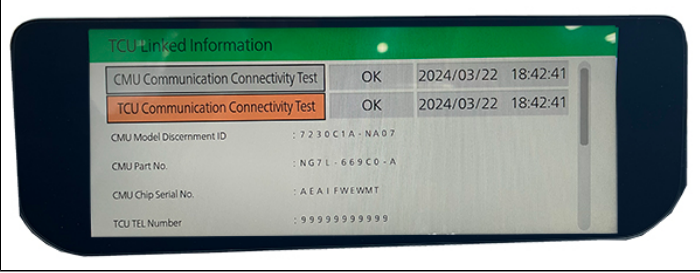
No Contract	CV enrollment needed. Go to Online Enrollment
2.	Perform CMU/TCU Communication Connectivity Test. Go to MGSS -> Diagnostic Assist Function -> Service Information -> TCU Linked Information. Perform: <ul style="list-style-type: none"> CMU Communication Connectivity Test (CMU, TCU Connection) TCU Communication Connectivity Test (TCU, Carrier Connection) 	OK	Go to next step
		NG	Go to Step 5.

<p>3.</p>	<p>Is the TCU software at the latest software version? (2019 Mazda3, Confirm CMU software is at the latest version) Go to MGSS Diagnostic Assist Function -> Service Information -> TCU Linked Information -> TCU Software Version</p>

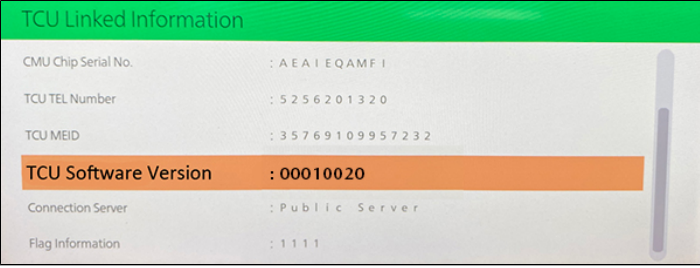
<p>Go to MGSS -> Infotainment/TCU -> Telematics Communication Unit (TCU) Updates and confirm at latest software version.</p>	<p>Yes</p> <p>Go to next step.</p> <p>No</p> <p>Update TCU software</p>																			
<p>4.</p>	<p>Check TCU CV Contract Status</p> <p>a. Go to MCVV -> Select "Vehicle Communication Line Status Reference"</p> <p>b. Enter VIN and then select "Search"</p> <p>c. Is the Status Detail "Open Completed" or "Closed Completed"?"</p> <p>Example of Open Completed</p> <table border="1" data-bbox="161 1133 963 1238"> <thead> <tr> <th colspan="3">Vehicle Communication Line Atatus</th> </tr> <tr> <th>Status</th> <th>Request Date</th> <th>Status Detail</th> </tr> </thead> <tbody> <tr> <td>Opened</td> <td>10/12/2022 23:01</td> <td>Open Completed 10/12/2022 23:51</td> </tr> </tbody> </table> <p>Example of Closed Completed</p> <table border="1" data-bbox="161 1274 963 1379"> <thead> <tr> <th colspan="3">Vehicle Communication Line Atatus</th> </tr> <tr> <th>Status</th> <th>Request Date</th> <th>Status Detail</th> </tr> </thead> <tbody> <tr> <td>Closed</td> <td>10/12/2022 23:01</td> <td>Closed Completed 10/12/2022 23:51</td> </tr> </tbody> </table>	Vehicle Communication Line Atatus			Status	Request Date	Status Detail	Opened	10/12/2022 23:01	Open Completed 10/12/2022 23:51	Vehicle Communication Line Atatus			Status	Request Date	Status Detail	Closed	10/12/2022 23:01	Closed Completed 10/12/2022 23:51	<p>Open Completed</p> <p>Go to next step</p> <p>Closed Completed</p> <p>CV enrollment needed Go to Online Enrollment</p>
